Post-Earthquake Rapid Damage Assessment of Road Bridges in Glina County

Anđelko Vlašić *, Mladen Srbić, Dominik Skokandić and Ana Mandić Ivanković

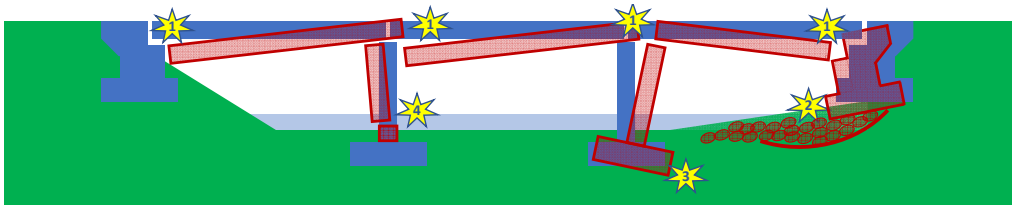
Figure 4. Most common earthquake types of bridge sudden collapses (any or all can occur): 1—bearing slippage; 2—abutment foundation soil landslide; 3—column turnover; 4—column shear failure.

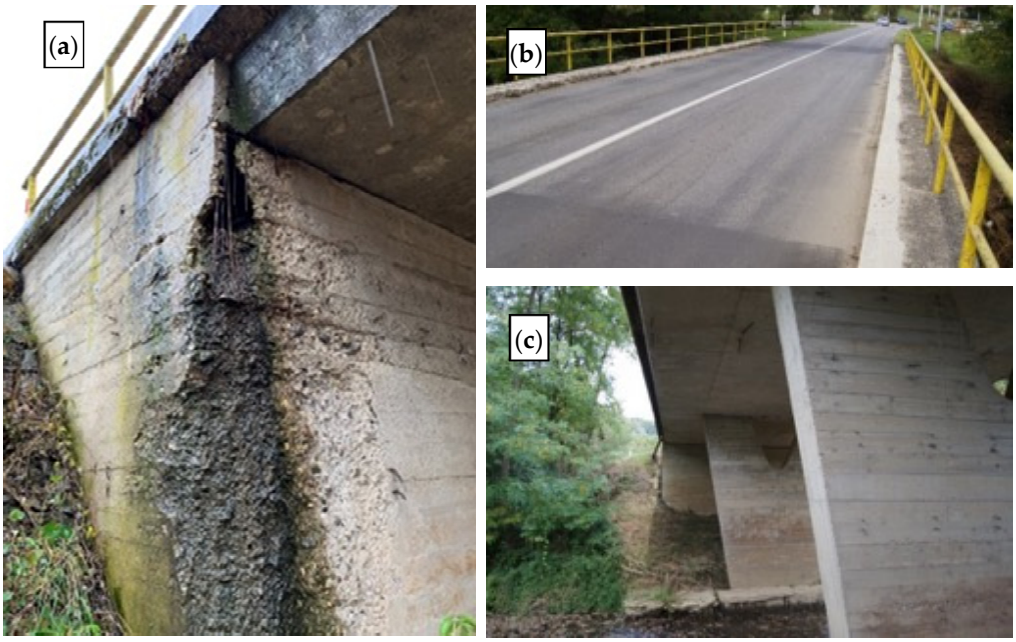
This bridge is located in the south access road to the town Glina (Figure 5). It is a reinforced concrete slab bridge with over three spans of 7.5 + 10 + 7.5 m (Figure 6). The superstructure comprises a 50 cm thick reinforced concrete slab that is directly supported by wide columns branching at the top. The width of the bridge is 8.5 m, columns are of variable cross-section between 3.2 × 0.5 m at the bottom and two branches (arms) at the top, each 1.5 × 0.5 m. The height of the columns is 5.7 m. The abutments are massive reinforced concrete structures with about 3–4 m high walls and 3.8 m long wings. Column foundations are 4.0 × 2.2 m slabs. There are no bearings present on the bridge and bridge is without any drainage elements. There was visible damage on the abutment walls, where the corner part of the side walls was found to be missing on both abutments, and reinforcement bars were protruding out of concrete (Figure 9a).

Figure 9. Roviška bridge: (**a**) damage to the abutment wall and wing, as well as drainage problems; (**b**) degraded footway (left) and new footway (right); (**c**) substructure without signs of earthquake damage.

Since the damaged parts of the wall showed heavy discolorations, traces of long-term water leakage, and algae sedimentations, it was evident that this damage was not caused by this earthquake. The quality of concrete in these fallen off parts of the abutment corners could be described as poor, exhibiting the local segregation of large fractions of aggregate and very low quantity of reinforcement. It is possible that this damage was a consequence of faults during erection since it resembled typical damage observed when improper concreating without vibration is performed. Since this damage was very localized and not in the main load transfer path, it was not considered serious at this stage of post-earthquake bridge evaluation. It did not compromise the load-bearing capacity of the abutment wall. One of the bridge footways and cornices were heavily degraded due to lack of waterproofing and reinforcement corrosion. The other footway had been rehabilitated in the past with a new concrete layer (Figure 9b).

Overall, the bridge was found to be in structurally good condition and showed no signs of damage due to the earthquake. There was no damage to the asphalt joint between the abutment and superstructure, and no displacements were recorded at the superstructure supports. Columns and abutments were without any major cracks, rotations, or settlements (Figure 9c). After the earthquake, the bridge was continued to be used for traffic without any restrictions. Further inspection and rehabilitation were recommended due to prior

abutment wall damage, visible reinforcement corrosion, and possible scour on foundation piers.

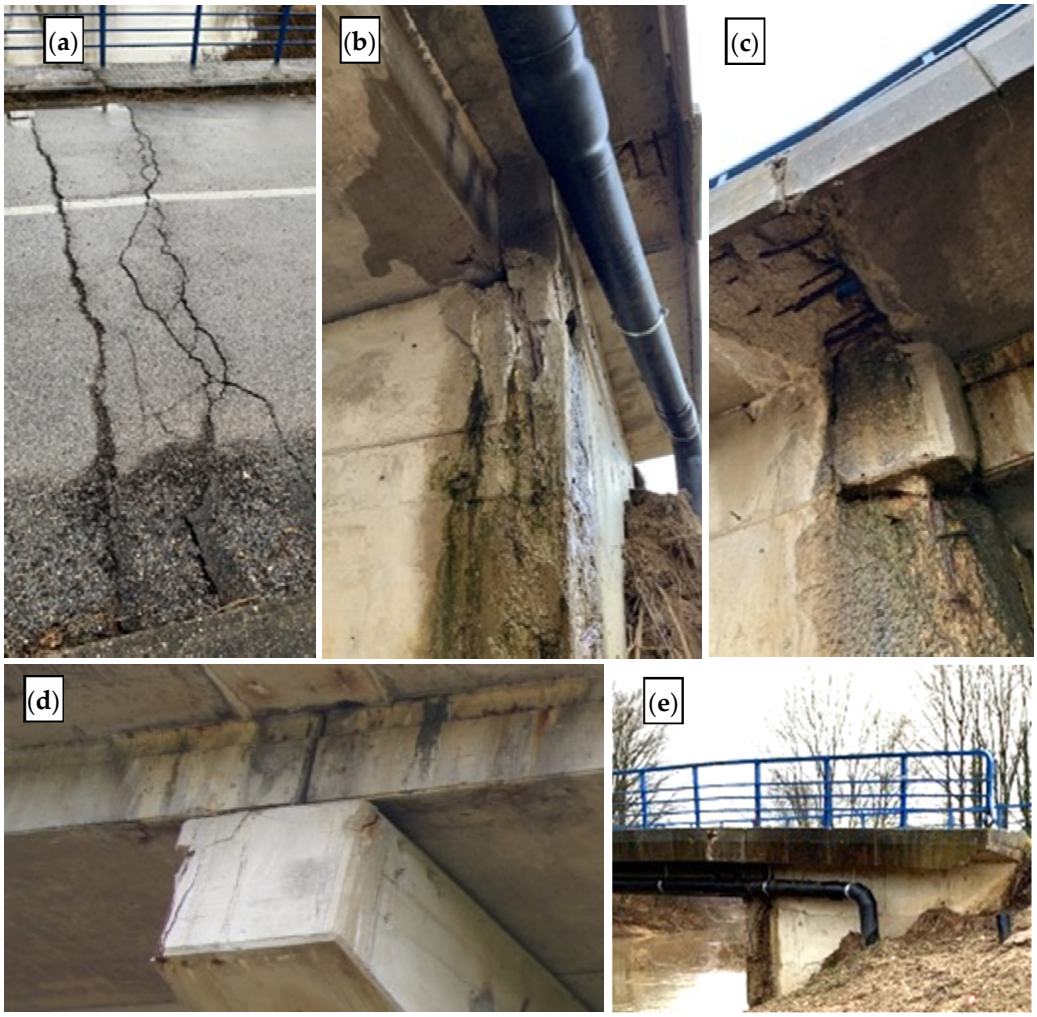
Earthquake-related damage was recorded on several elements of the bridge. It was evident that the bridge superstructure moved both longitudinally and transversely at a notable rate. The first proof of such movements could be seen on the asphalt layer at the ends of the bridge superstructure, which was heavily cracked, waved, and delaminated upwards (Figure 14a). This movement also caused the fracture of bridge cornice, which was executed without any dilatation between the abutment and superstructure (Figure 14c,e). It is surprising that a bridge this long does not have expansion joints at the ends that would accommodate for such movements without causing any damage. Secondly, transverse movements caused heavy damage to abutment side walls, thus cracking and completely fracturing parts of them (Figure 14b). It is also incorrect that the abutment side wall is so close to the superstructure with no tolerances for transverse movements of any degree (the abutment was found to be too narrow for this width of the superstructure). The structure of this bridge is very flexible due to tall single piers of circular cross-section, positioned centrally along bridge axis. Therefore, it is not surprising that the bridge exhibited large movements during the earthquake; it is more surprising that these movements were not accounted for in the design of both the expansion joints and spacing tolerances between the substructure and superstructure elements.

Figure 14. Hađer bridge: (**a**) damage caused by earthquake in the asphalt; (**b**) fractured abutment side wall due to the earthquake; (**c**) water leakage from superstructure end, causing damage to abutment; (**d**) uneven support length for the girders; (**e**) cracked cornice due to earthquake movement.

It is evident that all the damage due to the earthquake could have been easily avoided if proper design rules had been followed. Besides the described damage, which can be regarded as non-structural, the bridge performed well in this earthquake event. Further inspection and rehabilitation were recommended due to aforementioned earthquake damage and heavy reinforcement corrosion of column heads and abutment walls.

Regarding the recommendations for the other examined bridges, the Hađer Bridge most critically needs detailed inspection and rehabilitation following earthquake damage. Since this damage was caused by improper movement management, it is recommended that expansion joints allowing for seismic movements are added at the bridge ends and above the central dilatation column. The inelastic movements should also be checked by nonlinear calculations to determine if the safe tolerances against slippage of the girders are met.
