A Multidisciplinary Approach for the Vulnerability Assessment of a Venetian Historic Palace: High Water Phenomena and Climate Change Effects

The proposed multidisciplinary method is applied to the case study of Palazzo Malipiero, located in Campo San Samuele in Venice, focusing on theoretical and operational issues.

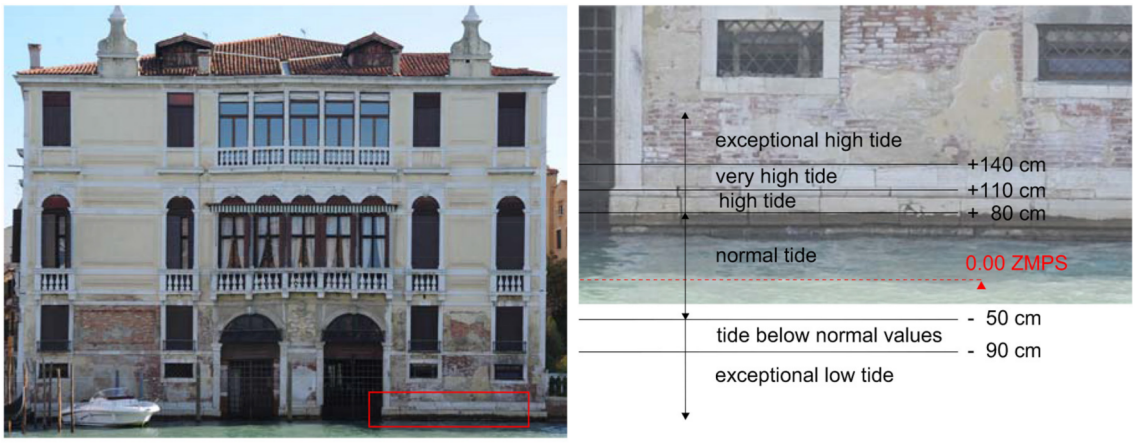
Analysis of the rooms on the ground floor of the palace has shown, from the preliminary stages, transformations consequent to continuity of use; frequent replacement of the wall's portions (i.e., the "*cuci-scuci*" technique) at the lowest levels; phenomena of erosion of blocks and mortar joints of the ancient materials but also those most recently employed against rising damp, the phenomena of saline crystallization and related to wave motion. In the facades overlooking the Grand Canal, the presence of "*cadene*" has been detected, the typical technical solution against the high tide for the Venetian palaces described in Section 3, which in this case, appear to be still effective up to a very high tide condition (+1.10 m ZPSM), Figure 9.

Figure 9. Palazzo Malipiero, Venice. Façade over the Grand Canal: (**a**) photo-rectification with identification of "*cadene*"; (**b**) detail of "*cadene*" with reference to tidal altimetric elevations.

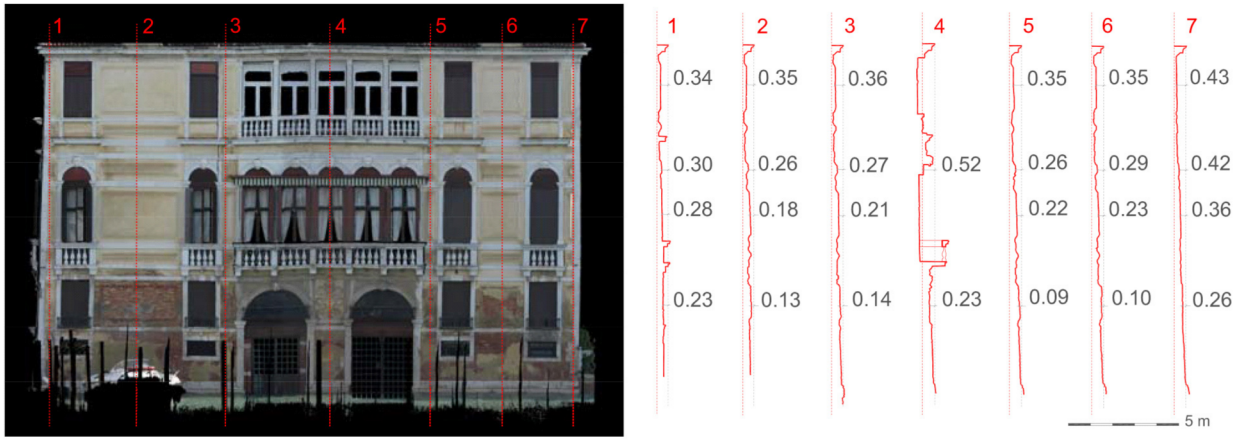
Figure 10. Palazzo Malipiero, Venice. Facade facing the Grand Canal: (**a**) geometric survey; (**b**) processing in false color scale to highlight the overhanging portions (blue, green and yellow). Survey and processing carried out by Circe photo-grammetry laboratory—Iuav University of Venice.

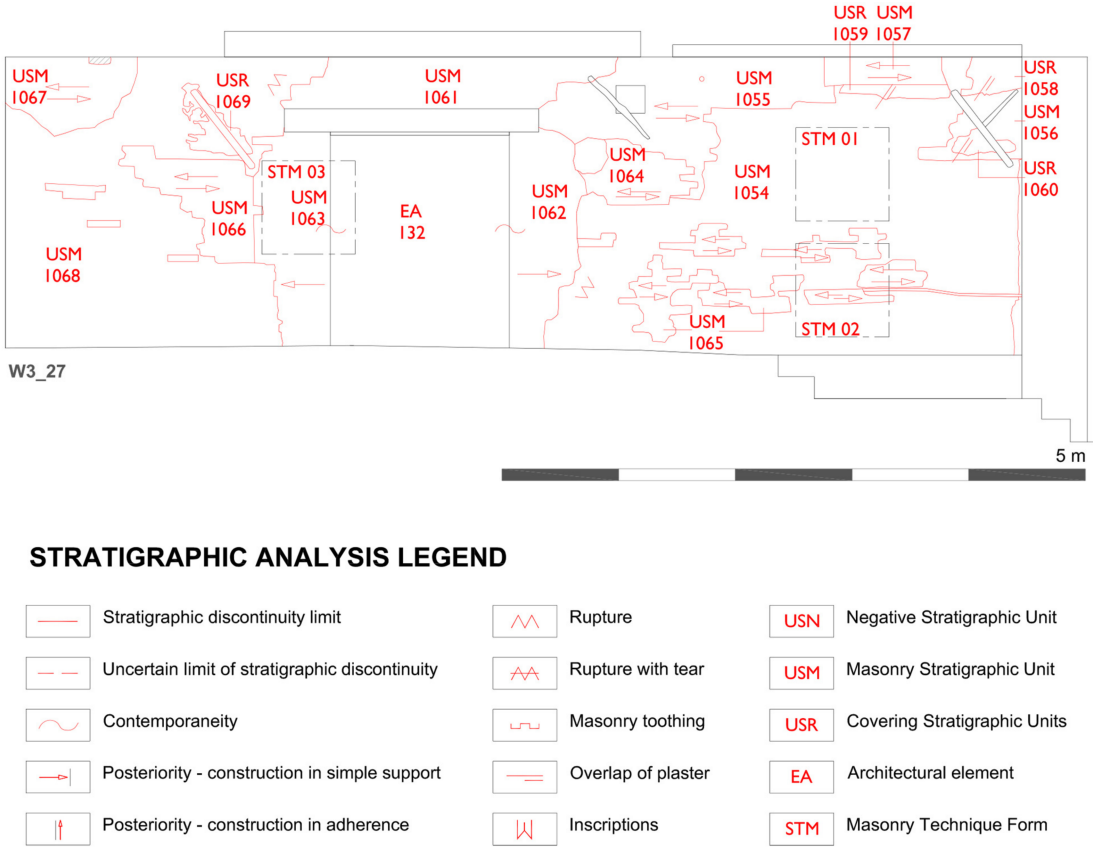
Masonry type M2 has the following characteristic: original bricks with some elements of reuse (recurring size 24 × 6 × 11 cm), arranged in the horizontal course (USM 1054); high erosion level of blocks and joints with consequent punctual replacement of bricks with new production elements (construction intervention described by USM 1065); lacing

courses with head elements; flush joints (horizontal thickness 10 mm), mixed mortar and punctual remarking of the concrete joints. It was not possible to examine the section, which has a thickness of 0.44 m, but on the basis of the information collected, a good connection of the cross-section can be hypothisized even in the absence of real through stones.

Figure 15. Palazzo Malipiero, Venice. Wall W03_27: stratigraphical survey.

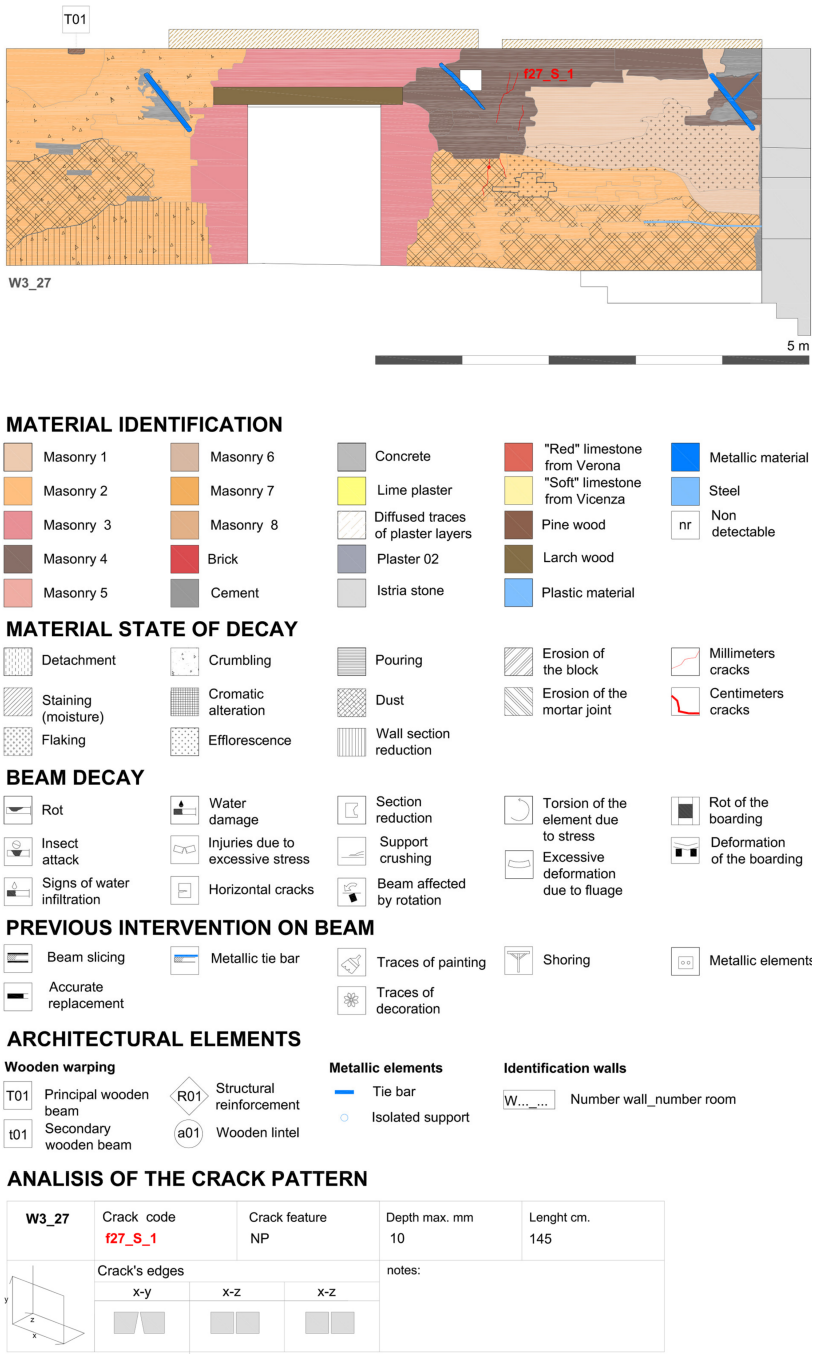
Figure 17. Palazzo Malipiero, Venice. Wall W03_27: material and degradation survey and crack pattern.

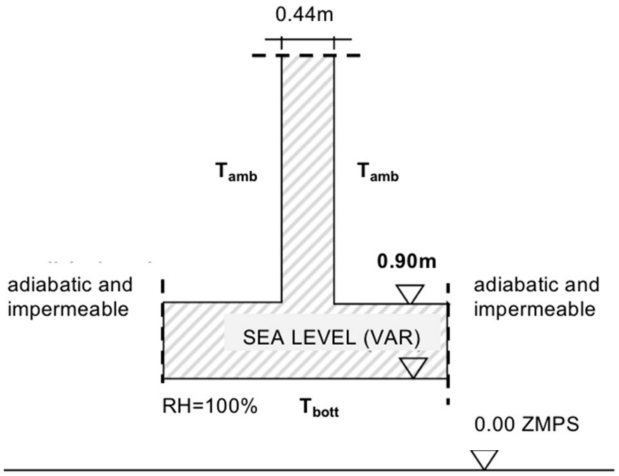
A scheme of the two-dimensional model with the relative boundary conditions is represented in Figure 18, where reference is made to the ZMPS elevation for the altitudes. The computational domain is bounded below by the sea level, so the domain base is assumed to be permanently moist (RH = 100%).

Figure 18. Scheme of the model with the boundary conditions adopted for the numerical simulation of the rising damp in the wall W03_27.

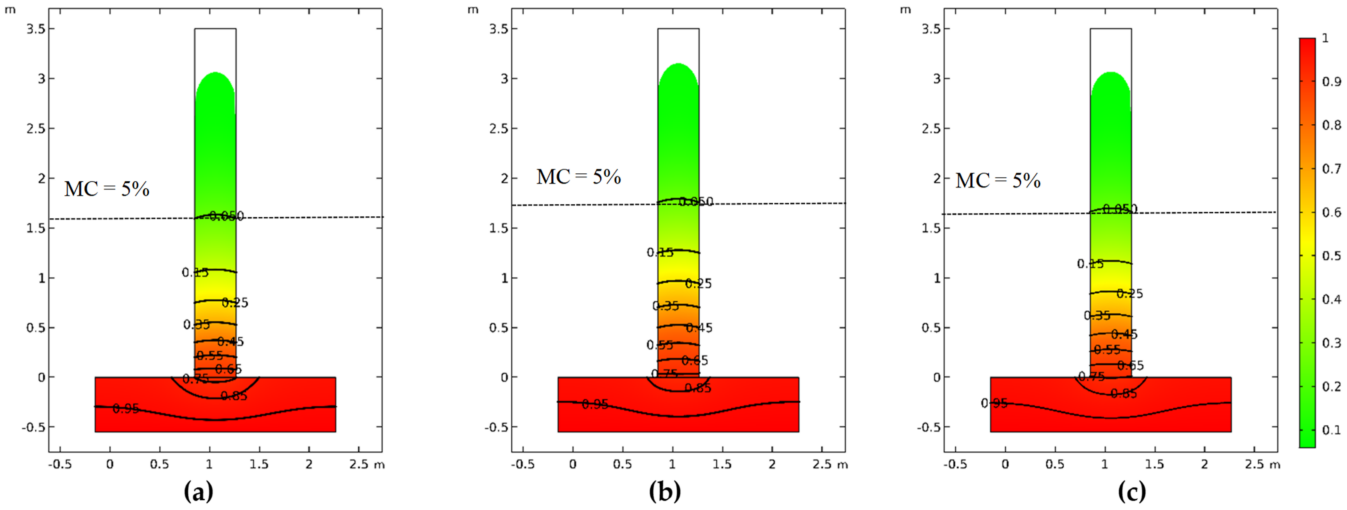
Figure 20. Contour of Moisture Content (MC): (**a**) in equilibrium conditions for moisture inside the wall with an average sea level at 0.35 m ZMPS; (**b**) Maximum rising damp front (MC = 5%) after an exceptional event, 7 days after the restoration of the average conditions; (**c**) Maximum rising damp (MC = 5%) after the exceptional event with MOSE activation, after 7 days from the restoration of the average conditions.

The same figure also indicates the rising damp front, which in this study was identified with the isoline corresponding to a water content MC = 5%, since for lower values the salts do not have the possibility of nucleation. In average sea level conditions, the rising damp settles at around 1.63 m from the ground level, which is a quite high value as this is an internal wall for which evaporation per unit of volume is limited, given the thickness and the absence of solar radiation. In the case of an exceptional event not regulated by the

MOSE (Figure 20b), there is an increase in the rising damp front of 0.15 m, which, therefore, settles at approximately 1.80 m ZMPS. Assuming the activation of the MOSE (Figure 20c), the maximum level reached from the rising damp front settles at around 1.70 m from the floor, with a lowering of about 10 cm compared to the previous case. The effect of MOSE activation, therefore, produces an improvement of the effects of rising damp, albeit in this case limited.

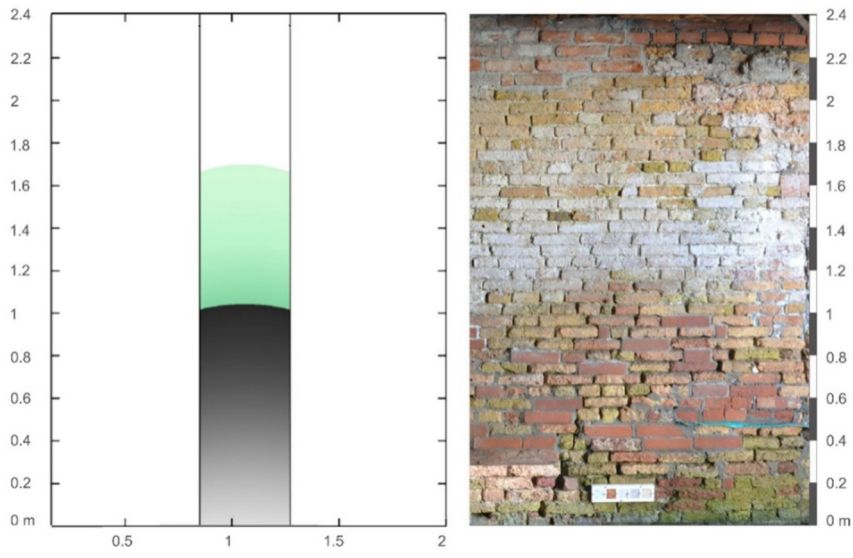
The analyses carried out show how three different moisture zones can be identified along the height of the wall: the lower zone is significantly soaked in water, then there is a zone in which the water content drops due to evaporation until it reaches an area where moisture is balanced by the environmental conditions. The intermediate zone is often associated with the maximum salt concentration for the nucleation of the salt crystals after precipitation. In particular, according to Biscontin [67], the zone of greatest crystallization varies between the permanently humid front and the sporadically humid front. Accordingly, the zone of possible salt formation was evaluated as the one corresponding to MC val-ues in the range 5–15% (MC = 5% in exceptional tide conditions–MC = 15% in average sea conditions), given that MC = 5% was assumed as the limit of the rising damp front and MC = 15% as a value beyond which there is a limited crystallization confirmed also by the results of Rirsch [68]. On the basis of the numerical results shown in Figure 20a,b, the area of possible precipitation of salts represented in Figure 21a was thus ob-tained, which affects a zone between 1.00 m and about 1.70 m ZMPS. This result is in good agreement with what has been observed in-situ on the considered wall which features a diffuse efflorescence on a band between 1.10 m and 1.80m from ground level, as shown in Figure 21b.

Figure 21. Area of possible precipitation of salts in the wall W1_27: (**a**) results of the numerical simulation (in green), (**b**) saline efflorescences detected on 23 September 2019.

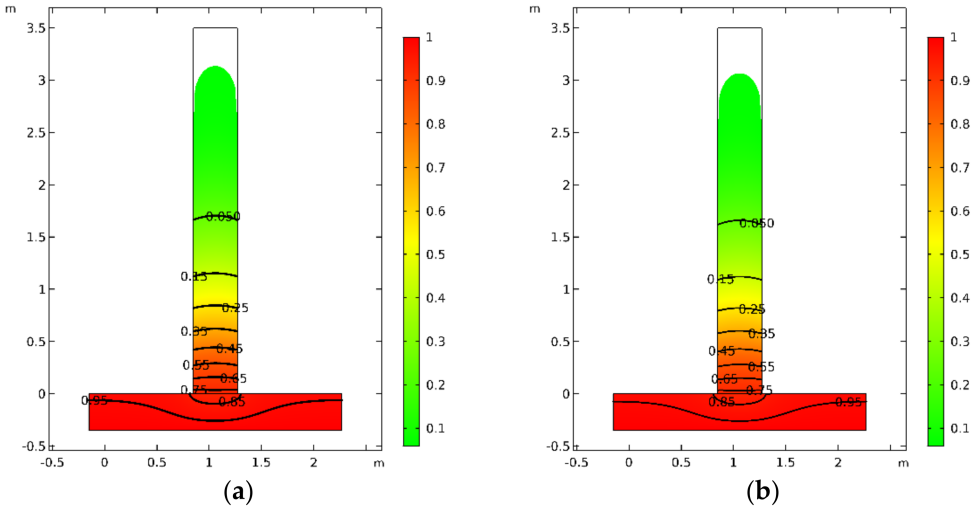
The results obtained from the numerical simulation assuming a sea level equal to +0.537 m are reported in Figure 23a. Adding also the effect of the temperature increase, the rising damp settles around 170 cm as can be seen in Figure 23b, slightly lower (about 5 cm) than the case with only sea level rise.

Figure 23. Prediction of capillary rise with reference to the scenario SSP5-8.5: (**a**) effect of sea-level rise; (**b**) combined effect of both sea level and temperature increase.
