Climate Risk and Conservation Challenges at Palermo's Specola Museum

Abstract: The Specola Museum is housed on the premises of the old Palermo Observatory, founded in 1790, and preserves most of the observatory's cultural heritage. Environmental monitoring following the activation of air conditioning systems in 2018 revealed significant deviations from the historic thermo-hygrometric trends, with particularly dangerous fluctuations in relative humidity. A notable example of the impact of these changes is a 19th-century painted wooden Model of Mars, displayed in the Merz Hall since 2021. In less than two years, the Model has shown progressive damage to its paint layers. Conservation actions have been adopted to stop the deterioration process, but the risk of further deterioration phenomena involving other objects is expected to increase substantially in the absence of intervention. This paper presents the outcomes of a preliminary study on the thermo-hygrometric conditions in the Merz Hall. Based on the European Standard EN 15757: 2010 and the Italian Legislative decree of 10 May 2001, safe ranges for temperature and relative humidity have been identified for the long-term preserva

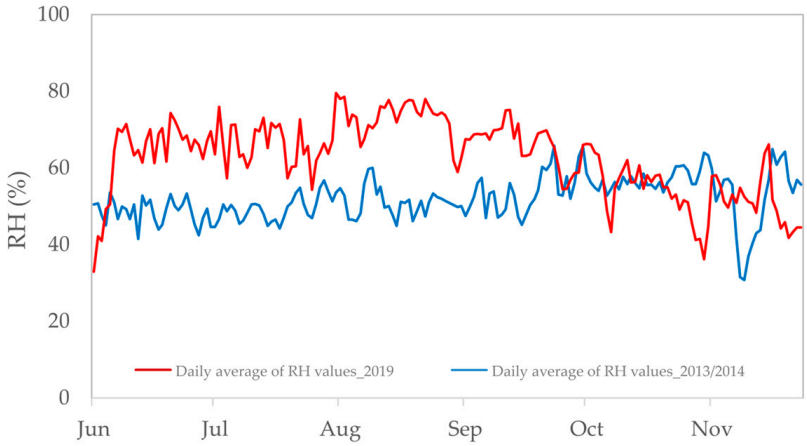
Figure 7. Comparison of the daily average RH values recorded between June and November for the 2013–2014 and 2019 series. It should be noted that between June and October 2019, the average relative humidity values (%) and the maximum daily fluctuations recorded inside the room were higher than those observed during the same period when the air conditioning system was inactive.

The comparative graphs (Figures 7 and 8) clearly illustrate the difference in RH trends before and after the system's activation. A comparison with external conditions highlights that the internal climate was far more stable when the conditioning systems were inactive. The current management of the system brings a climate that contrasts sharply with previous conditions, indicating that the climate the objects had adapted to was disrupted, albeit with the intention of preservation.

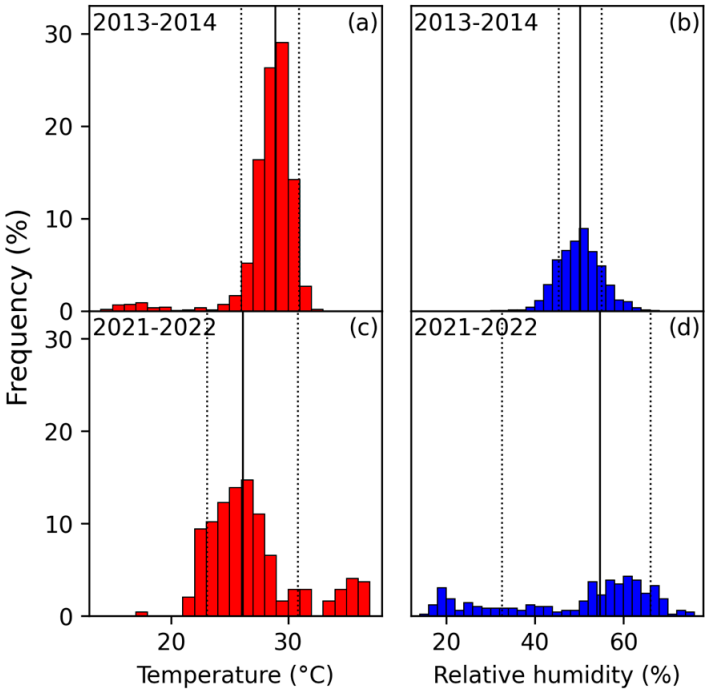
Figure 8. Comparison of daily mean temperature and relative humidity distributions in the Merz room during the periods 2013–2014 (**a**,**b**) and 2021–2022 (**c**,**d**). The continuous vertical lines are the median of the data for each distribution; the dotted vertical lines show the mean ± σ values.

The data show notable shifts in temperature and humidity distributions over time. For the 2021–2022 period, the microclimatic conditions associated with damage observed

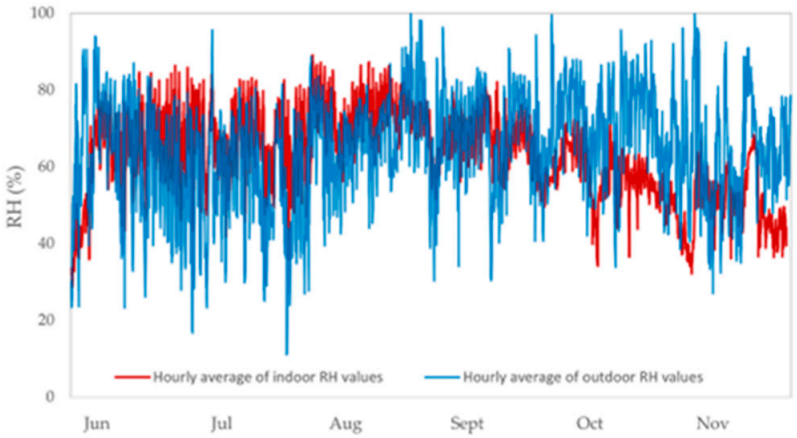
However, in 2019, the data show that from June to October, the parameter trends in the room no longer followed the outdoor ones. This year was, in fact, characterized by average daily RH excursions of 10–15%, sometimes larger—between 20–25% and 30%—occurring multiple times within a single day and by prolonged periods of low RH (Figure 9).

Figure 9. Comparison of the hourly average RH values recorded outdoors and indoors in 2019.

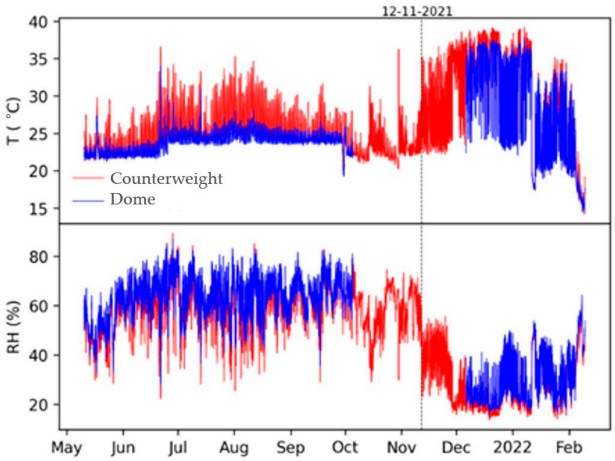
An even more dangerous trend in RH was recorded in Merz Hall from November 2021 onwards. The data presented in Figure 10 reveal that between November 2021 and February 2022, the temperatures in the Hall were unusually high, ranging from 35 °C to nearly 40 °C. This indicates that the air conditioning system overheated the environment, most likely due to a failure. This resulted in a drop in relative humidity, frequently to dangerously low levels, well below 40% for several days. During this extended period of low RH, the Model suffered critical failure.

Figure 10. High temperature values were recorded between November 2021 and February 2022. The excessive warm air introduced by the system caused a drop in the RH values, often below 40%.

The climate control systems have therefore introduced complications, particularly when failures occurred, as happened in November 2021 (Figure 10).

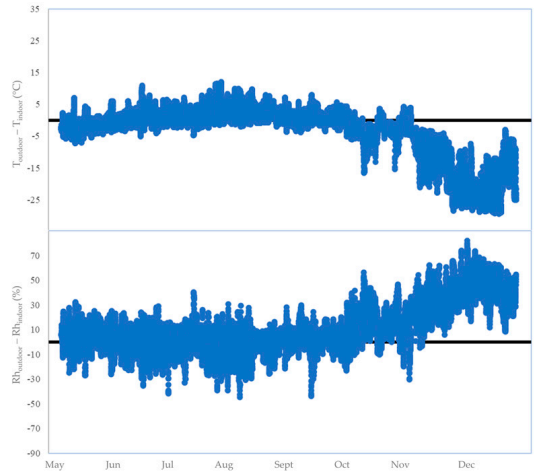
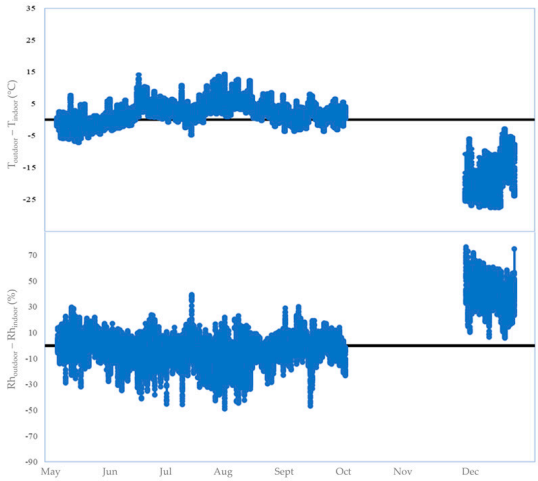
A clear pattern emerges when comparing the conditions inside the dome with those of the external environment during the same period (Figure 11). Initially, up until September–October, the indoor temperature and humidity levels closely matched those of the outside. However, after September, a noticeable shift occurred. Indoor temperatures began to fall below the corresponding outdoor levels, while humidity levels rose above them. This divergence strongly suggests that the indoor environment was becoming increasingly disconnected from the natural external conditions.

Figure 11. (**a**) Difference between the temperature and the relative humidity inside the dome and the external values. (**b**) Difference between the temperature and the relative humidity values recorded in the lower part (counterweight) and the external values. Up until October 2021, indoor values followed the outdoor trends. Starting in November, the pattern shifted with indoor T values consistently higher and RH values lower than the outdoor ones. The gaps in the graphs are due to sensor battery failures.

This anomalous trend is more apparent in the graphs related to data recorded in the dome area than in that reflecting the conditions in the lower part of the room. Here, the effects of excessive heating are less visible, likely because warm air tends to rise, concentrating the impact in the upper part of the room, particularly in the dome. This discrepancy between the upper and lower parts of the room further underscores the uneven distribution of temperature and humidity, which could have significant implications for the preservation of materials within the space.

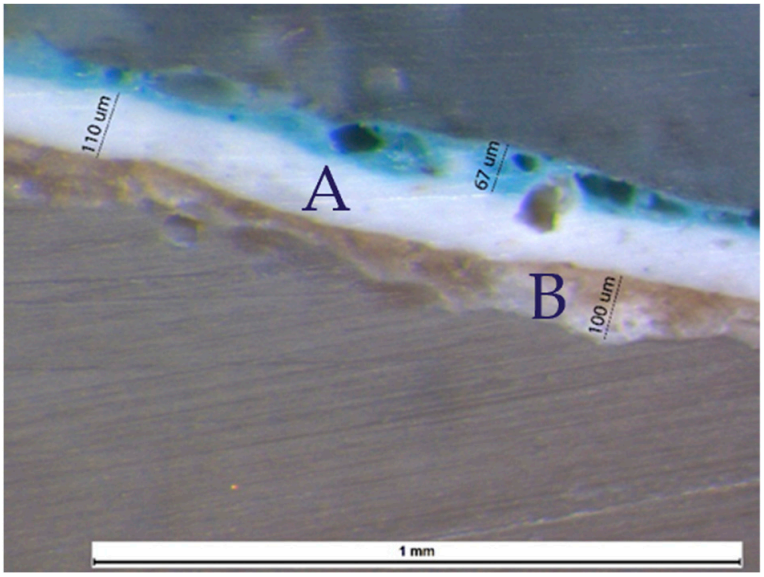
The cross-section of a sample with traces of blue pigment, observed under optical microscopy, revealed two ground layers: a compact white layer beneath the paint layer, and another one, less brilliant and less compact, directly applied to the wood (Figure 12). The layers appeared well-adhered and cohesive. Figure 12 shows the thickness of each layer.

Figure 12. Cross-section of a fragment of the pictorial layer with blue pigment, under visible light, with metric scale. Two ground layers (A and B) beneath the blue paint layer are visible.

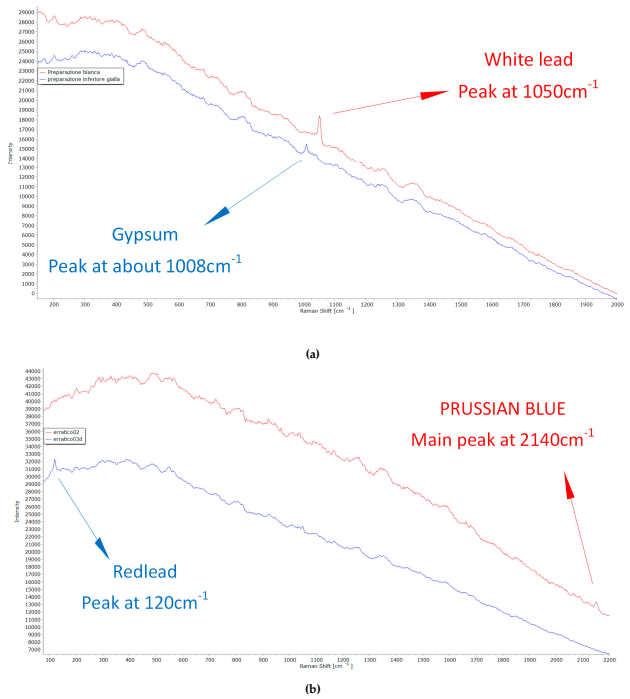
Raman spectra of layer A showed a peak at approximately 1050 cm^{-1}, indicating the presence of white lead while layer B exhibited the characteristic peak of gypsum (Figure 13a). In Figure 13b, the spectra of the orange and blue pigments are reported. The spectrum of the blue pigment showed a main peak at 2140 cm^{-1}, consistent with Prussian blue. The orange paint layer exhibited the typical peak of red lead (Pb_3O_4) at around 120 cm^{-1}, along with the peak of white lead at 1050 cm^{-1}.

Figure 13. (**a**) Raman spectra of the ground layers shown in Figure 10. White lead is identified in layer A, while layer B contains gypsum; (**b**) Raman spectra of the pictorial layers reveal the presence of Prussian blue in the blue layer and red lead in the red paint.

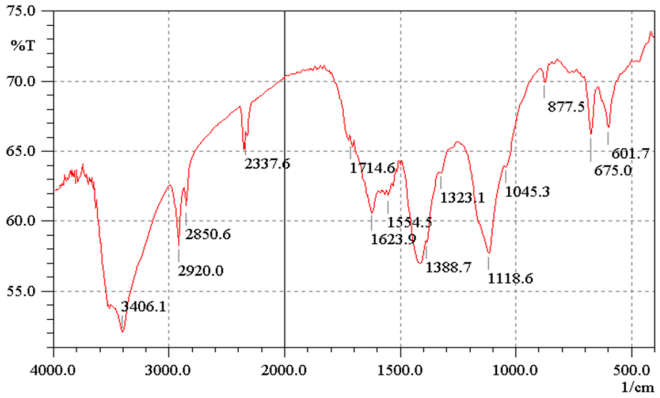
Infrared spectra of the ground layer (Figure 14) confirmed the presence of gypsum, indicated by peaks at 1119 and 601 cm^{-1}, and double peak at approximately 3406 cm^{-1}. The peak at around 1400 cm^{-1} is associated with both calcium carbonate (peak at 877 cm^{-1}) and white lead (peak at 675 cm^{-1}). The spectra also showed a double amino peak between 1630 and 1550 cm^{-1}, suggesting the presence of a proteinaceous adhesive in the ground layer.

Figure 14. FTIR spectra of the sample shown in Figure 12.

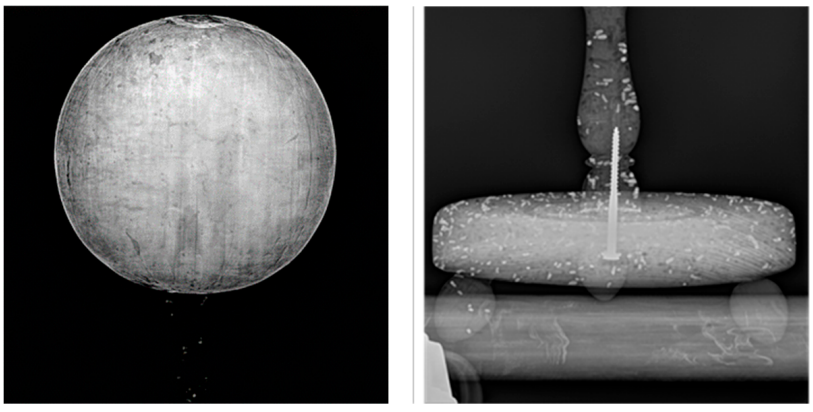
The images obtained by X-ray radiography revealed a "tenon and mortise" joint system between the Model and its wooden pedestal (Figure 15a). The tenon, carved from the wooden rod, is inserted into a mortise cut into the sphere, with the mortise being slightly larger than the tenon. Additionally, a modern screw was visible, securing the base to the rod by penetrating about one-third of its length (Figure 15b). Note that both the base and the rod exhibit numerous insect exit holes, visible due to the complete radiolucency of the black varnish applied during a previous restoration. Most of the holes had been filled.

Figure 15. (**a**) The wooden sphere; (**b**) the painted wooden structure anchoring the Model.

The X-ray images also documented the exit holes from wood-boring insects and the fractures in the wooden support, running parallel to the wood grain. This pattern of cracks and detachment aligned with the wood grain strongly suggests that thermo-hygrometric stresses, which induced volumetric changes in the wood, are likely the primary cause of the degradation observed on the surface of the wooden sphere.

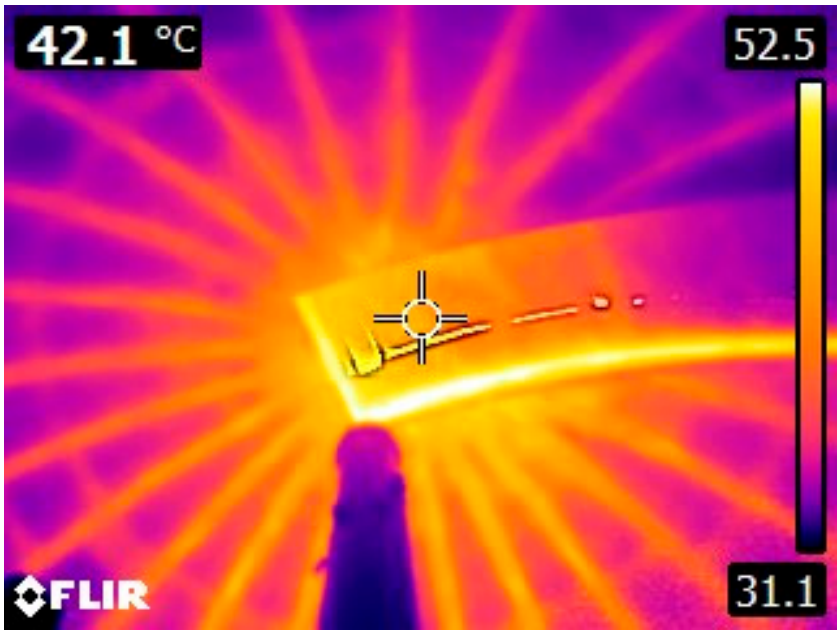
The other critical factor is the infrared radiation (IR) coming from the dome. In dome-shaped rooms, IR is generated by the dome itself, being exposed to sunlight during the day. The dome, built with high thermal conductivity materials, absorbs solar radiation and re-emits it as IR into the indoor environment during the daytime. This re-emitted IR can significantly exacerbate air stratification issues and further destabilize the indoor climate. Moreover, prolonged exposure of the objects on display to IR can accelerate their ageing process, leading to the fading of colours, the degradation of organic materials, and the embrittlement of polymers.

Thermal imaging captured with an infrared camera reveals that the dome reaches high temperatures, particularly in the metallic sections of the structure. The thermogram in Figure 16, taken in June 2023 in the afternoon, shows the radiant surface temperatures of the dome materials.

Figure 16. The surface temperature of the dome (T °C) detected with an infrared thermal camera in June 2023. The metallic ribs reach temperatures close to 53 °C, while the insulated panels show a temperature of around 30 °C. The thermogram was acquired using a FLIR E6xt infrared camera and processed through the FLIR Tools® Mobile app, version 2.6.0.215.

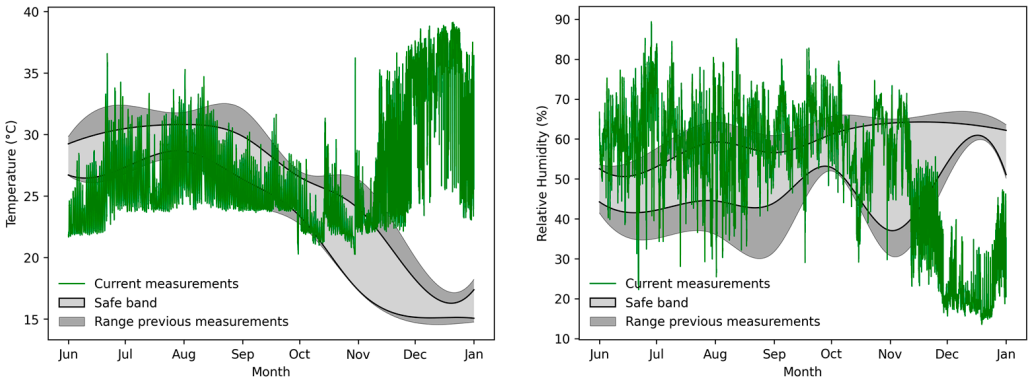
As shown in the graphs (Figure 17), in 2021, the parameters frequently exceeded the boundaries of the safe band, posing a significant risk to the displayed objects.

Figure 17. Determination of the safe band for T (**a**) and for RH (**b**) as explained in the EN 15757:2010 standard.

Given that part of the collection cannot be relocated from Merz Hall without risking decontextualization, it is crucial to develop strategies that address the conservation challenges posed by the room's environment. A viable solution involves minimizing dependence on the air-conditioning system by leveraging the building's inherent thermal inertia. This may be achieved through a combined active and passive approach to microclimate control, which prioritizes the exploitation of the museum building's thermophysical properties, reserving the use of air-conditioning systems only for extreme scenarios to adjust parameters that fall outside the safe bands identified during the study.

In addition, the replacement of current display cases with climate-controlled models should be considered as an effective mitigation measure. This would offer localized protection for sensitive artefacts, shielding them from harmful environmental factors and enhancing long-term preservation efforts.

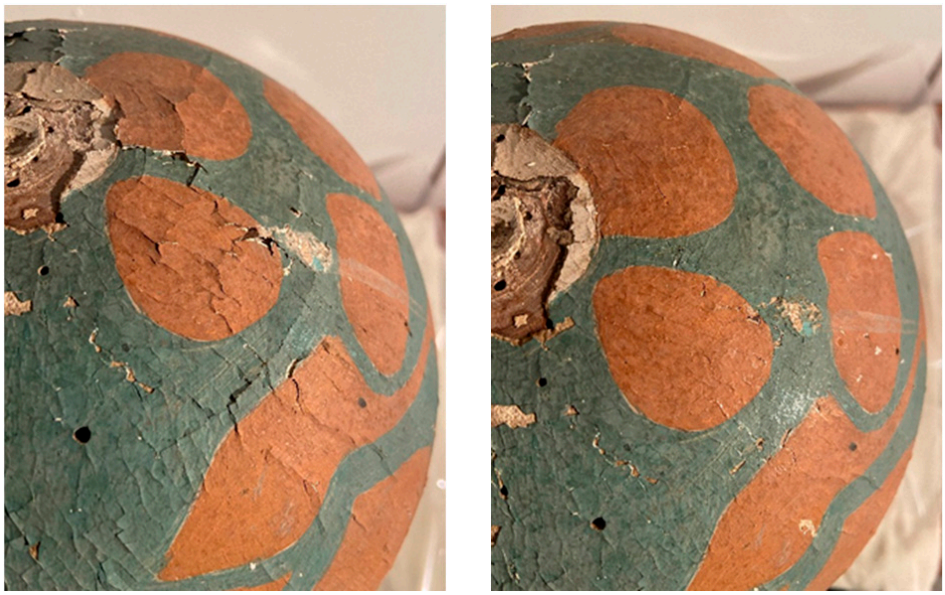
Figure 18. The Model of Mars before consolidating the pictorial layers (**a**) and after the treatment (**b**).

In areas with widespread flaking, the glue was applied by a brush, interposing a sheet of Japanese paper. After a few seconds, gentle pressure was applied to the area protected by the paper, using the brush bristles or cotton swabs, to promote the re-adhesion of the layers. Once the Japanese paper had been carefully removed, heat and pressure were applied with a spatula or thermocautery, protecting the painted surface with the heat-resistant polyester film [52–55].

These operations ensured the preservation of the object in its authenticity and saved all original paint fragments that had lost cohesion and adhesion (Figure 18a). Visible traces of a probable protective layer applied to the upper half of the Model (Figure 18b) were not removed on this occasion to allow for future analysis of the object and its conservation history.

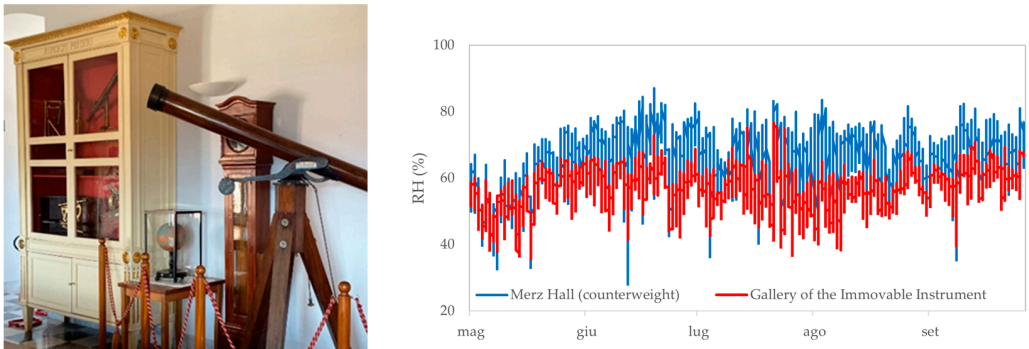
Once the pictorial film had stabilized, the Model was moved temporarily to a room of the museum (Figure 19a) with a more stable climate, where no significant RH peaks have

been recorded in recent years (Figure 19b). In the next months, the Model of Mars will be placed inside a new climate-controlled display case to ensure appropriate temperature and relative humidity values for the long-term conservation of the object.
