# Unfavorable Relative Humidity as a Cause of Deterioration–Risk Assessment for the Humidification of a Medieval Polychromed Wooden Panel in Historic Context

### *1.1. Case Study: Maundy Thursday Retable*

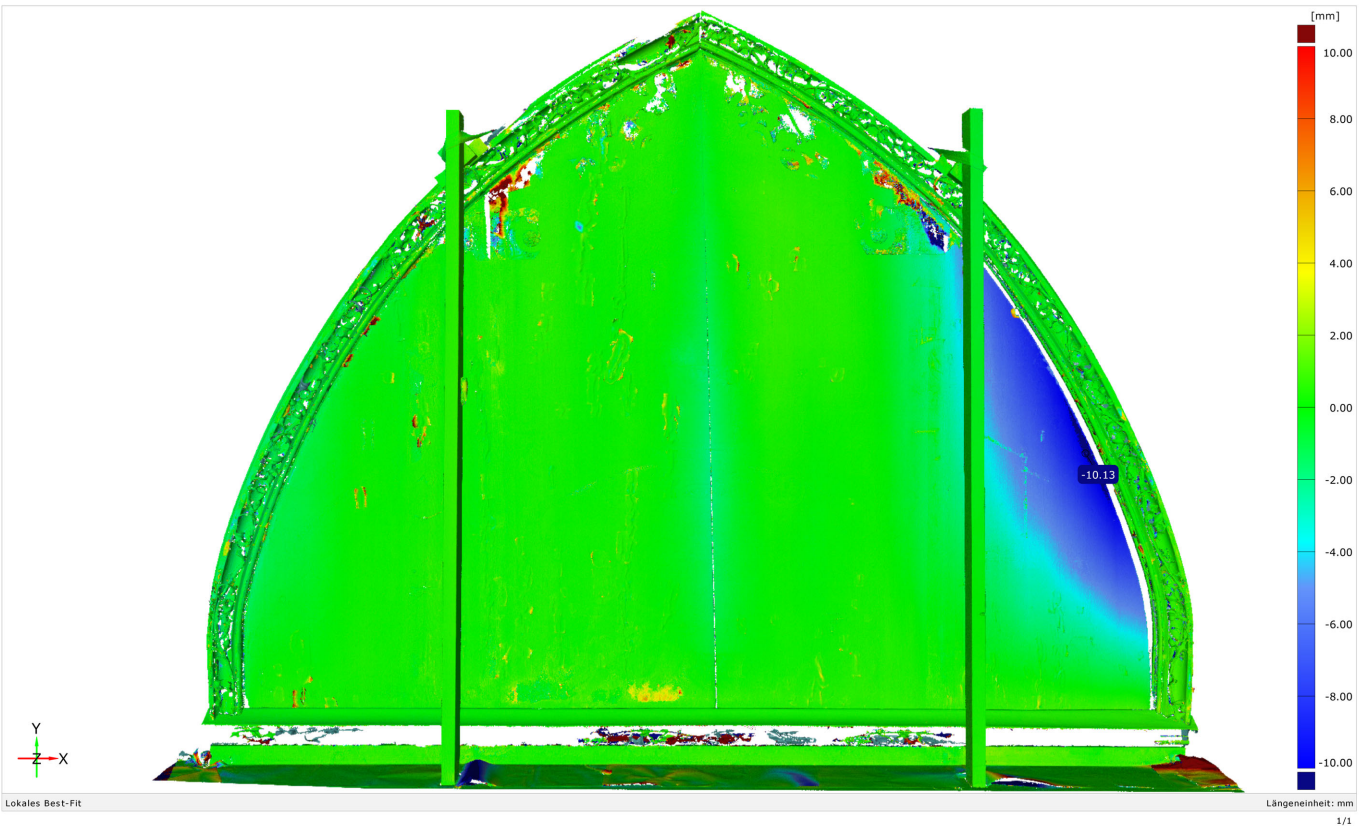
Based on the point cloud comparison of the opto-technical monitoring, the right side, which had migrated out of the panel frame, was identified as the one with the largest movements or warping (e.g., up to 10 mm in the z-axis in 2022; Figure 11).

**Figure 11.** False color matching of two 3D scans from 27.01 ($\bar{x}$ January 2022 = 17.4 °C/53.2% rH) and 24 March 2022 ($\bar{x}$ March 2022 = 18.5 °C/43.2% rH) to demonstrate the movement of the board with a maximum difference of 10 mm with an average change of ~10%-points [© KDWT, Leander Pallas].
