# Full-Scale Fatigue Testing of a Wind Turbine Blade in Flapwise Direction and Examining the Effect of Crack Propagation on the Blade Performance

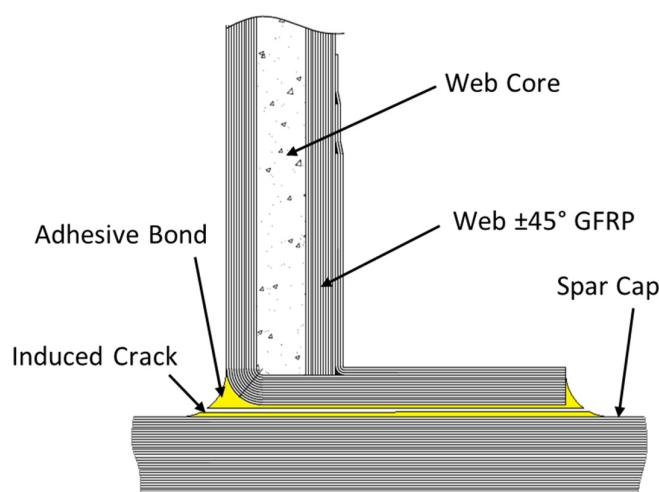
**Figure 1.** Schematic of induced crack location.

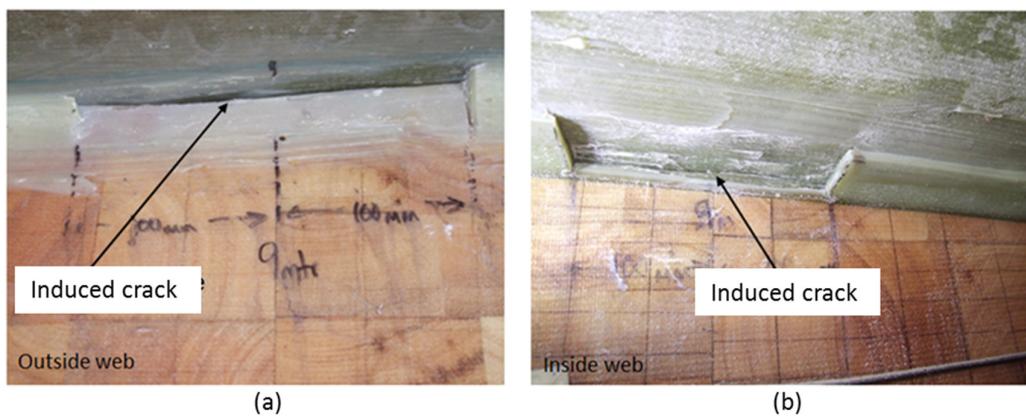
A 200 mm crack was created by cutting the adhesive bond between the shear web and spar cap at 9 m from the blade root. Figure 6a shows the crack from outside and Figure 6b shows the crack from inside of the shear web box. Four AE sensors were fitted on the shear web wall to monitor the crack growth and to understand its behaviour during cyclic loading.

**Figure 6.** Creating a 200 mm crack at 9 m from the root. View from (a) outside and (b) inside of the shear web box.

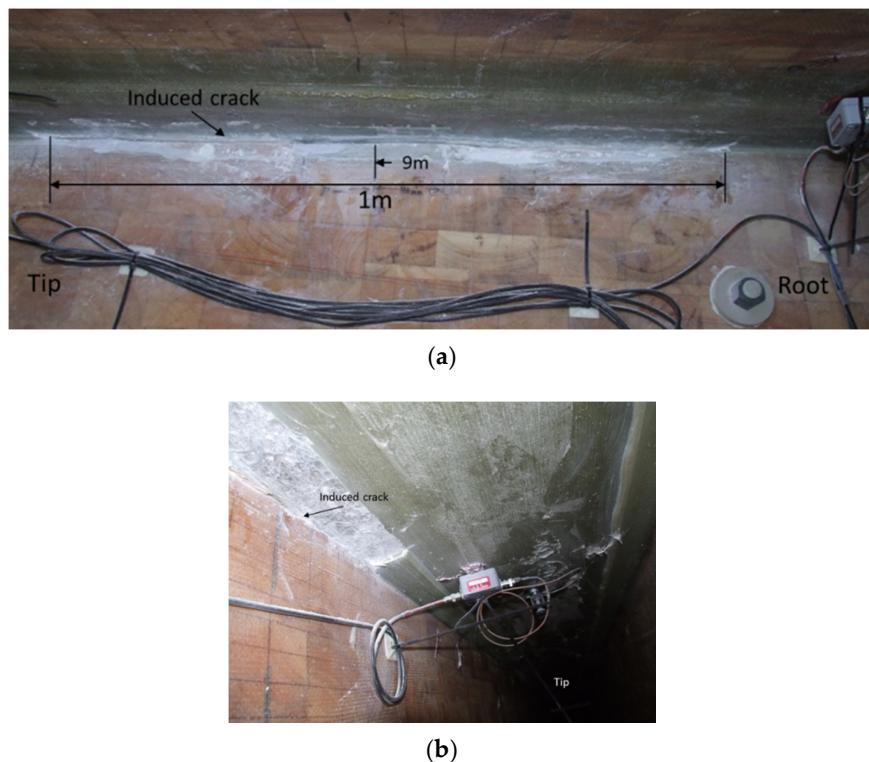
The blade structural response to crack propagation was studied further by extending manually the 200 mm crack after calibration, modal and fatigue test to 1000 mm. The centre of de-bonded crack was kept unchanged at 9 m from the blade root and it was extended symmetrically from both sides as shown in Figure 7.

**Figure 7.** Extension of the crack to 1000 mm at 9 m from the blade root. View from (a) outside of the shear web box; (b) from inside of the shear web box.
