# Long-Term Atmospheric Corrosion Behavior of Epoxy Prime Coated Aluminum Alloy 7075-T6 in Coastal Environment

**Abstract:** The atmospheric corrosion of epoxy prime coated aluminum alloy 7075-T6 exposed for 7, 12 and 20 years was investigated. The remaining thicknesses of epoxy prime coatings for macroscopically intact coating areas followed a normal distribution and decreased linearly. EIS results demonstrated that the corrosion resistance of the coating decreased with exposure time. After 20 years of exposure, the epoxy coating had lost its protection as cracks existed within the coating and exfoliation corrosion had occurred on the substrate. The substrate was sensitive to exfoliation corrosion through metallographic and TEM analysis. The corrosion products were mainly hydroxides of aluminum. The morphology and chemical compositions of the coating bubbling area and propagation characterizations of exfoliation corrosion were analyzed by SEM, EPMA and EDS. Cracks between the lumps of corrosion products provided the channels for the transmission of corrosion mediums. Furthermore, the mechanical model was proposed to analyze the propagation characterization of exfoliation corrosio

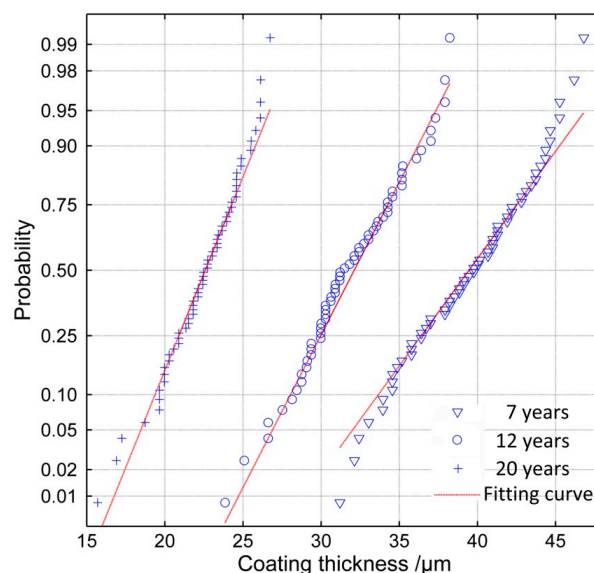
When the sample size ( $n$ ) is 60 and the significance level  $\alpha$  is 0.01, the  $r_c$  is 0.330. It can be seen in Table 3 that all the distributions have a good correlation with the remaining thickness; however, the data is fitted most effectively by the normal distribution function, while the Gumbel distribution describes the data least effectively. The probability paper test of normal distribution of the remaining thickness is shown in Figure 6 and these data for 20 years are from areas where coating still existed (about 70% of the surface). According to the results, it can be concluded that the remaining thickness of the epoxy coatings exposed over 7 years satisfies a normal distribution.

**Figure 6.** Result of the probability paper test of normal distribution (20 years' data from coating-still-existing areas).

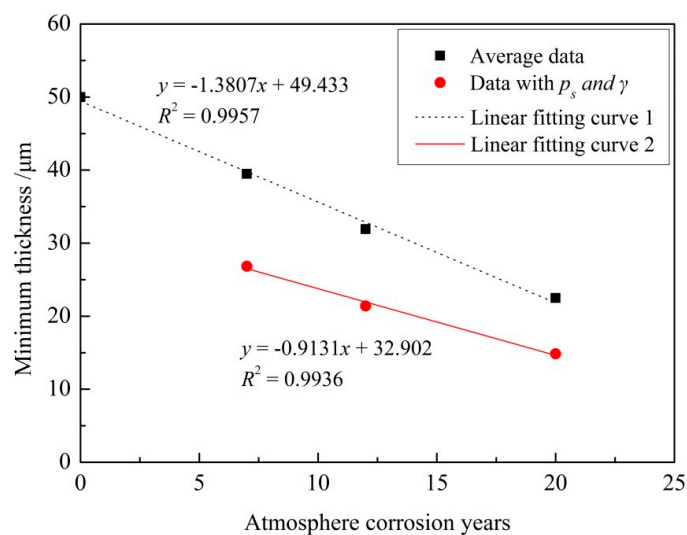
**Figure 7.** Relationship between atmospheric corrosion exposure years and remaining thickness (20 years' data from coating-still-existing areas).

It can be seen that the remaining thicknesses of epoxy coatings decrease linearly as the exposure time increases (Figure 7). As those thickness data for 20 years are from areas where coating still existed, this linear degradation relationship is only valid for macroscopically intact coating areas. This linear degradation phenomenon may be mainly due to the fact that yearly variations of the atmospheric environment are negligible, although there are seasonal and daily variations. Thus the rate of aging and corrosion and of thickness decrease of the coating was constant.

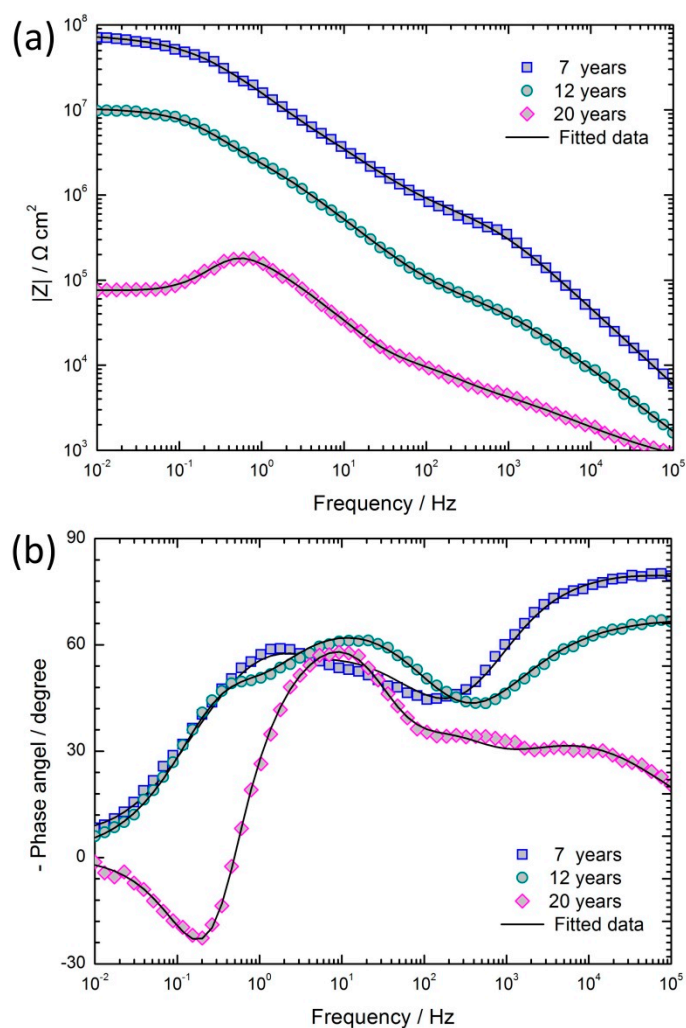
The experimental Bode plots of coated samples after different exposure periods are shown in Figure 8, where the experimental data (scatter plot) can be seen to be accurately described by the fitted data (curves). The Bode  $\log |Z|$  and the Bode phase angle plots can better explain the frequency specific impedance behavior. From the Bode  $\log |Z|$  plots (Figure 8a), it may be observed that the oblique lines of the impedance curves at high frequency, corresponding to the coating capacitance,

shift towards lower frequencies with the exposure time. This result indicates that the capacitance of the coating increased and its corrosion resistance decreased with the increase in exposure time. In addition, as the coastal exposure time increased, the values of the impedance at 10 mHz,  $|Z|_{f=0.01}$ , decreased significantly from 70.8 MΩ cm<sup>2</sup> to 0.075 MΩ cm<sup>2</sup>. After 12 years of exposure, the impedance of the coating still had a higher value, and the epoxy zinc chromate coating had a protective effect on substrate. On the contrary, after 20 years of exposure, the phase angle was less than zero at the low frequency region (Figure 8b). This phenomenon shows the inductive characteristics, and indicates that the coating has lost its capability of protecting the substrate.

**Figure 8.** EIS results and its fitted data of coated specimens exposed for 7, 12, and 20 years: (a) Bode log  $|Z|$  versus log (f/Hz) plots; (b) Bode phase angle versus log (f/Hz) plots.

The Bode log  $|Z|$  plots in Figure 8a are all described by lines with slopes between  $-0.5$  and  $-0.2$  in the middle frequency section, where a linear platform should appear. This characteristic of the coated specimen usually occurs in the middle stage of immersion and is called the Warburg impedance characteristic [28]. The production of Warburg impedance is due to the resistance of additive particles in organic coatings: the electrolyte seeps into the interior from gaps between particles along the winding routes, rather than along the direction of the concentration gradient. This phenomenon is also known as ‘tangent direction diffusion’ [29]. According to the characteristics of the epoxy zinc chromate coating, the phenomenon may be due to the addition of zinc chrome pigments into the coating. When the electrolyte seeps into the coating, zinc chromates will hydrolyze and generate

The Bode phase angle plots of coated samples exposed for 12 and 20 years showed the existence of three time constants. When the electrolyte reached the anodic oxide film surface through the coating, the chlorine ions accelerated the dissolution of the anodic oxide film, and the corrosion of the aluminum alloy substrate occurred at the site of the destruction of anodic oxide film [30]. Therefore, the three time constants corresponded to the time constant of the impedance of coating, the time constant of the dissolution of the anodic oxide film, and the time constant of the corrosion of the aluminum alloy substrate.

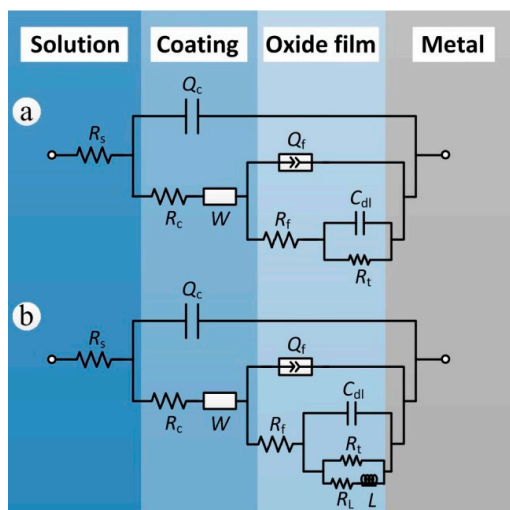
Although the compositions of the coated samples after exposure for 7, 12, 20 of years were basically the same, since the EIS results of samples exposed for 20 years showed inductance characteristics it became necessary to add inductance and inductive resistance in the equivalent electrical circuit selection of samples exposed for 20 years [31]. The equivalent circuits that were found to most closely reproduce the impedance diagrams are shown in Figure 9. The curves were fitted using the ZSimpWin software. The elements of the two chosen equivalent electrical circuits are as follows:  $R_s$  is the solution resistance,  $R_c$  and  $Q_c$  are the coating resistance and coating capacitance, respectively, and  $W$  represents the Warburg diffusion impedance of the coating. The parameter groups  $Q_f$  and  $R_f$  represent the interface double layer capacitance and the charge transfer resistance of anodic oxide film corrosion reaction, respectively. The parameter groups  $C_{dl}$  and  $R_t$  represent the charge-transfer reaction at the electrolyte/substrate aluminum alloy.  $L$  and  $R_L$  respectively represent the inductance and inductive resistance produced by substrate corrosion. The inductive loop is usually obtained by the corrosion products deposited or adsorbed on the sample surface [32,33].

**Figure 9.** Electrochemical equivalent circuits for fitting the impedance data: (a) 7 and 12 years; (b) 20 years.

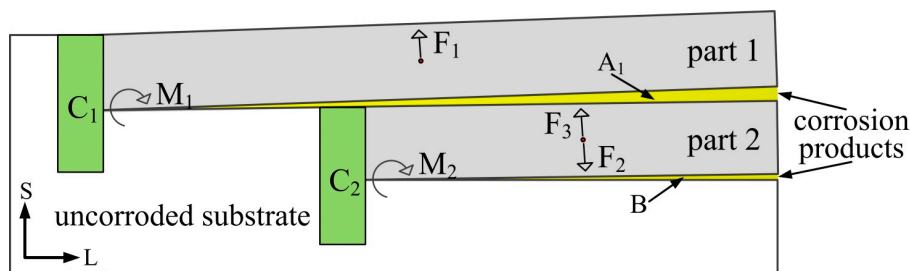
The analysis of wedge exfoliation that occurred near the A area in Figure 13b can be simplified into the mechanical model shown in Figure 14. Under the action of the expansion force of the corrosion product in the  $A_1$  area, structures of aluminum alloy on the upper side (part 1) exfoliated outwardly, and the intergranular corrosion of structures under the lower side (part 2) also occurred along the L direction. Compared to the area of un-corroded substrate, the exfoliation of the structures on both the upper and lower sides of the  $A_1$  area can be considered as the bending of the cantilever beam under load. For the equilibrium of part 1, the wedging force of corrosion products,  $F_1$ , and the bending moment,  $M_1$ , produced at the cantilever beam base,  $C_1$ , must be in balance. Similarly, for the equilibrium of part 2, the wedging forces of corrosion products,  $F_2$  and  $F_3$ , and the bending moment,  $M_1$ , produced at the cantilever beam base,  $C_2$ , must be in balance. It was obvious that before the part 1 had been completely exfoliated outwardly, if part 2 appeared the same degree of wedge exfoliation as part 1, it would require a greater wedging force of the corrosion products in the B area. However, due to the fact that the intergranular corrosion in the B area was not deep enough to provide enough wedge force, part 2 does not form the obvious wedge exfoliation as shown in the  $A_1$  area.

Figure 14. Mechanical model of wedge exfoliation analysis.
