# Article Analysis of the Technical Condition of a Late 19th Century Public Building in Łódź

Wioletta Grzmil \*D, Justyna Zapała-Sławeta D and Jagoda Juruś D

Faculty of Civil Engineering and Architecture, Kielce University of Technology, 25-314 Kielce, Poland

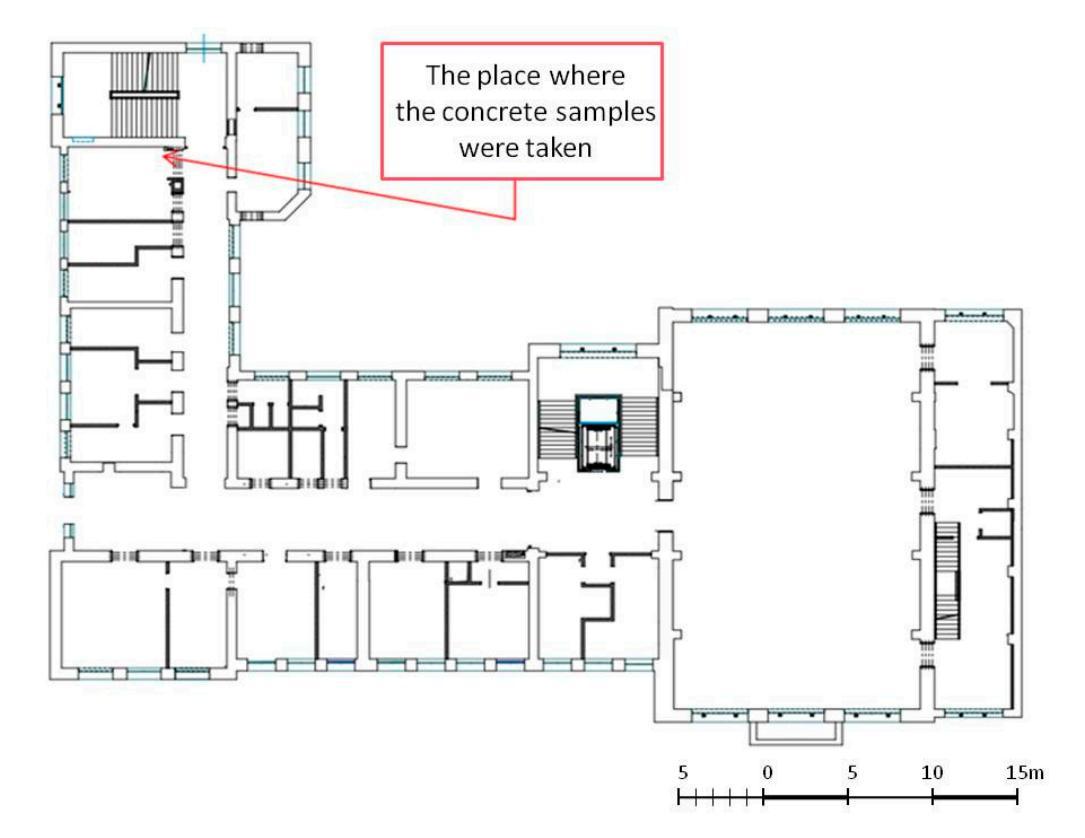
Figure 10. The locations in the building from which the concrete samples were taken for testing.

A compressive strength test and a saturation test were carried out on samples taken using a core drill. Six core borings were taken from each floor slab on every floor. Since the building is supervised by a conservation officer, the opportunity to take samples was limited to only the selected sites that were to be demolished. The locations where the concrete core samples were taken are shown in Figure 10.

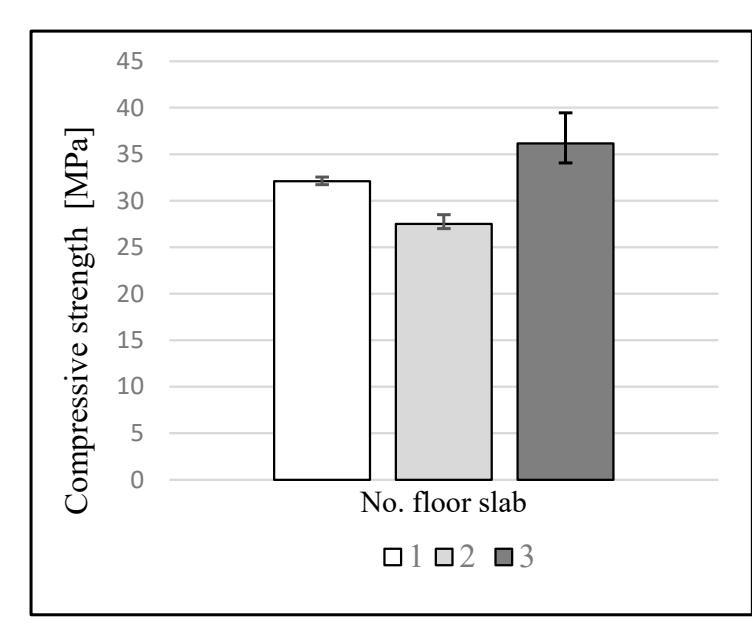
**Figure 12.** The average compressive strength of the concrete from each floor. The error bars indicate the maximum and minimum values in the floor slabs.

The average compressive strength (for three samples) determined for the three analyzed floors was in the range of 27.5 to 36.5 MPa.

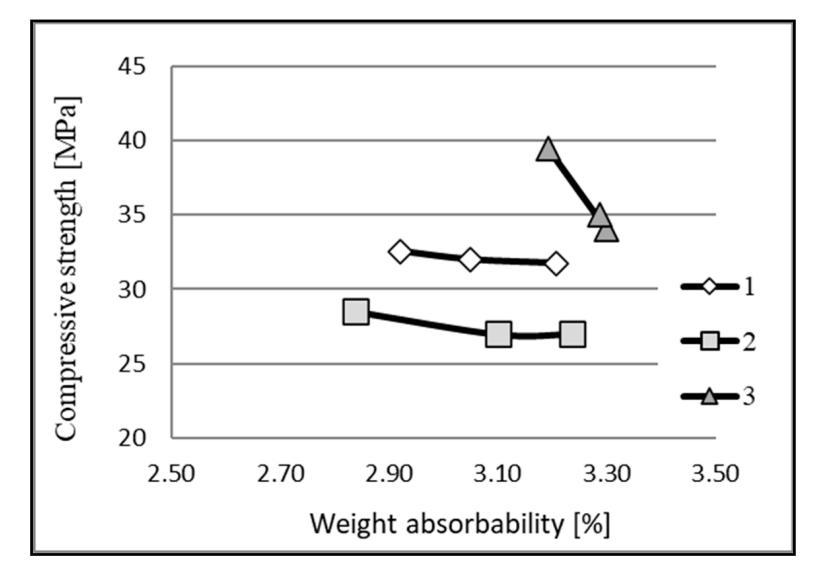
Figure 13. Dependence of the compressive strength on the weight absorption.

The weight absorption of the concrete samples from floor slabs 1 and 2 was similar, and ranged from 2.8 to 3.2%, but the samples had different compressive strengths. The concrete samples from floor 3 had the highest compressive strength and weight absorption among all the samples.

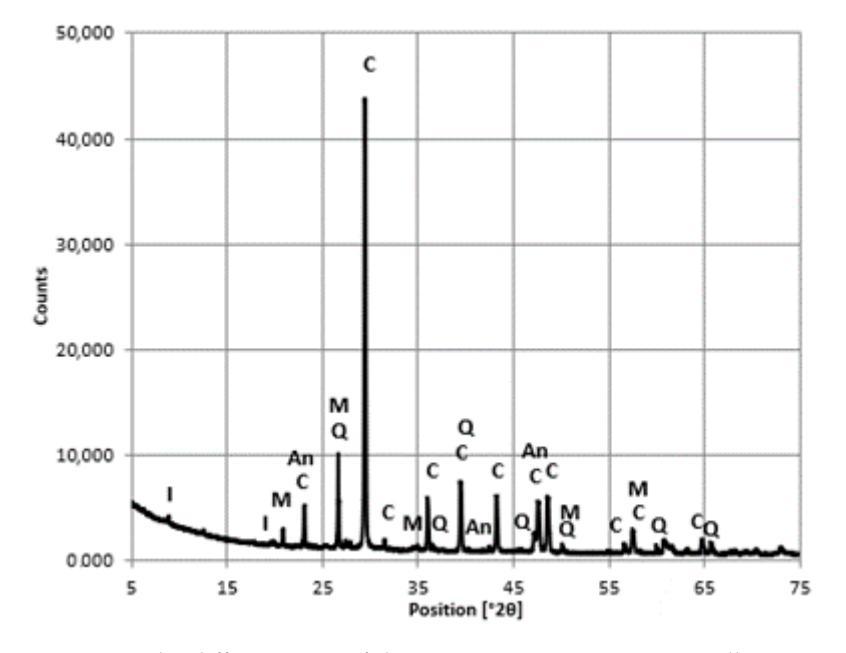
The analyzed concrete consists of a cement binder and natural aggregate, showing variations under macroscopic evaluation. An X-ray analysis indicated that the concrete was composed of aggregate from sedimentary rocks, mainly limestone (calcite), feldspar (anorthoclase), and quartz. Clay minerals were identified, i.e., illite, found in small amounts, as well as muscovite, a common rock-forming mineral (Figure 15).

**Figure 15.** The diffractogram of the aggregate. Designation: I—illite, M—muscovite, Q—quartz, C—calcite, An—anorthoclase.

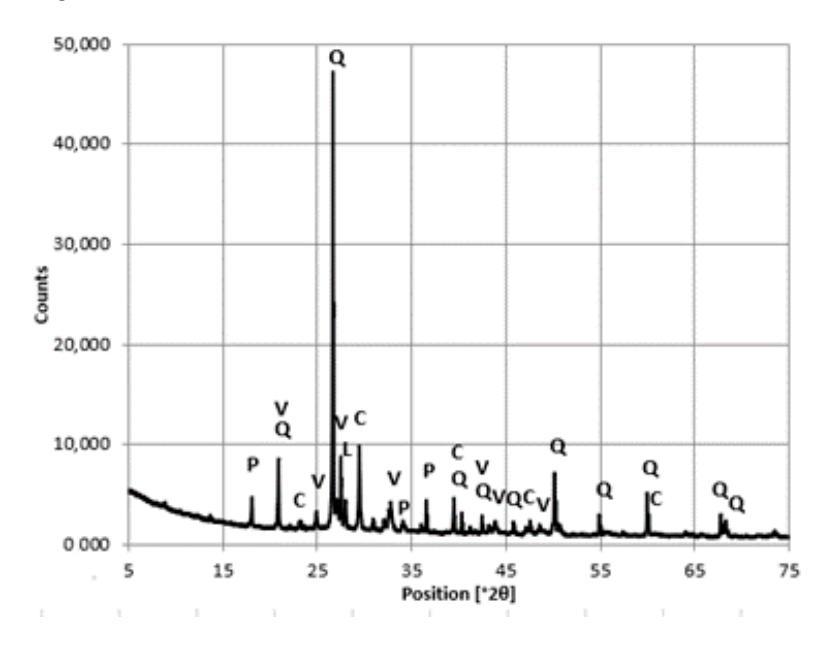
Analysis of the phase composition of the cement slurry demonstrated the presence of polymorphic varieties of calcium carbonate, i.e., calcite, vaterite, and aragonite (Figures 16 and 17).

**Figure 16.** A diffractogram of the cement slurry from the concrete samples, top floor slab layer. Designation: P—portlandite, V—vaterite, A—aragonite, C—calcite, Q—quartz, L—larnite.

Differences in the intensity of the reflections of portlandite, vaterite, and calcite were observed. The intensity of the portlandite reflections was lower in the concrete taken from the bottom layer of the floor slab, with simultaneously less intense vaterite reflections and higher intensity of calcite reflections comoared with the concrete from the top layer of the floor slab. The results indicate a higher degree of concrete carbonation processes in the bottom layer of the floor slab.

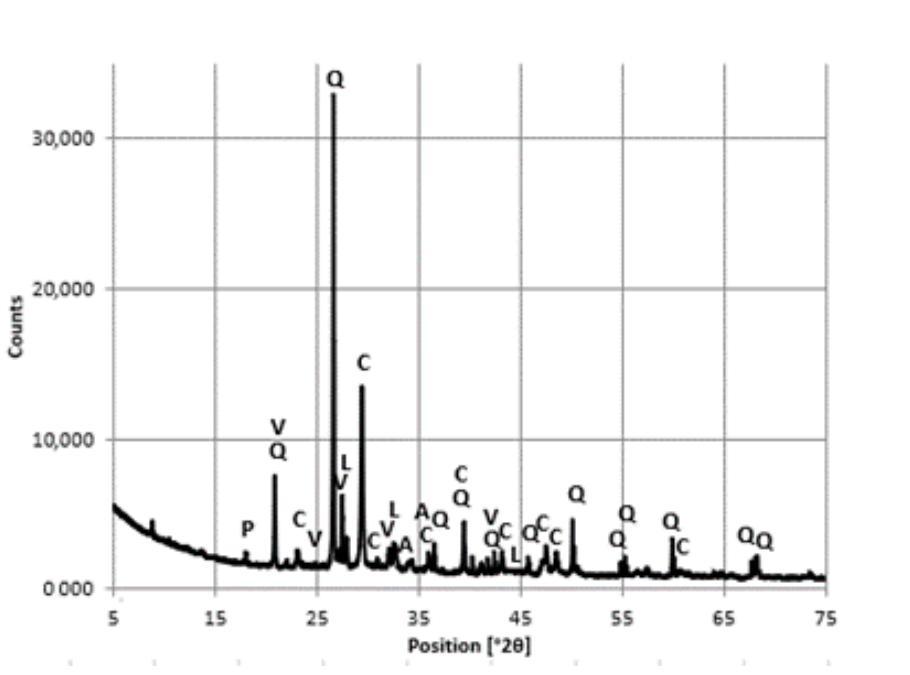
**Figure 17.** A diffractogram of the cement slurry from the concrete samples - bottom floor slab layer. Designation: P—portlandite, V—vaterite, A—aragonite, C—calcite, Q—quartz, L—larnite.
