# Assessment of the Structural Integrity of the Roman Bridge of Alcántara (Spain) Using TLS and GPR

**Keywords:** TLS; GPR; structural assessment; roman bridge; conservation

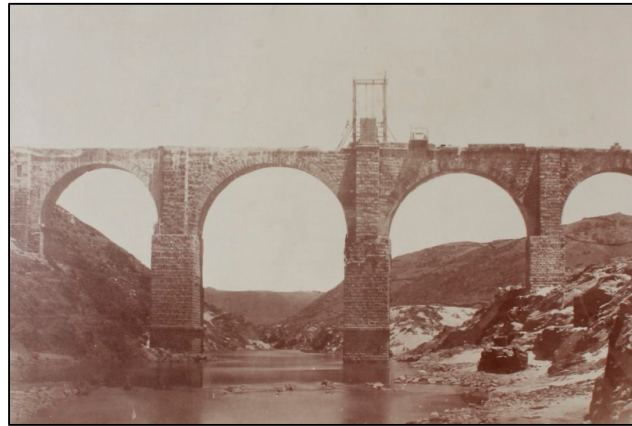
rainwater that “fall in channels between the joints in the ceilings of the arches” [14], producing the deterioration of the joints and even the loss of stones. The same situation is described by Alejandro Millán in 1857, who indicated that in one arch seven voussoirs had to be replaced as the granite disintegrated in their hands [15]. In this intervention, other repairs were also made [10,12], leaving the bridge in the state in which it now stands (Figure 3).

**Figure 3.** Photograph from downstream during the reconstruction work of the triumphal arch in 1857 after having reconstructed the fifth arch, which had been destroyed [16].

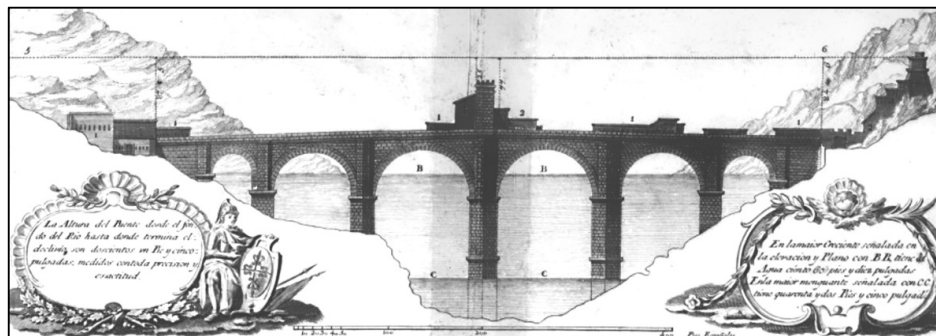
Finally, the bridge has been modified in such a way that its structural behaviour has been affected, and therefore its safety. The most important change was the elimination of the longitudinal slope of the bridge during the intervention by Millán in 1857. According to [18], over a length of 370 feet between the end of the bridge on the left and the triumphal arch, there was a rise of 10 feet and 5 inches in its height (Figure 5), meaning there would have been a slope of 2.7%. After taking it out, there was a fall

in the height by over 1.5 m (5 feet) in the surfaces over the larger arches, which reduced the capacity of load diffusion [22].

**Figure 5.** Print showing the variation in height between the ends of the bridge and the triumphal arch [23].

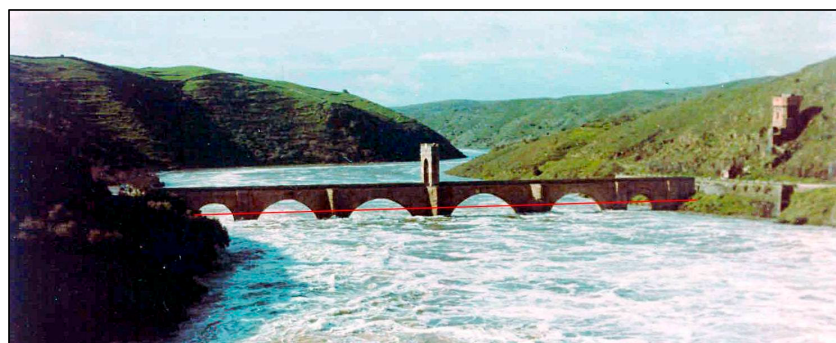
The parameters of the formula are defined in the normative, except  $V(T)$ : water velocity for flooding in the return period of  $T$  years. Throughout its history, the bridge has seen large floods, as reflected in the prints from historical documents [18,19,23]. More recently, we have reliable information of several floods in 1876, 1940, 1947, 1965 and 1970 (Figure 6), but in these later ones the water level remained below the level shown on the prints.

**Figure 6.** Flood of 1965. The flood level from the historical prints is marked by a red line [26].

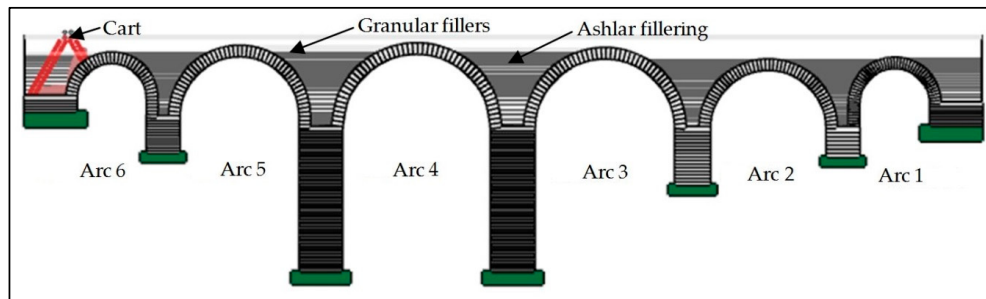
The analysis was performed using the software Ring 2.0 [55], which has been applied in different research projects on factory bridges [56,57] (Figure 14). In this model, it was developed using the real defined geometry taking into consideration the way the fillers lay as deduced from the research using GRP and taking into account the vicissitudes that the structure has undergone.

- S0: original longitudinally sloping bridge. From the data of Bonet, 1991 [23].
- S1: demolition of arch no. 6, modelling arches 1 to 5 and longitudinal slope.
- S2: demolition of arch no. 5, modelling arches 1 to 4 and longitudinal slope.
- S3: entire bridge in the present condition.

Figure 14. Model for analysis of level I.
