# Failure Analysis of Two HP-Nb Heat-Resistant Tubes after 46,000 h Exposure to Reformer Service Conditions

**Abstract:** This study presents a failure analysis in two reformer tubes used for hydrogen production in a petrochemical industry. These tubes (Tube A and Tube B) were made by the centrifugal casting of HP-Nb alloy in such a way that one contained titanium as a micro-element, and the other was free from titanium in its chemical composition. Although the two tubes were subjected to similar creep conditions, Tube A failed after only 46,000 h of operation against the design life of 100,000 h. SEM images showed initiation and growth of creep pores next to chromium carbide particles, as well as the formation of microcracks in Cr<sub>23</sub>C<sub>6</sub> carbides. Pore initiation occurs as a result of grain boundary sliding and is strongly dependent on structural morphology. The tube containing titanium (Tube B) showed higher thermal stability and higher creep resistance than the tube without titanium (Tube A), which was due to the formation of finer and more discrete carbide particles. The final fracture of the tube without titanium (Tube A) occurred due to the coalescence of

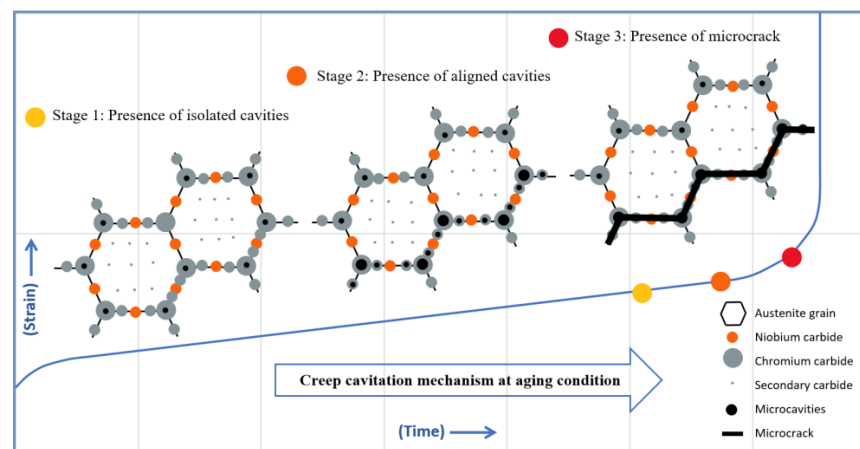
Exposure to high temperatures results in the dissolution of carbide particles present in the structure. This removes the barriers to dislocation movements and decreases creep strength. These conditions lead to the formation of creep pores perpendicular to the direction of the applied stress. Over time, these pores coalesce together and create microcracks. Finally, the growth of microcracks results in the formation of macrocracks and the failure of the specimen. The failure scenario is schematically shown in Figure 11 and summarized in the following steps: including initiation of isolated cavities, aligned cavities, and the formation of microcracks next to continuous carbide particles.

**Figure 11.** The initiation and growth mechanism for creep pores adjacent to interdendritic carbide particles during service transposed on a general creep graph.
