Confirming Debonding of Non-Metallic Inclusions as an Important Factor in Damage Initiation in Bearing Steel

In this work, we investigated a failed tapered roller bearing that operated in a wind turbine. The bearing was removed from the gearbox following the formation of an axial crack. All specimens were extracted from the inner ring. The specimens are made of AISI 52100 martensitic steel and have a chemical composition as shown in Table 1. The resulting microstructure consists of tempered martensite, spheroidal carbides homogeneously distributed in the martensitic matrix, and transition carbides [42]. Transition carbides are precipitates formed during tempering treatment from supersaturated martensite; they include η and ϵ carbides [46]. To examine the presence of non-metallic inclusions (NMIs) and any associated damage in the bearing, 4 samples were cut from the zone of interest along circumferential and axial planes in the loaded zone (Figure 1). Samples were prepared for metallographic observation using a Struers (Struers, Ballerup, Denmark) type 50A15 cut-off wheel on a Discotom-5 cutting machine. Cutting was performed at a low speed and with underwater cooling to prevent an

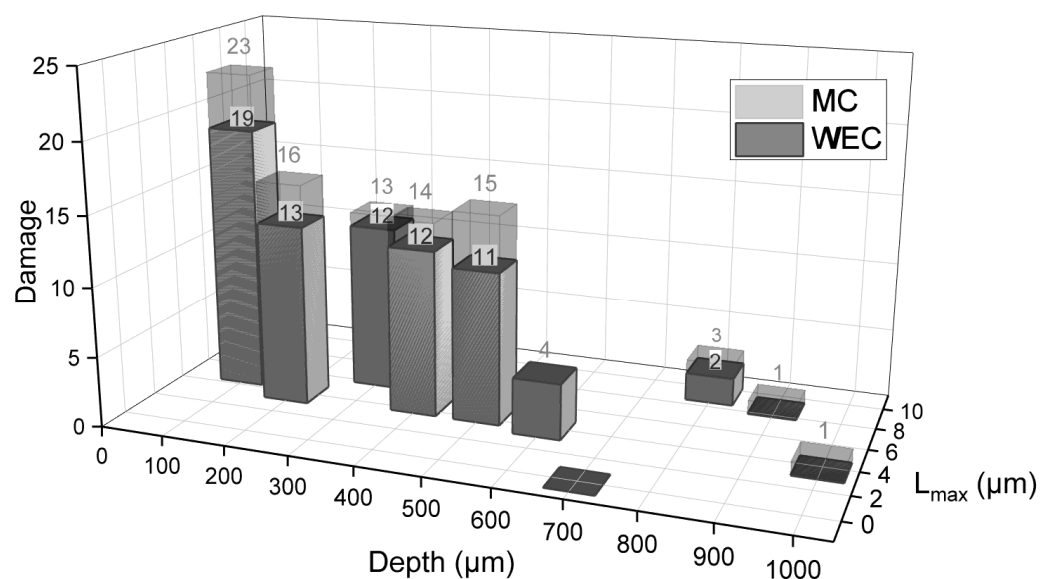
Figure 11 shows the occurrence of white etching cracks and matrix cracks across the depth of the sample and their corresponding length. The average value of multiple inclusions length per 100 μm is shown. A clear trend can be observed with a high number of cracks (matrix cracks and white etching cracks) up to 500 microns, followed by a steep decline, with only one matrix crack present at a distance between 900 and 1000 μm . Moreover, the average length of inclusions varied from 4 to 6.5 μm , up to 500 μm below the raceway surface, and at distances greater than 500 μm longer (around 9 μm), inclusions initiated a matrix crack. Furthermore, the size of white etching areas changes as the distance from the raceway surface increases. Within a range from the raceway surface up to 200 μm , the length of the white etching varies from 10 to 30 μm , with one exception where a length of 100 μm was measured. The longest white etching cracks (in a range of 100 μm) were found in a zone between 200 and 500 μm . At larger distances within the range of 500–1000 μm , shorter white etching cracks with an average length of 30 microns were observed. This indicates the influence of stresses, i.e., at greater distances (>500 μm), longer inclusions are required for damage initiation.

Figure 11. WEC and matrix crack initiation in relation to inclusion size and distance from the raceway surface.

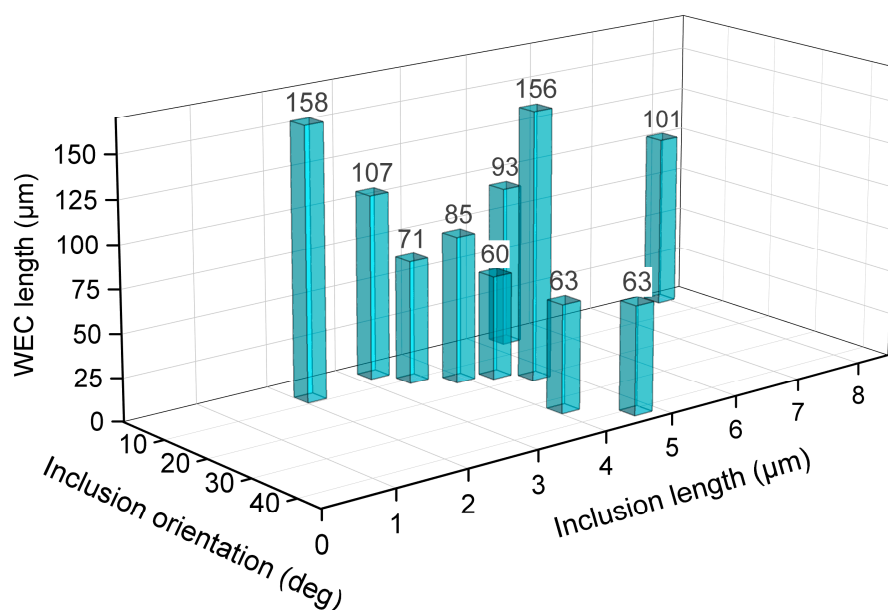
In this section, the lengths of the inclusions that caused the longest WECs in this bearing were analyzed to disclose the main factor for the damage initiation from the size, shape, angle, or debonding. However, it is important to note that all observations were conducted in two-dimensional sections. WEC networks were relatively short (up to 160 μm)—as such, the inclusions related to WECs were considered to be the initiation locations of WECs rather than the propagating WECs being incidentally connected to the inclusion. Figure 12 shows the length of WECs, the length of inclusions, and the orientation of the inclusions to the raceway surface. The lengths of the inclusions that initiated the longest WECs were in the range of 2–5 μm ; most of them (90%) ranged from 350–500 μm below the raceway surface. The orientations of the inclusions varied from 3 to 44 degrees with respect to the over-rolling direction, suggesting that there is no strong link between the inclusion orientation and the initiation of damage. The majority (85%) of inclusions showing WECs were debonded from the steel matrix. In this case, the shape was not considered because most inclusions (85%) in the studied bearing were globular. The chemical composition of the inclusions that initiated long WECs was, in most cases, (87.5%) pure manganese sulfide without the addition of calcium, magnesium, or alumina. It should be noted that the percentage of so-called multi-phase inclusions was low throughout the bearing at only 23%. Based on this observation, it is suggested that small (2–5 μm) debonded MnS inclusions caused damage initiation.

Figure 12. Overview of the longest WECs observed in the studied bearing. The length of WECs was plotted to the corresponding length of the inclusion that initiated WEC and the inclusion orientation to the over-rolling direction.
