# Article Effects of Grain Boundary Microconstituents on Heat-Affected Zone Cracks in a Mar-M004 Weldment

**Abstract:** Repair-welding of a cast Mar-M004 superalloy by gas tungsten arc welding was performed. Liquation cracks of the heat-affected zone (HAZ) in a Mar-M004 weldment were closely related to the presence of low-melting constituents along the solidified boundaries in the weld. The metal carbides (MC),  $M_3B_2$  and  $M_5B_3$  borides,  $Ni_7(Hf,Zr)_2$  intermetallic compounds, and  $\gamma$ - $\gamma$ 'colonies were found at the interdendritic boundaries. Fine boride precipitates mixed with intermetallic compounds in lamellar form were more likely to liquate during repair-welding. The melting of borides and intermetallic compounds in 1180 °C/4 h treated samples confirmed the poor weldability of the Mar-M004 superalloy due to enhanced liquation cracking. In addition to boride formation, fractographs of liquation cracks revealed strong segregation of B element in carbides and intermetallics, which might further lower the solidus temperature of the repair weld.

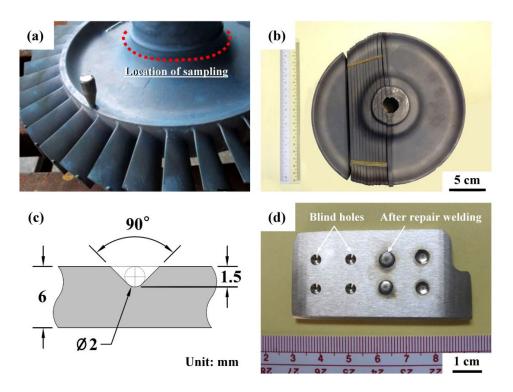
Figure 1a shows the macro-view of the vacuum-casted Mar-M004 turbine. The Mar-M004 test plate was wire-cut from the central portion of the cast turbine as illustrated in Figure 1b. Table 1 displays the chemical composition of Mar-M004 in wt. %. Stress relief heat treatment at 1050 °C for 5 h was applied to the Mar-M004 turbine in a vacuum of  $5 \times 10^{-3}$  Pa before wire cutting. The size of the specimen used in the repair-welding test was about  $60 \text{ L} \times 35 \text{ W} \times 6 \text{ T}$  in mm. Several blind holes were machined on the specimen. Figure 1c shows the joint geometry; each blind hole has a bevel angle of 90°, a depth of 1.5 mm, and a root of 2 mm at bottom of the hole to simulate the repair-welding of both surface and sub-surface defects in the Mar-M004 turbine. IN625 wire was used as the filler for TIG arc welding, and the macro-view of the repair weld is shown in Figure 1d. Cross sections of the weld were made either perpendicular or parallel to the top weld surface after repair-welding. A standard metallographic procedure to inspect microcracks in the HAZ and the fusion zone (FZ) of the weld was carried out.

**Figure 1.** (**a**) The macro-view of the cast turbine; (**b**) the tested sample cut from the turbine; (**c**) the joint geometry of the repair weld; and (**d**) the macro-view of the repair weld.

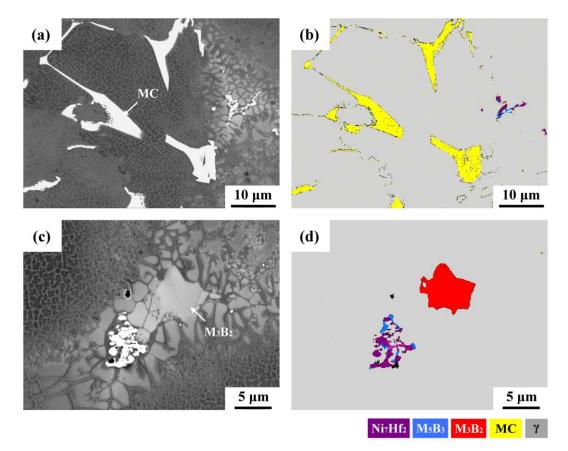
In Figure 4, different microstructures in the cast Mar-M004 were observed by SEM with the BSE mode and identified with the aid of EBSD analyses. The BSE image supported that the irregular bright phases with distinct morphologies (Figure 4a) were MC carbides, as further confirmed by their compositions (listed in Table 3) and EBSD identifications (Figure 4b). The EBSD map revealed that the yellow phases with different morphologies were all MC carbides, which were composed of significantly high Nb and Hf concentrations. It was noticed that few residual white phases could be seen ahead of the  $\gamma$ - $\gamma'$  eutectic colonies (Figure 4a,c). Such events indicated that those white phases solidified at a temperature lower than the  $\gamma$ - $\gamma'$  eutectic colonies. It has been reported that complex grain boundary constituents, such as MC carbides, M<sub>2</sub>SC sulphocarbides, Cr-Mo borides, Ni-Zr intermetallic compounds, and  $\gamma$ - $\gamma'$  (Ni<sub>3</sub>(Al,Ti)) eutectics, were obtained in IN738/IN738LC superalloy [13,14,16,25,26]. The EBSD map (Figure 4d) shows that the blocky gray product in Figure 4c was  $M_3B_2$  boride, which was checked by EPMA measurements as listed in Table 3. The  $M_3B_2$  boride consisted of very high Cr and Mo concentrations. White eutectic constituents in Figure 4c were proven to be Ni<sub>7</sub>Hf<sub>2</sub> intermetallic compounds by the EBSD analysis shown in Figure 4d. Furthermore, fine M<sub>5</sub>B<sub>3</sub> borides were inter-dispersed in the lamellar Ni<sub>7</sub>Hf<sub>2</sub> compounds. The presence of borides at the interdendritic boundaries inevitably depressed the terminal solidification temperature, thus deteriorating the weldability of the cast superalloy.

**Figure 4.** The analysis of solidification products in the cast superalloy: (**a**) back-scatter electron (BSE) image of MC carbides and their associated (**b**) electron backscatter diffraction (EBSD) map; (**c**) BSE image showing the boundary microconstituents and related (**d**) EBSD map showing the presence of borides and lamellar intermetallics.

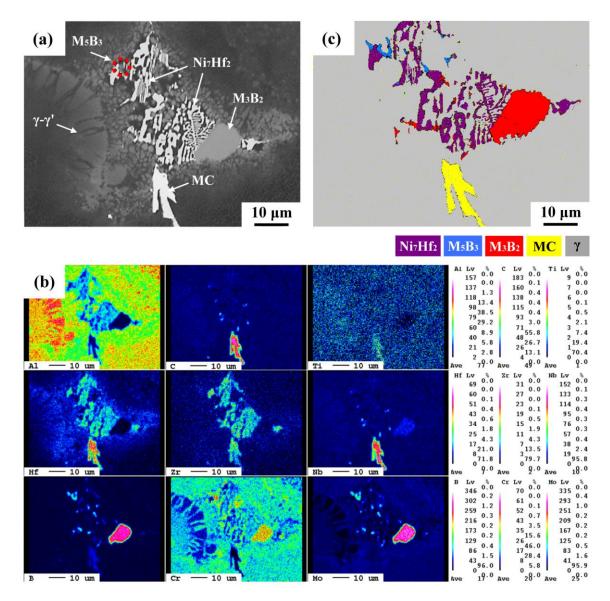
As shown in Figure 3c, lamellar eutectics and solidification products in gray color are present ahead of  $\gamma$ - $\gamma'$  eutectic colonies, which are expected to be the terminal solidification products. Further analyses were oriented to understand the constituents of grain boundary products. Figure 5 presents micrographs showing the morphology, distributions of alloy elements, and phase constituents at the solidification boundary. The BSE image (Figure 5a) was useful in distinguishing the possible solidification products according to the image contrast. The EPMA maps (Figure 5b) displayed the distributions of distinct alloy elements. In addition, the EBSD map (Figure 5c) was able to identify the phase constituents of the solidification products. As shown in Figure 5a, several different products, namely irregular white phase, lamellar bright phase, and blocky gray phase, formed near the grain boundary. The Al distribution map indicated that the  $\gamma$ - $\gamma'$  eutectic colonies were rich in Al, but co-segregation of Ti was not found as a result of its low concentration. By contrast, co-segregation of Al and Ti was noticed in the  $\gamma$ - $\gamma'$  eutectic colonies of IN738 superalloy. The C map could be used to indicate the carbide sites. The results displayed that the C, Nb, and Hf maps showed the same trend of distribution. This meant that the carbides were rich in Nb and Hf. The irregular island-like white phase, indicated by an arrow in Figure 5a, was expected to be MC carbide. The Ti and Zr maps also revealed that Zr and Ti tended to participate in the carbides. Moreover, some fine carbide particles were inter-dispersed along the profile of the lamellar white phase. The EBSD map confirmed that the MC carbides formed in those sites of high C, Nb, and Hf concentrations (Figure 5c). The B map showed the distribution of B, which could be linked to the boride locations. The gray blocky product (Figure 5a), which enriched in B, Cr, and Mo in the corresponding maps in Figure 5b, was proven to be  $M_3B_2$  boride (Figure 5c). The Zr and Hf maps displayed that the lamellar eutectic (indicated by an arrow in Figure 5a) was rich in Hf and Zr, which naturally showed high brightness in the BSE image in Figure 5a. The lamellar white phase in Figure 5a at the grain boundary region was identified as Ni-Hf-Zr (Ni<sub>7</sub>Hf<sub>2</sub>) intermetallics in Figure 5c. Moreover, it was found that M<sub>5</sub>B<sub>3</sub> and M<sub>3</sub>B<sub>2</sub> borides could be inter-dispersed in the Ni<sub>7</sub>Hf<sub>2</sub> intermetallics as shown in Figure 5c.

**Figure 5.** The identification of complex grain boundary microconstituents: (**a**) BSE image showing the interdendritic microconstituents ahead of  $\gamma$ - $\gamma'$  colonies; (**b**) the elemental maps of the boundary microconstitutents determined by electron probe micro-analyzer (EPMA); and (**c**) the EBSD map to distinguish the MC carbide, borides, and lamellar intermetallics.
