# Damage Evaluation and Seismic Assessment of a Typical Historical Unreinforced Masonry Building in the Zagreb 2020 Earthquake: A Case Study—Part I

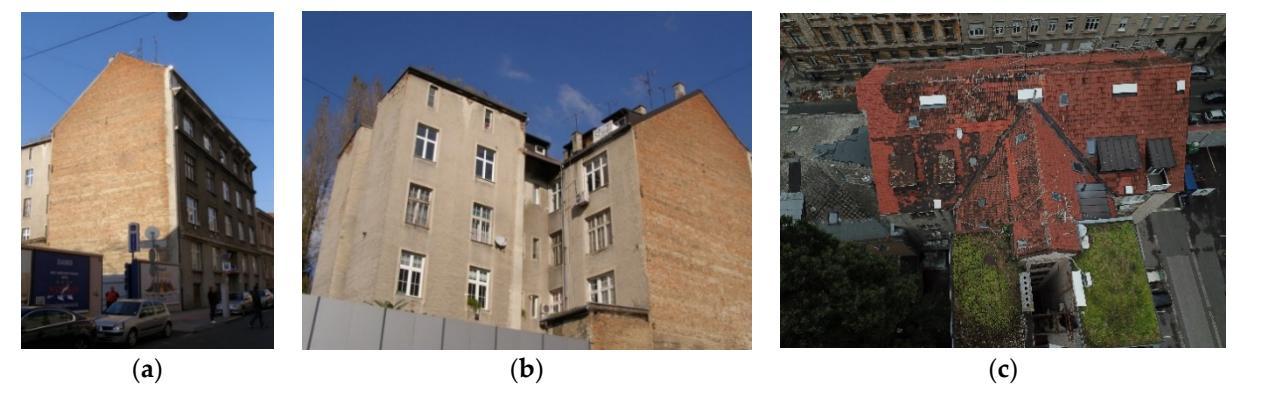
The building analyzed in this study was built in 1922 and is a typical example of a building type found in the Lower Town of Zagreb [1,5] (Figure 3). The epicentral distance to the analyzed building is approximately 8 km.

**Figure 3.** Photographs of the case study building: (**a**) south- and street-facing facade; (**b**) side view; (**c**) aerial view.

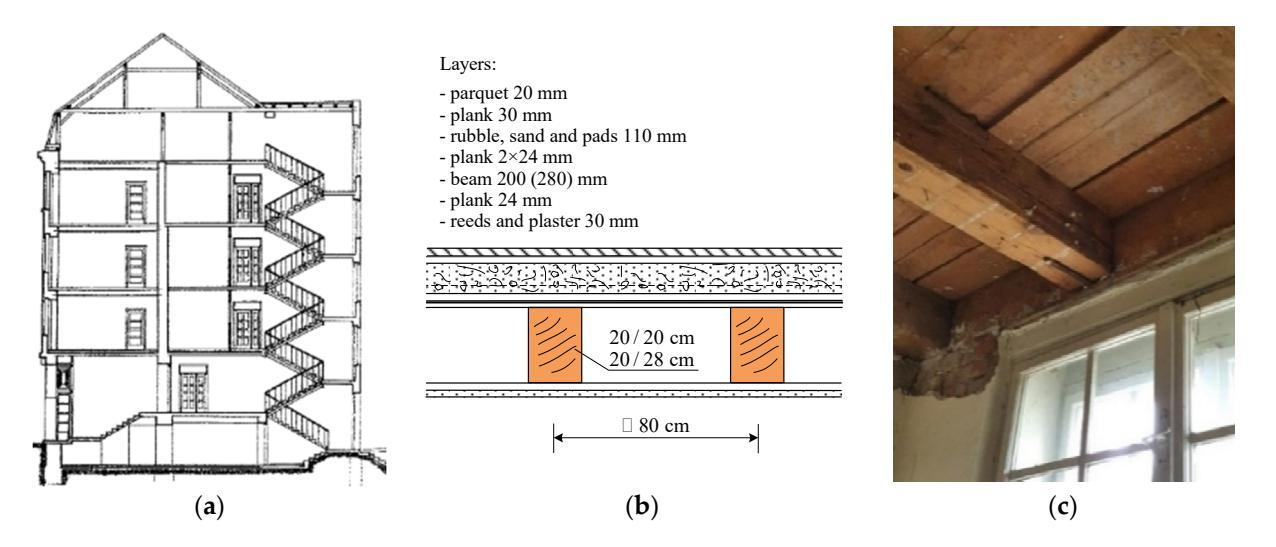
The floor structure (Figure 5) located above the basement on the street side of the building is a solid RC slab with a system of RC beams. As for the upper floors, they feature timber joists that are arranged in a transverse manner, with rubble filling used in the floor structure. During renovations, RC slabs measuring 8 cm in thickness were added above the ground floor and the third floor on the southern side of the building. The floor structure consists of timber joists with a layer of concrete with unknown reinforcement and properties on top. In the middle part of the building next to the staircase landing, there is an RC slab supported by RC beams on the edge.

**Figure 5.** Cross-section and timber floor structure. (**a**) cross-section of the building; (**b**) layers of the timber floor structure; (**c**) photograph of the timber floor structure.

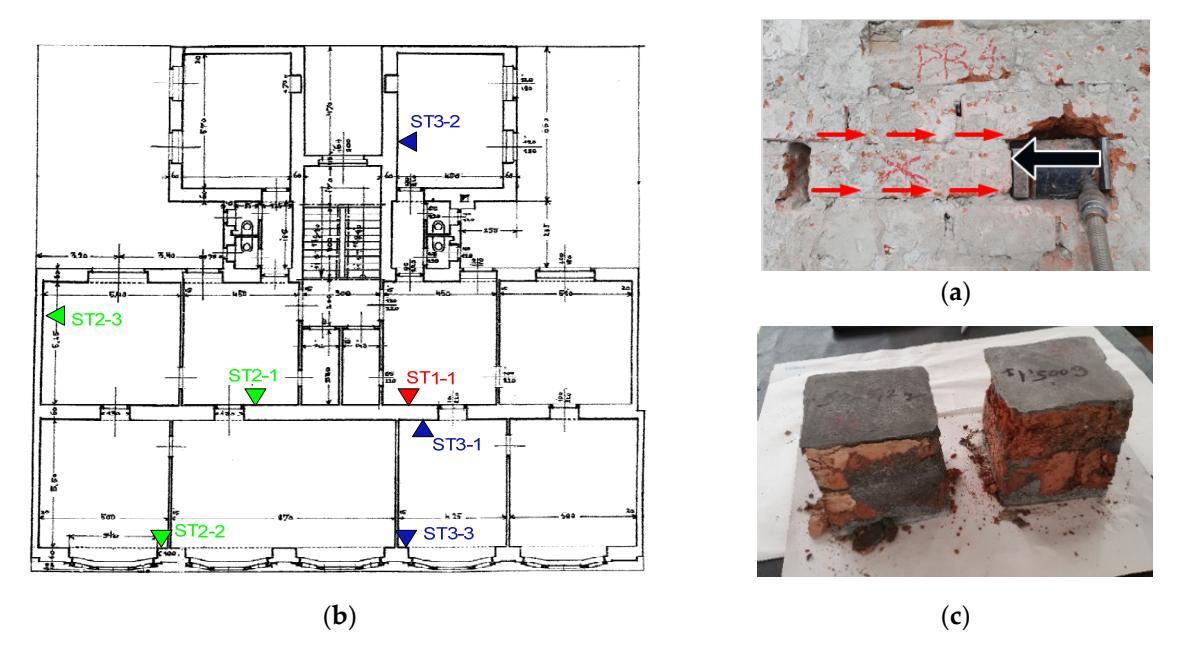
where  $f_v$  is the shear strength of the masonry,  $\mu$  is the coefficient of friction,  $\sigma_0$  is the normal compressive strength,  $F_h$  is the experimentally determined shear force at the time of shear failure, and  $A_u$  and  $A_l$  are the upper and lower areas of the brick. With the selected in situ method, it is possible to obtain  $f_{v0}$ . First,  $f_v$  must be determined experimentally, and then the value of the friction coefficient can be assumed to be 0.4 (HRN EN 1998-3) and the vertical compressive stress can be obtained from the numerical model. The advantage of the chosen method is that it can be carried out in a short time (45 min/location). However, the disadvantage of the method lies in the assumptions already mentioned. In this study, the protective layer of the plaster was removed at a total of eleven locations, a shear test was performed at seven locations, and the remaining four locations were only used for visual identification of the masonry. All shear tests were carried out approximately 100 centimeters above the floor, on the locations shown in Figure 7. The results of the shear test and compressive strength we performed are summarized in Table 2.

**Figure 7.** (a) Characteristic floor plan and locations of the shear test, (b) shear test of mortar without control of vertical stress, (c) samples for determination of compressive strengths of solid bricks.

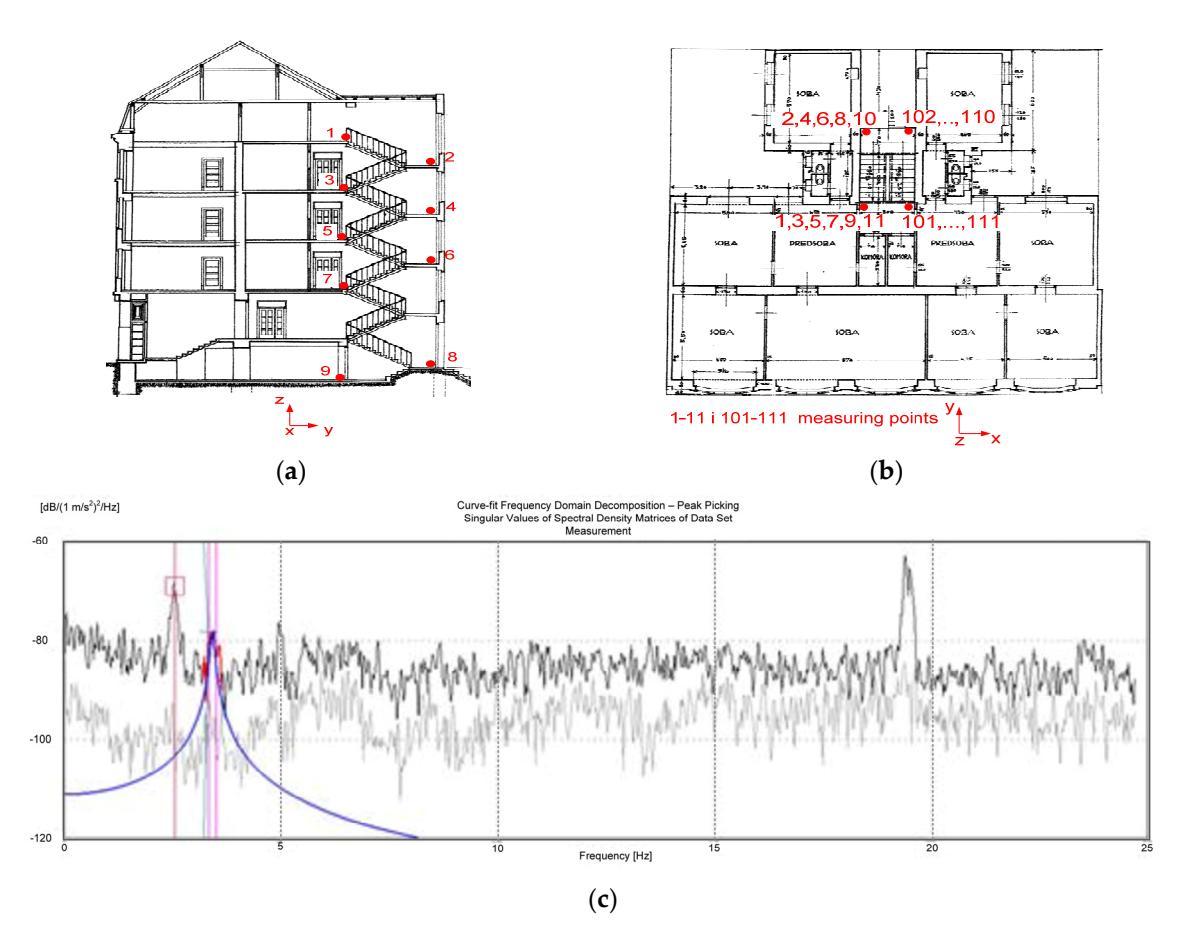
The measurement of the ambient vibrations of the studied building was carried out in October 2014 and September 2020 (number of degrees of freedom measured: 44). The measurement points were located in the core of the staircase and are shown in Figure 8. The measurements were performed in two horizontal directions (X and Y directions). A classical frequency domain decomposition (FDD) was used for the estimation of natural frequencies (Table 3) and mode shapes (Figure 8), while the enhanced frequency domain composition (EFDD) method was used for the estimation of damping.

**Figure 8.** Measurement point locations (**a**) in cross-section and (**b**) in floor plan. (**c**) Characteristic record of frequency domain decomposition (FDD) for the determination of natural frequencies.

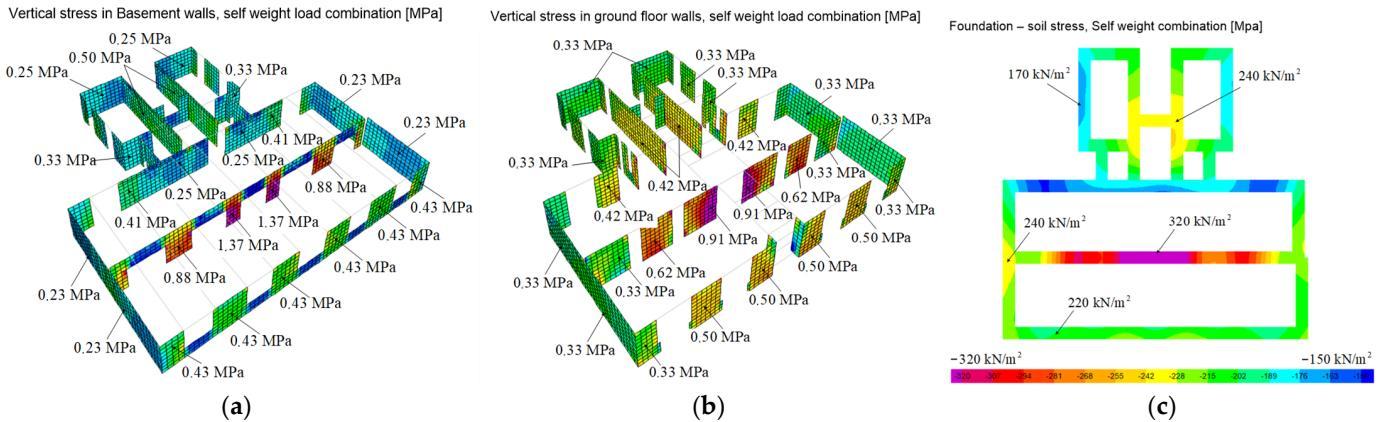
The subfigures in Figure 11 show the load-bearing elements' normal stresses due to the permanent vertical loads in the basement and on the ground floor. The average stresses of the walls are mainly between 0.3 and 0.6 MPa.

Figure 11. Normal stress distribution and soil stresses (for permanent vertical load). (a) stress distribution in the basement walls. (b) stress distribution in the ground floor walls. (c) soil stresses.

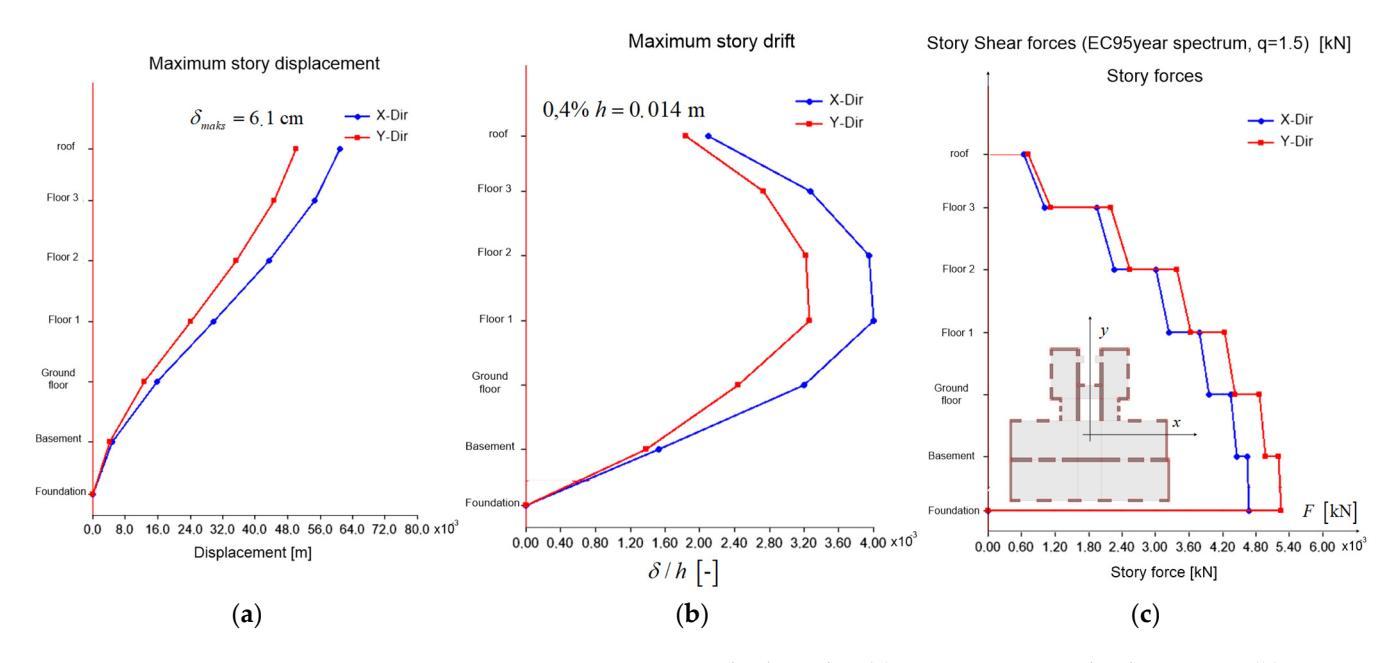
**Figure 13.** Response spectrum method results: (**a**) maximum story displacements. (**b**) maximum story inter-story drifts. (**c**) seismic lateral forces in the X and Y directions for a 95-year return period.

It can be observed that the maximum displacements are close to reaching the SD limit state and are up to 6 cm for the X direction and 5 cm for the Y direction in the attic. The maximum value of story drift for the X direction is approximately 0.004 ( $\Delta$ /h = 0.4%), which is also the bounding value for the SD limit state for elements for which the shear failure mechanism is critical. This is not realistic since the model is linear–elastic, so displacement can be expected to be larger.

The distribution of story shear forces obtained using the design spectrum for a return period of 95 years is shown in Figure 13c. In the case of a 95-year return period, the value of the base shear (BS) coefficient is 15% for direction X and 16% for direction Y. The average shear stress in each story for a 95-year return period is between 0.14 and 0.16 MPa for the X and Y directions, with higher values corresponding to higher floors due to lesser thicknesses of walls. It is important to note that this method of calculating shear stress provides only a rough estimate and does not accurately represent the actual distribution. Since it is anticipated that the building will not meet the conditions of a 475-year return period earthquake, the analysis focuses on the effects of the 95-year earthquake ( $a_g = 0.125 \text{ g}$ ).

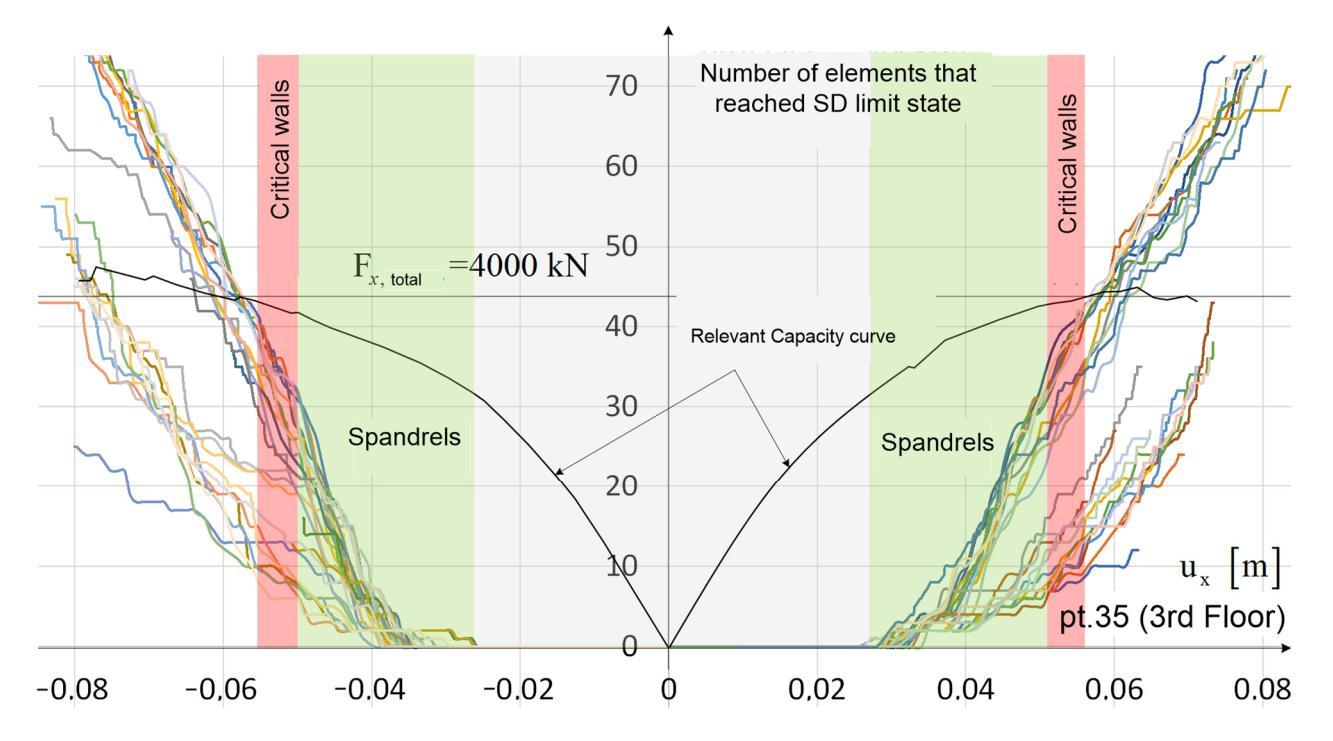
Figure 19 presents a diagram showcasing the cumulative count of elements that reached the significant damage limit state. The diagram overlaps with the most important bearing capacity curve for the X direction. An area where the spandrels begin to enter a state of SD (highlighted in green) can be observed. It can be seen that in this area, a large number of spandrels, depending on the load case, enter a state of SD, and for critical cases already analyzed, the number is 38. After that, at a displacement of CM of about 5.1 cm, the critical pier enters a state of SD (red area), and soon after that, the critical pier also fails (near the red area).

**Figure 19.** Number of elements that have reached the limit state SD as a function of the control point displacement.

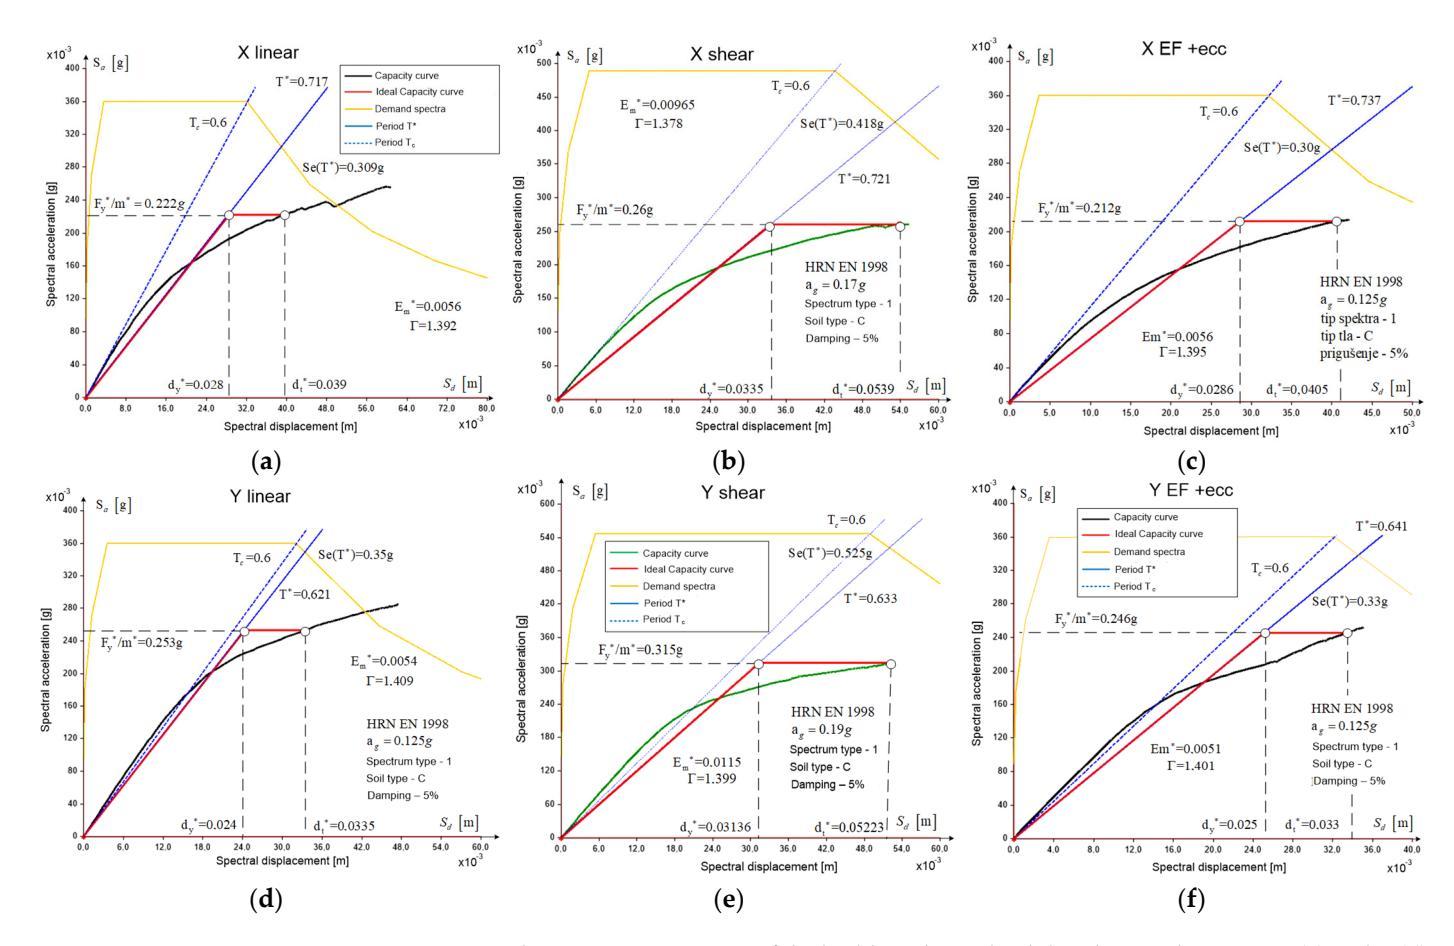
Figure 20a,d show idealized bearing capacity curves of an equivalent SDOF system for a PGA of 0.125 g (r.p. 95 years—level 2) and for linear load distribution without eccentricity. The system's deformation capacity in both directions is higher than required. The maximum PGA value that would satisfy the demand in this case of load distribution is approximately 0.17 g for the X direction and 0.16 g for the Y direction. It should be noted that this load case is not paramount but is presented only to illustrate the main parameters and coefficients.

**Figure 20.** Relevant capacity curves of the building: linear load distribution directions X (**a**) and Y (**d**). shear load distribution directions X (**b**) and Y (**e**). lateral load method distribution directions X (**c**) and Y (**f**).

Similarly, Figure 20b,e show an idealized load capacity curve of an equivalent SDOF system for a PGA with 0.17 g in the X direction and 0.19 g in the Y direction for shear load distribution without eccentricity, as well as the load distribution during deformation of the shear building (parabola) also without eccentricity. It can be seen that for both distributions, the building has a similar deformation capacity that satisfies the ground acceleration requirement on the bedrock, of 0.17 g and 0.19 g, respectively, which is approximately equivalent to the earthquake return period of 225 years.

Figure 20c,f show the idealized capacity curve of an equivalent system for a ground acceleration on the base rock of 0.125 g for the X and Y directions and for a distribution of load over the height of the building using the lateral force method with a 5% eccentricity of the building width. The system deformation capacity can be concluded to be approximately equal to the required capacity. The maximum ground acceleration on the bedrock that fulfils the displacement requirement is close to 0.125 g, and this load case is critical. The system deformation capacity can be concluded to be close to the requirements, and we can surmise that there are no load-bearing reserves for horizontal actions.

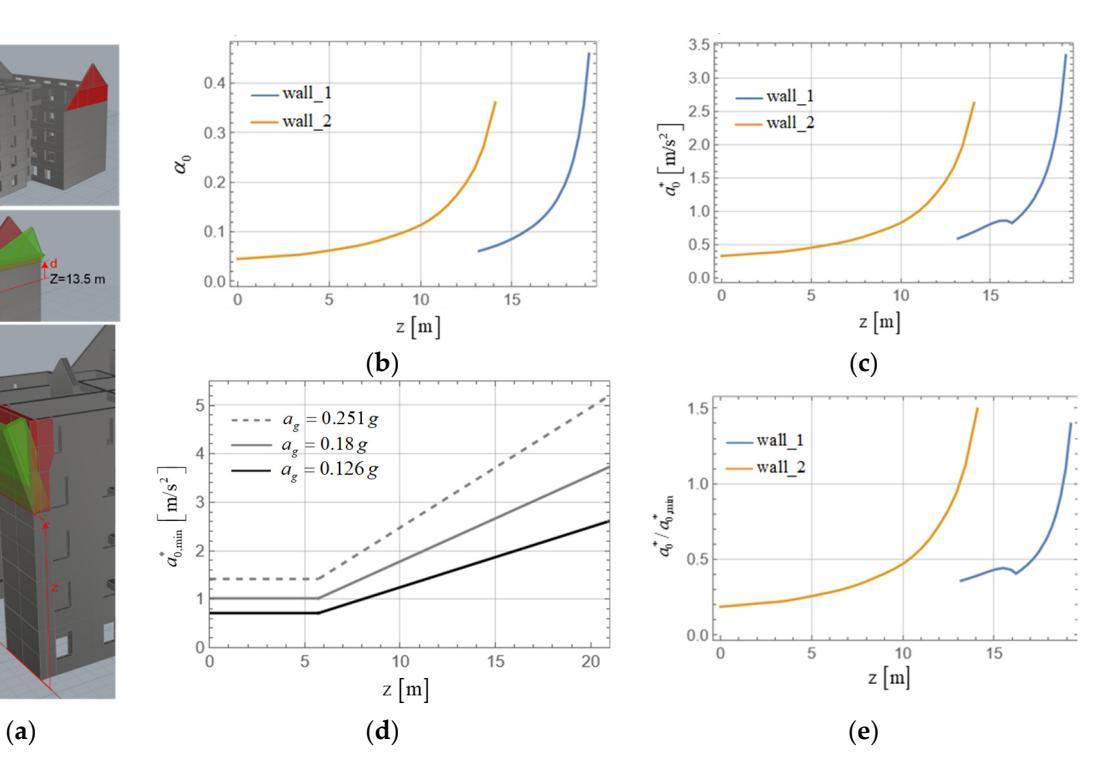
For these two walls shown in Figure 21a, the position of the line hinge was considered to be a variable parameter. The results for the activation coefficient and corresponding spectral acceleration are given in Figure 21b,c. As the position of the line hinge increased over the height of the building, the volume of each block decreased and, as a consequence, the activation factor increased, manifesting the ratio of the thickness and height, i.e., elements with higher slenderness had a lower activation factor.

In addition, for the type of mechanism that considers the formation of an internal line hinge and the formation of a kinematic chain, two cases of façade walls were considered. It is worth noting that for these cases, a relatively good connection between floor structures and walls was assumed. The vertical position of the inner line hinge is assumed to be a variable parameter. For wall\_3, it was assumed to form over the height of the pier and, for wall\_4, it was assumed to form between the openings of the lower and upper floors. The results in Figure 22 show that the one-story mechanism (wall\_3) had a high activation requirement regardless of the position of the internal line hinge formation. However, if the geometry of the local mechanism included two stories (wall\_4), the activation coefficient

decreased considerably. Moreover, in this case, the sudden drop in the activation coefficient and spectral acceleration observed for the formation of the internal hinges at 13.2 m was a consequence of the change in wall thickness from 45 cm (lower story) to 30 cm (upper story), which was taken into account in the numerical calculation.

**Figure 21.** (a) Solid model of the case study building and selected overturning local mechanisms in Rhinocheros; (b) activation factor; (c) spectral acceleration that activates mechanism; (d) minimum demanded value for the spectral acceleration over the building height; and (e) safety factor value for the 95-year return period of seismic action.

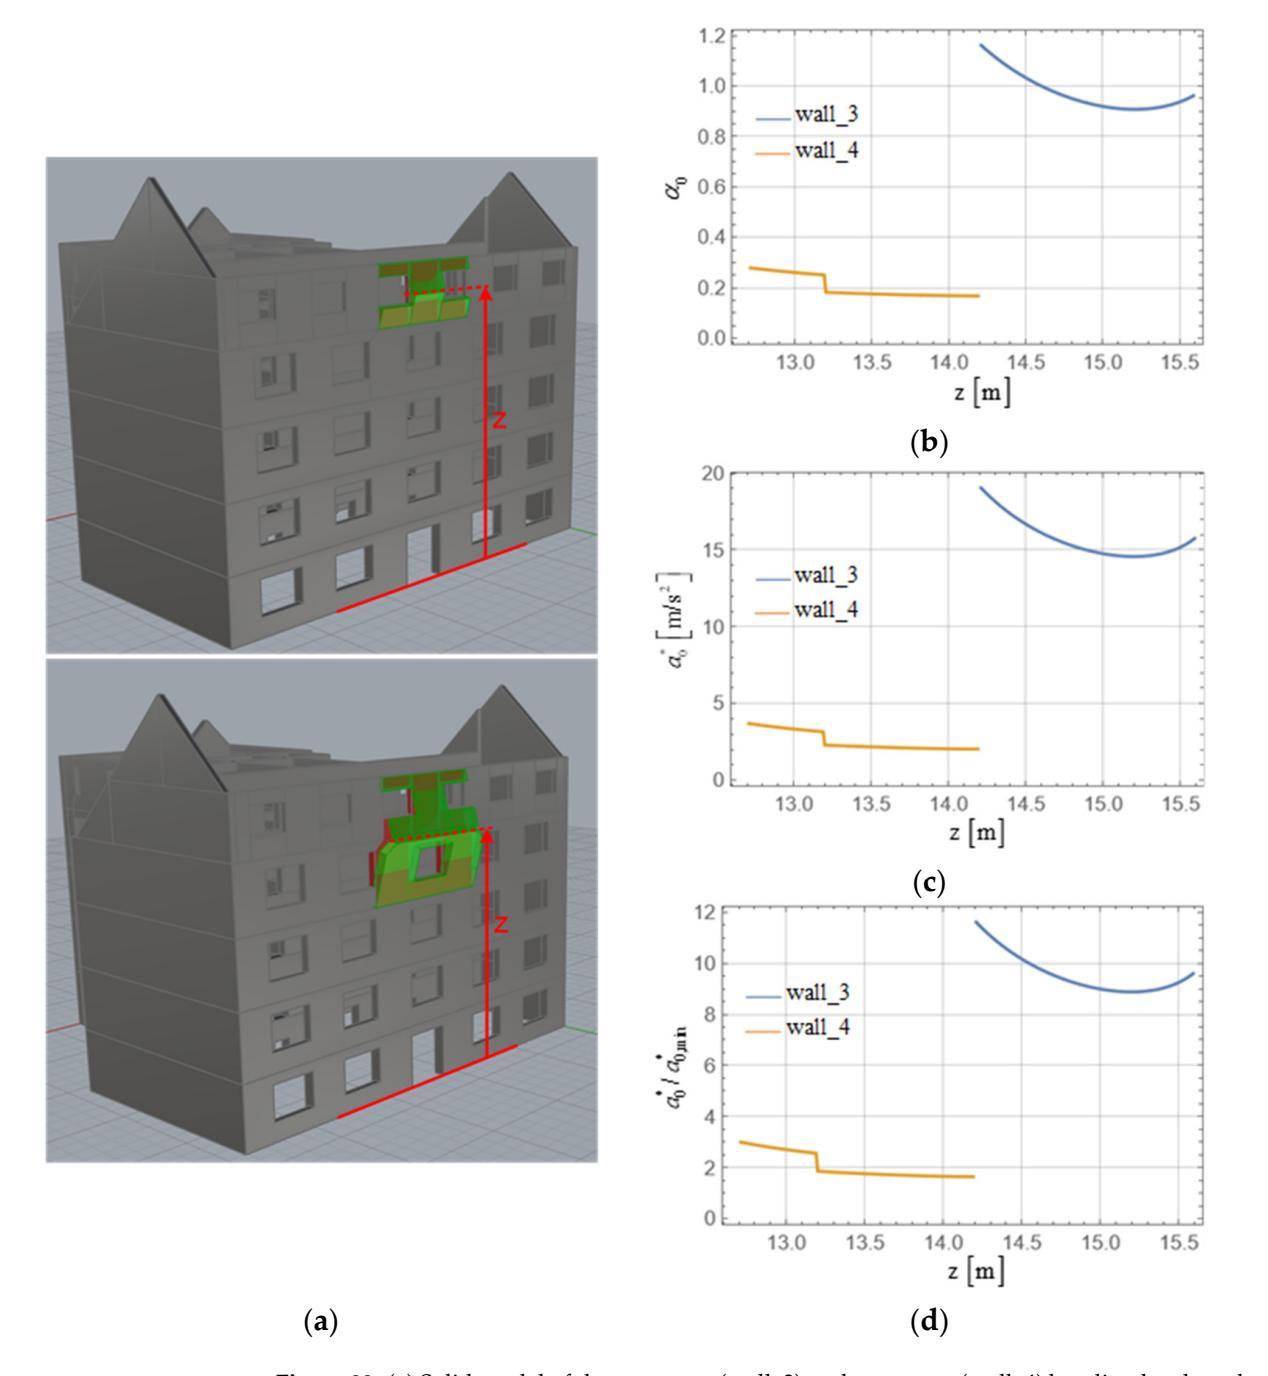
In order to compare this to seismic action, the demand  $a_{0,min}^* = max\left(a_g \frac{S}{q}; S_e(T_1)\Gamma_1 \frac{z}{H}q\right)$ was used, where the participation factor of the fundamental mode approximated by the number of stories is  $\Gamma_1$ , z is the height of the formation of the line hinge, H is building height, and q is a factor with the value 2. The corresponding minimum values are plotted for different return periods in Figure 21d. When comparing demand values with those obtained in the analysis, it was evident that for the return periods of 475 and 225 years, it does not satisfy requirements for all considered mechanisms except for wall\_3. However, it should be mentioned that the formation of the line hinge of wall 2 below z = 10 m is unlikely because this mechanism assumes the formation of cracks on all spandrels of the orthogonal wall that will contribute to the separation of the considered wall. Furthermore, for the 95-year return period, the activation demand was satisfied in the case of a line hinge forming above the height of 13 m for the west courtyard wall (wall\_2), and for gable (wall\_1) above approximately z = 18.5 m. Nevertheless, it is worth mentioning that this analysis considered only the activation of the mechanism and not the eventual overturning of walls. Furthermore, this criterion is in most cases conservative, which is common of linear methods. Although the position of the line hinge of the presumed mechanisms shifted toward higher floors and the value of the activation acceleration increased, which was favorable, the walls of higher floors were still more prone to out-of-plane failure. Elements of the higher floors tended to be subjected to higher values of floor acceleration and generally had fewer connections, which constrained the mechanism to some extent, or like gable wall\_1, they had no constraint at all. In the case of the two-story bending mechanism (wall\_4), our investigation of the 95-year return period of seismic action returned an acceptable degree of

safety. However, the formation of this kind of mechanism is highly dependent on adequate constraint at the top of the mechanism.

**Figure 22.** (a) Solid model of the one-story (wall\_3) and two-story (wall\_4) bending local mechanisms in Rhinocheros; (b) activation factor; (c) spectral acceleration that activates mechanism; and (d) safety factor value for the 95-year return period of seismic action.

The possibility of activation of out-of-plane failure was also considered when performing a parametric analysis of the local mechanisms using the linear kinematic analysis method. The analysis carried out for the west courtyard wall showed the possible activation of the mechanism if the linear hinge formed below the third floor level when considering seismic action for a 95-year return period. By taking into account the damage patterns identified by the pushover analysis on the structural elements, especially on the piers and spandrels on the side walls, the possibility of the linear hinge formation and the activation of the mechanism between the first and third levels was found to be probable. Therefore, it is extremely important to draw special attention to strengthening connections, especially in the area of the lintels and parapets on the side walls. In addition, our analysis of the gable wall showed that it can be particularly critical for out-of-plane failure because it is partially cantilevered. It has low vertical loading (only self-weight), which has a stabilizing effect, and insufficient connections with perpendicular elements. While in the case of the west wall, the initiation of the overturning process depends on the damage of the joints, for this wall, it is very likely even with a very low intensity of seismic action. Finally, the numerical analysis of the cases in which a kinematic two-body chain was formed showed that this mechanism should be the preferred one, but it requires that adequate connections with the floor structures are provided on each floor.
