Earthquake Environmental Effects and Building Properties Controlling Damage Caused by the 6 February 2023 Earthquakes in East Anatolia

Keywords: 2023 Turkey earthquakes; coseismic surface ruptures; liquefaction; landslides; damage; structural failure

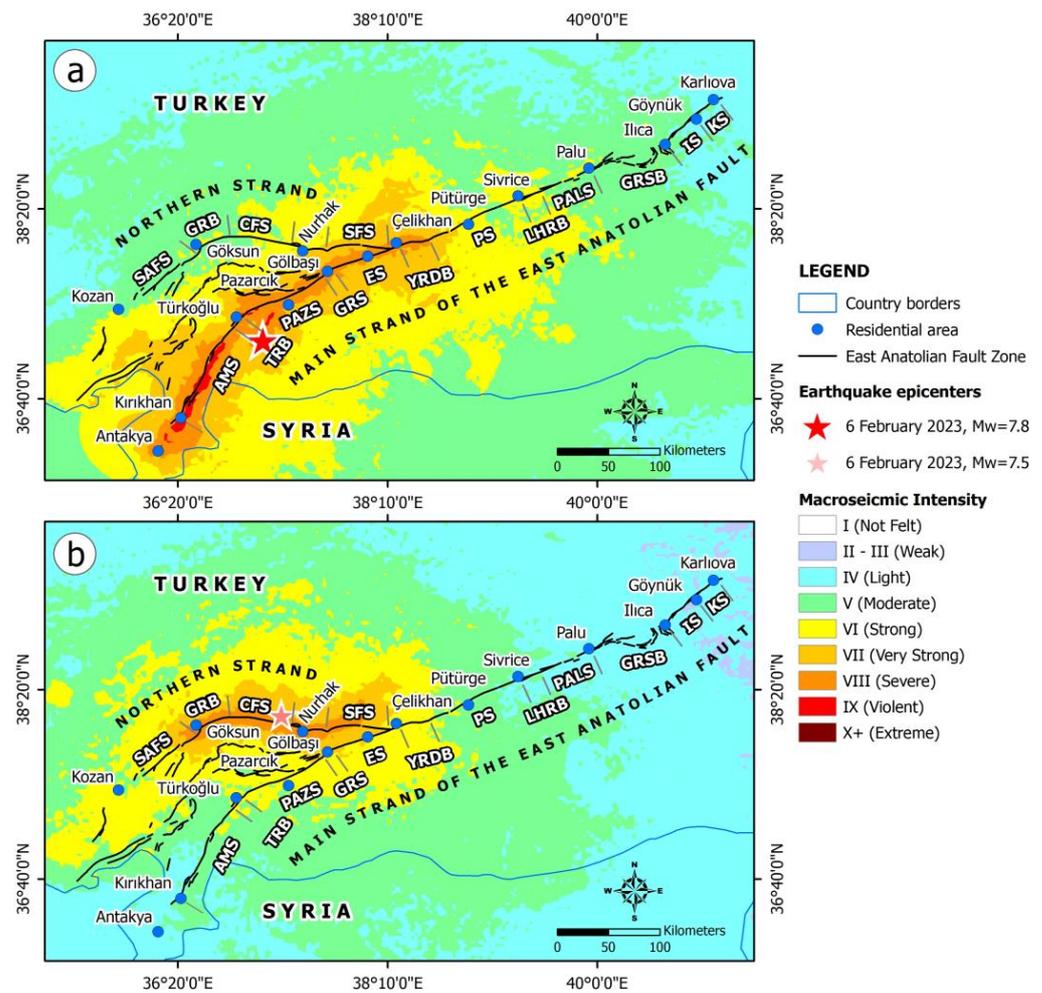
Figure 1. The macroseismic intensity maps of East Anatolia for the Mw = 7.8 (a) and the Mw = 7.5 (b) earthquakes on 6 February 2023 based on data provided by the United States Geological Survey [1,2]. The main and the northern strands of the EAFZ with their segments and fault jogs as well as densely populated residential areas located along the EAFZ are also presented. KS: Karliova segment; IS: Ilıca segment; GRSB: Gökçedere restraining bend; PALS: Palu segment; LHRB: Lake Hazar releasing bend; PS: Pütürge segment; YRDB: Yarpuzlu restraining double bend; ES: Erkenek segment; GRS: Gölbaşı releasing stepover; PAZS: Pazarcik segment; TRB: Türkoğlu releasing bend; AMS: Amanos segment; SFS: Sürgü fault system; CFS: Çardak fault system; GRB: Göksun releasing bend; SAFS: Savrun fault system. Faults from Duman and Emre [13] and earthquake epicenters from USGS [1,2].

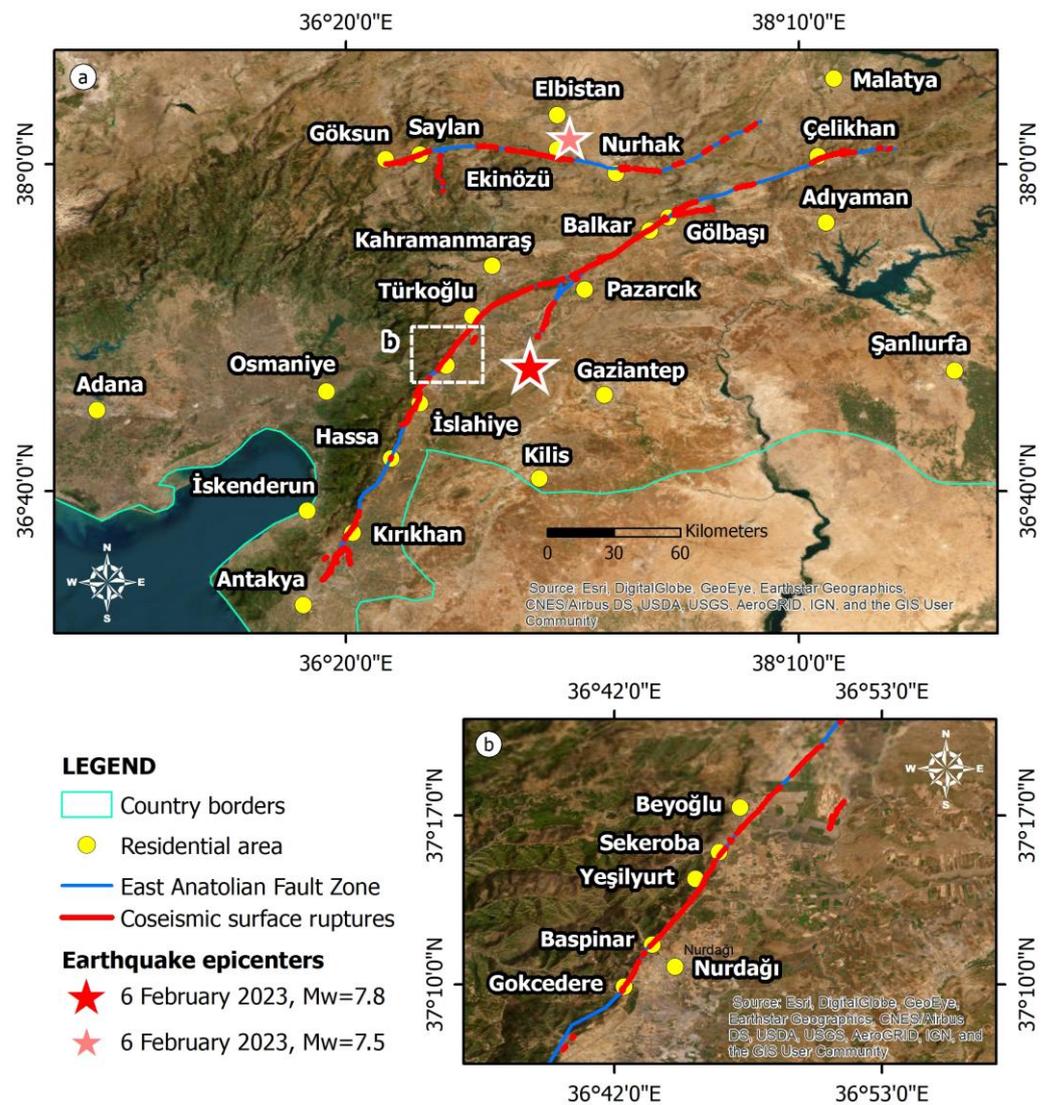
Figure 2. The primary environmental effects of the early 6 February 2023 earthquakes include extensive coseismic surface ruptures (a,b) generated along the main and the northern strand of the EAFZ. The areas visited by the authors and mentioned in this study are also presented.

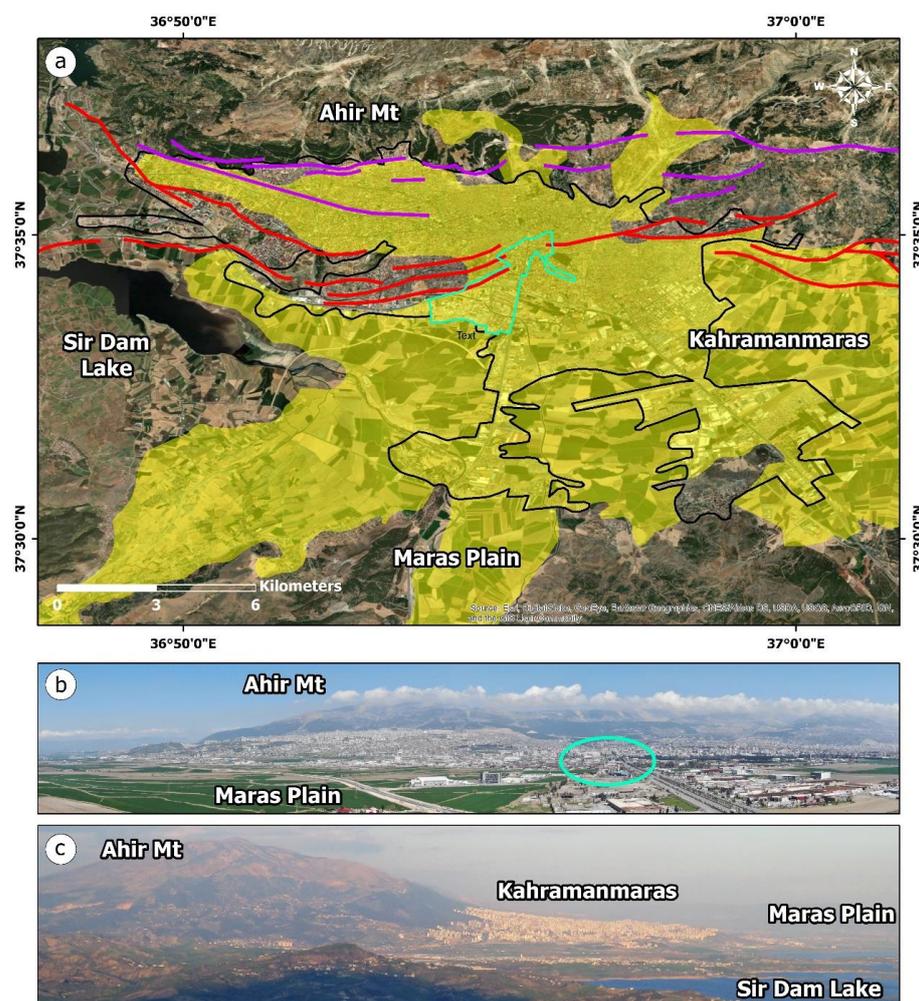
Figure 20. (a) Kahramanmaras city (black polygon) is located along the front of Ahir Mt. The largest part of the city is founded on Quaternary deposits (yellow polygon). This mountain front is disrupted by active faults that produced surface rupture during Holocene (red lines) and Pleistocene (purple lines) according to Emre et al. [14]. The heavily affected part comprises the city center (light blue frame). (b) View of Kahramanmaras from S (Maras Plain) to N (Ahir Mt) and (c) from W (Sir Dam Lake) to E. An eastern section of the Sir Dam Lake has been formed close to the southwestern part of the city.

The synergy of the aforementioned geological, geomorphological, hydrogeological and geotechnical characteristics of disrupted, soft and loose soils along a mountain front affected by active faults contributes to the increase in seismic intensity by two or three degrees in the Kahramanmaras built-up area [66]. This is further evidenced with related soil studies revealing a high potential for earthquake-triggered liquefaction in the southern part of the city [64] as well as with the spatial distribution of related landslide susceptibility and landslide hazard indices in the southern part of the Kahramanmaras province [65], including the city. More specifically, taking into account the spatial distribution of the landslide susceptibility and hazard indices, as presented in related maps compiled with AFAD [66] and by Biçer and Ercanoğlu [65], it is revealed that the landslide susceptibility and hazard indices within Kahramanmaras city increase from E to W. In particular, its western half is characterized with high to very high values of both indices, while the eastern half with very low to medium ones. By comparing the spatial distribution of the landslide susceptibility and hazard indices and the distribution of damaged buildings in

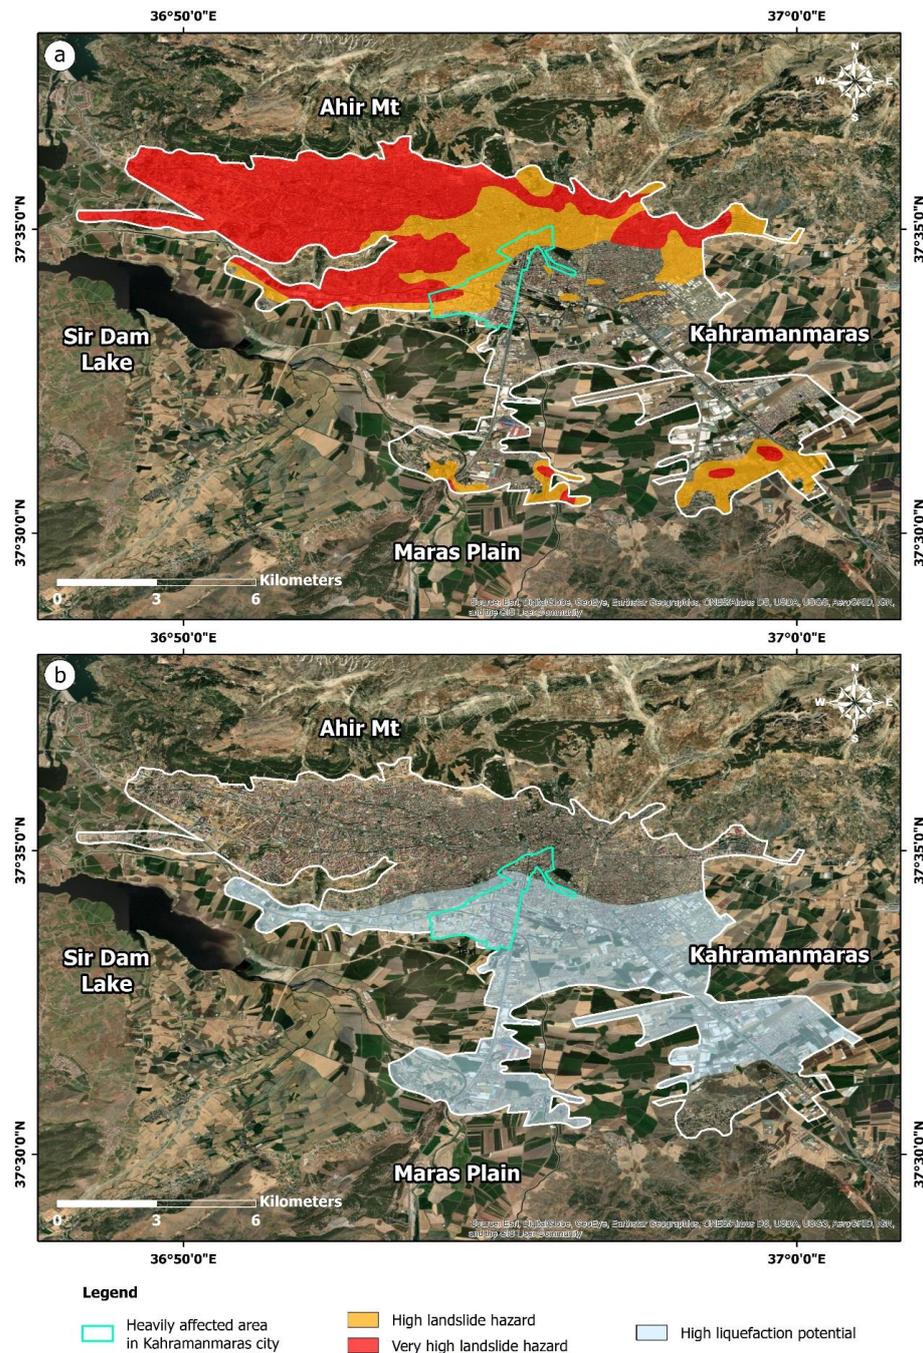
Kahramanmaras city, it is revealed that the majority of damage is concentrated in an area of high values of landslide susceptibility and hazard (Figure 21a). Taking into account the liquefaction potential maps of Cabalar et al. [64], it is revealed that the areas that suffered the most with the February 2023 earthquakes coincide with areas characterized with high potential for liquefaction of formations at various depths (Figure 21b). Based on the aforementioned, it can be said that the synergy of the aforementioned properties of the formations in the Kahramanmaras area contributed to the destruction.

Figure 21. Maps of the Kahramanmaras city (white polygon) illustrating the parts with high and very high landslide hazard (a) as revealed with relevant research of Biçer and Ercanoğlu [65] and with high liquefaction potential (b) based on the relevant research of Cabalar et al. [64]. The heavily affected area presented high liquefaction potential and high landslide hazard, factors contributing to instability conditions and large damage in the city center.
