# Insights into the Oroville Dam 2017 Spillway Incident

**Abstract:** In February 2017, a failure occurring in Oroville Dam’s main spillway risked causing severe damages downstream. A unique aspect of this incident was the fact that it happened during a flood scenario well within its design and operational procedures, prompting research into its causes and determining methods to prevent similar events from reoccurring. In this study, a hydroclimatic analysis of Oroville Dam’s catchment is conducted, along with a review of related design and operational manuals. The data available allows for the comparison of older flood-frequency analyses to new alternative methods proposed in this paper and relevant literature. Based on summary characteristics of the 2017 floods, possible causes of the incident are outlined, in order to understand which factors contributed more significantly. It turns out that the event was most likely the result of a structural problem in the dam’s main spillway and detrimental geological conditions, but analysis of surface level data also reveals operational issues that were not present during previous larger floods, promoting a discussion about flood control d

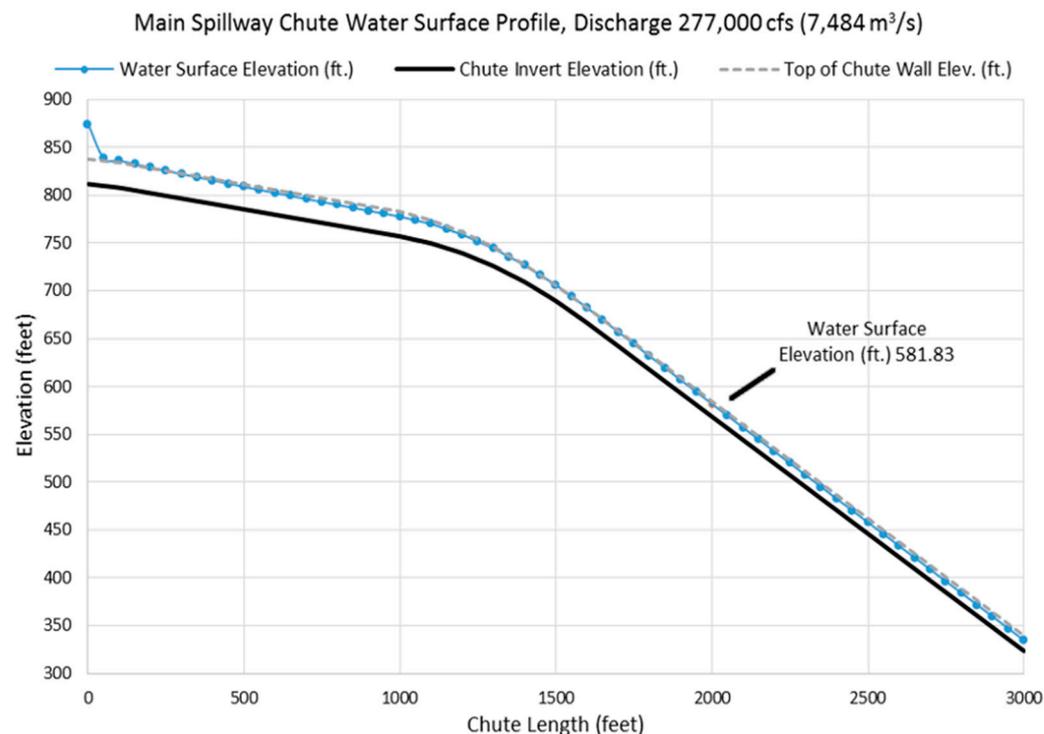
**Figure 6.** Oroville Dam main spillway chute water surface profile, discharge  $7484 \text{ m}^3/\text{s}$ .

From the chute flow analysis, it is clear that the initial assumption of critical flow depth at the chute's beginning does not negatively impact the results significantly, as due to the chute's design, flow depth quickly approaches normal depth with a standard S2 curve for supercritical flow [52]. For low discharge profiles, normal depth is reached fairly quickly, and only when the spillway is running at maximum capacity,  $7484 \text{ m}^3/\text{s}$  (277,000 cfs), does the flow reach normal depth close to the chute's end. No surface flow irregularities are immediately apparent from this analysis, indicating that cavitation is probably not the initial cause of the of main spillway's failure. However, as this model assumes hydrostatic pressure, to confirm this assumption one could use the method recommended in Reference [53], that allows for the detection of cavitation despite one-dimensional flow assumptions.
