Analysis and Disposal of Typical Breakdown Failure for Resin Impregnated Paper Bushing in the Valve Side of HVDC Converter Transformer

Hao Tang ^{1,2,*}, Guangning Wu ¹, Ming Chen ³, Jiang Deng ¹ and Xining Li ²

Keywords: valve side bushing; resin impregnated paper; HVDC converter transformer; bushing breakdown failure; field repair

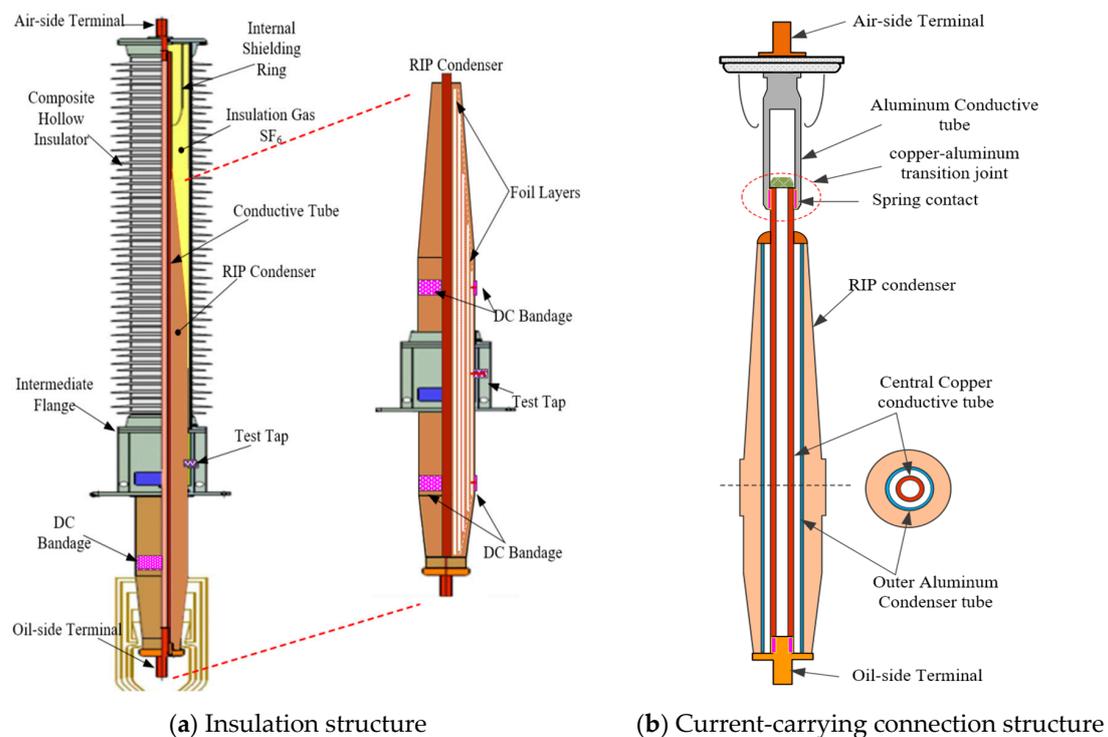
Figure 1. Structure of the failed resin impregnated paper (RIP) valve side bushings.

All these bushings have the same insulation and current-carrying connection structure. This paper takes the failed bushing of the Baoji converter station as an example to analyze characteristics and the root cause of this breakdown failure.

The external envelope of the failed bushing is a composite hollow insulator, and its inner insulation is resin impregnated paper condenser body. The space inbetween the insulator and condenser is filled with SF₆. Foil layers arranged inside the RIP condenser can control both axial and radial electric field inside the bushing, and as well to adjust external electric field outside the envelope insulator. DC-bandages are designed on the upper and lower surface of RIP condenser to release the surface charge. Inside the RIP condenser of the failed bushing is designed by a double-tube structure. The outer tube is an aluminum alloy tube, which is used to winding the condenser body but does not carry any current. The inner central tube is a copper current-carrying conductive tube. Outside the upper part of RIP condenser body, the inner copper conductive tube and another aluminum conductive tube form a copper–aluminum transition joint through spring contact, which can offset relative displacement of the insulator and conductor when temperature changes.

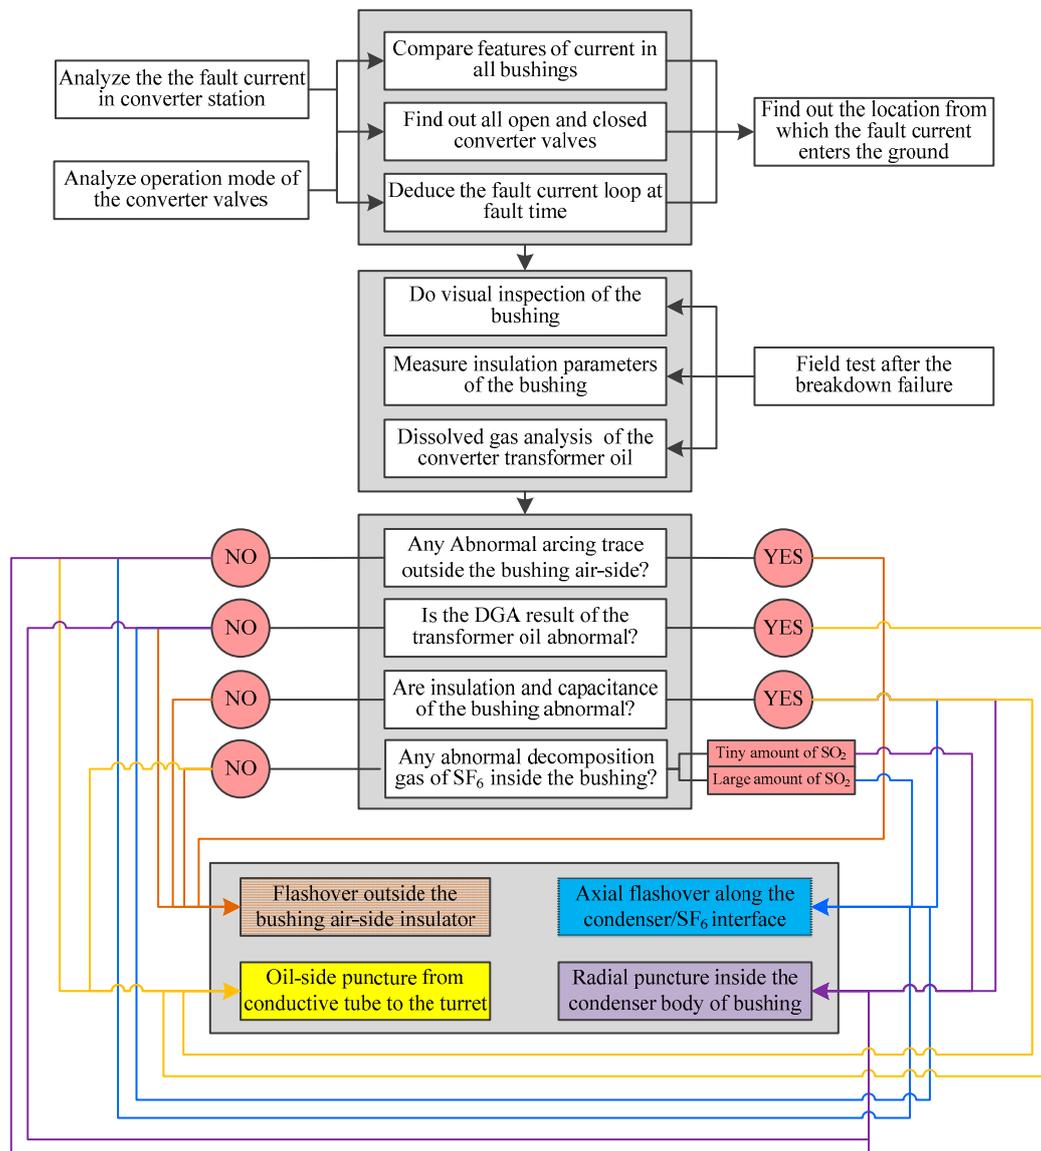
According to four characteristics of failed RIP valve side bushing and its related converter transformer, which include external arcing traces of the bushing air-side, dissolved gas analysis results (DGA) of converter transformer oil, capacitance and insulation characteristics of bushing's condenser,

decomposition gases of SF₆ inside the bushing's composite hollow insulator, four typical breakdown failures and their diagnosis method are proposed. These breakdown failures are flashover outside the air-side of the composite hollow insulator, axial flashover along the RIP condenser/SF₆ interface, radial puncture inside the RIP condenser, and oil-side puncture from conductive tube to the bushing turret. The diagnosis flow chart is shown in Figure 6. Some more cases of breakdown bushings indicate that a defect caused by axial flashover along the condenser/SF₆ interface is generally accompanied by large amount of SO₂, and the recommended concentration of this gas is greater than 100 μL/L. While a defect caused by radial puncture inside the condenser body of bushing is usually accompanied by tiny amount of SO₂, and the recommended concentration of this gas is undetectable or less than 5 μL/L.

Figure 6. Typical breakdown failure diagnosis flow chart.
