Article

Detection and Diagnosis of Defect in GIS Based on X-ray Digital Imaging Technology [†]

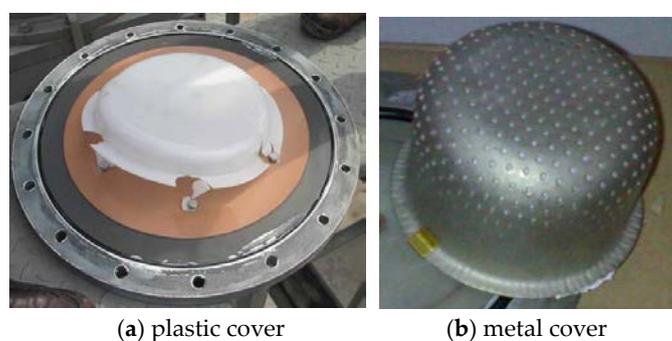
Figure 11. The covers with two different materials.

In order to absorb moisture in SF₆ gas, adsorbents were installed in the adsorbent cover inside GIS. The adsorbent cover was generally made of stainless steel. Some manufacturers use plastic covers to reduce costs. However, the thermal expansion coefficient of plastic material is much larger than that of metal material. When the temperature changes greatly, the degree of thermal expansion and contraction of GIS metal tank and plastic adsorbent cover varies greatly, which makes the cover age and damage easily. Facts have proved that if the adsorbent cover breaks down and the adsorbent drops off, it will cause the internal discharge fault in the GIS. It is necessary to detect and distinguish the cover material, then it could be possible to eliminate defects of the plastic cover. Figure 11 gives the covers with two different materials.

Because there is no partial discharge before the cover is damaged, it could not be effectively detected by live detection methods such as UHF and ultrasound. Nevertheless, X-ray digital imaging technology could be used to detect the adsorbent cover in GIS in order to avoid equipment failure. The perspective images of the adsorbent covers made of different materials are given in Figure 12.

According to the features above, the material of the adsorbent cover in GIS can be clearly distinguished and hidden troubles can be investigated in the visualization detection by X-ray digital imaging technology. The major problem that the adsorbent cover defect is difficult to identify and judge effectively could be solved, and this detection method provides strong technical support for condition-based maintenance of GIS equipment. Moreover, the equipment power outage and blindly disassembly inspection is also avoided.
