Water Wall Tubes' High Temperature Corrosion Root Cause Investigation: A 300 MW Level Boiler Case

Xiaohe Xiong, Falin Chen, Liangyu Li and Houzhang Tan *

MOE Key Laboratory of Thermo-Fluid Science and Engineering, Xi'an Jiaotong University, Xi'an 710049, China
* Correspondence: hzt@xjtu.edu.cn

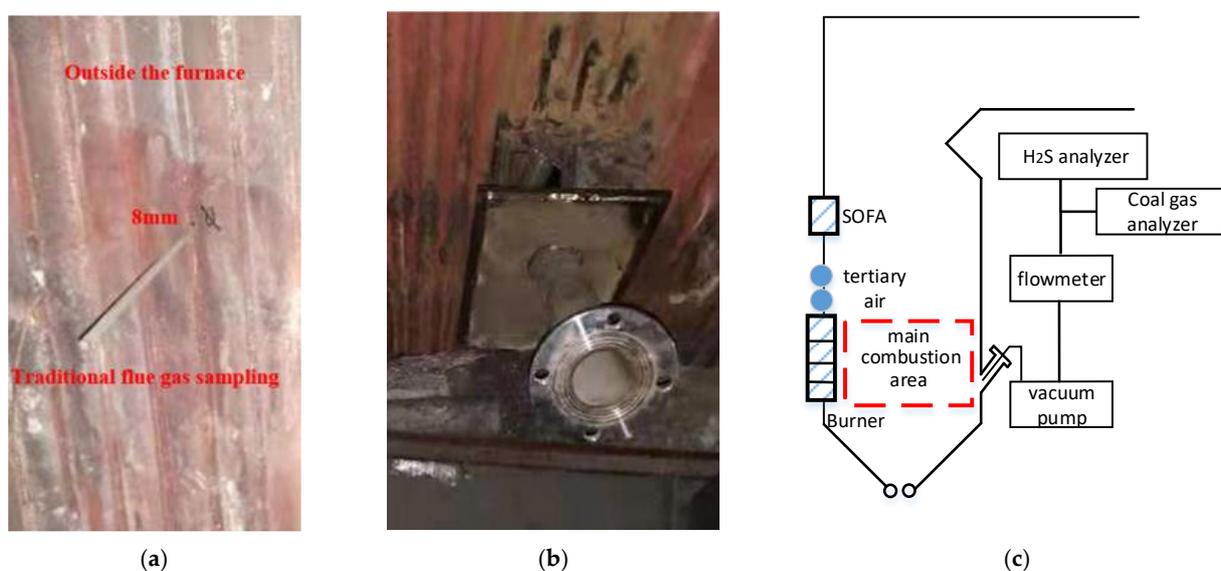
The traditional water wall tubes ambience gas sampling method is to weld an 8 mm steel tube to the membrane between the two water wall tubes, as shown in Figure 3a. The issue for this gas sampling method is that the 8 mm sampling tube no longer works once the tube is blocked by the slag. To ensure the H_2S can be continually measured, a new gas sampling vent method was developed, i.e., two water wall tubes were retrofitted to ensure that the flue gas sampling tube diameter is large enough to prevent the slag blocking the sample tube, or the sample tube can be reopened by cleaning the slag. Hence, a 70 mm large diameter sampling tube was mounted on the water wall with a flange connected at the end outside, as shown in Figure 3b. The reducing ambience test diagram can be seen in Figure 3c. The CO , H_2 , CO_2 and O_2 were detected by coal gas analyzer (Gasboard 3100p), while the H_2S was measured by Sulfur sentry analyzer, Event Eng corporation.

Figure 3. The sampling tubes description and reducing ambience measurement diagram. (a) The traditional sampling tube; (b) New sampling tube in this test; (c) Reducing ambience measurement diagram.
