# Identification of the Destruction Model of Ventilated Facade under the Influence of Fire

**Abstract:** Ventilated facades are becoming an increasingly popular solution for external part of walls in the buildings. They may differ in many elements, among others things: claddings (fiber cement boards, HPL plates, large-slab ceramic tiles, ACM panels, stone cladding), types of substructures, console supports, etc. The main part that characterizes ventilated facades is the use of an air cavity between the cladding and thermal insulation. Unfortunately, in some aspects they are not yet well-standardized and tested. Above all, the requirements for the falling-off of elements from ventilated facades during a fire are not precisely defined by, among other things, the lack of clearly specified requirements and testing. This is undoubtedly a major problem, as it significantly affects the safety of evacuation during a fire emergency. For the purposes of this article, experimental tests were carried out on a large-scale facade model, with two types of external-facade cladding. The materials used as external cladding were fiber cement boards and large-slab ceramic tiles. The model of large-sc

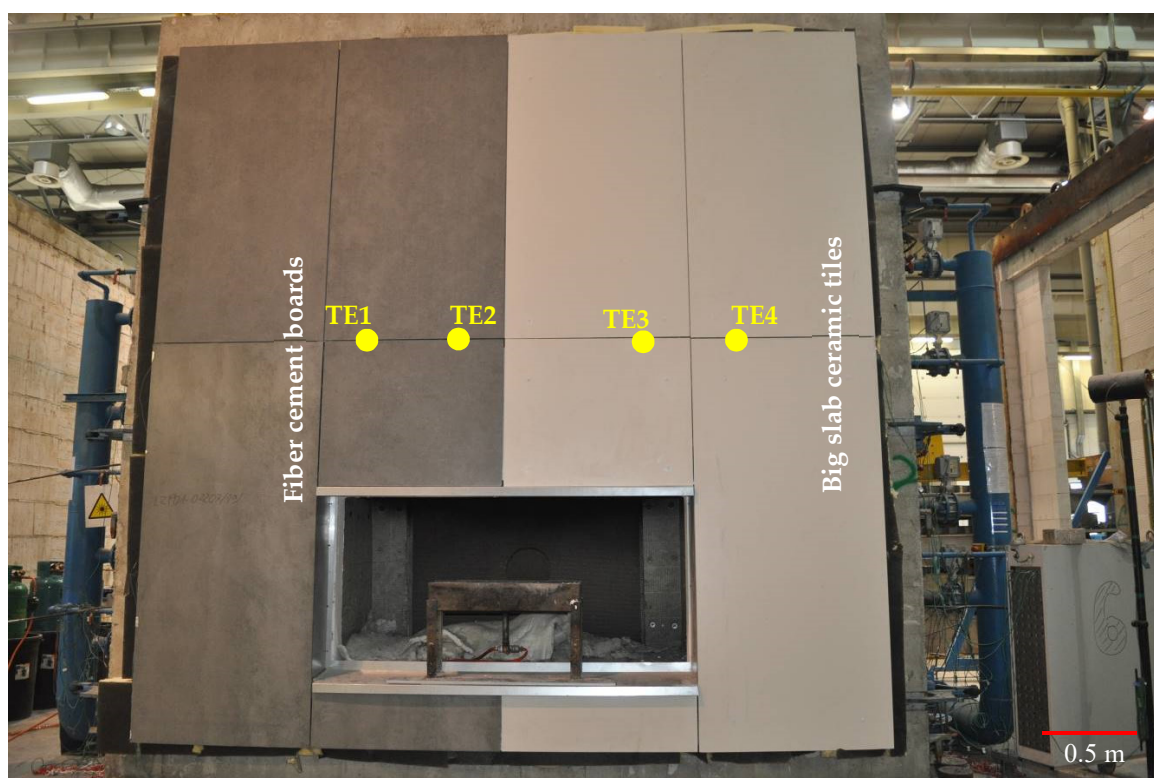
**Figure 3.** Ventilated facade model with location of thermocouples.

The results of temperature measurement from the thermocouples located in the part of the fiber cement boards, as shown in Figure 3, are presented as a function of time in Figure 6 for thermocouples TE1 and TE2. On the other hand, the results for TE3 and TE4 thermocouples located in the part of large-slab ceramic tiles are shown in Figure 7. The results presented for TE1 and TE2 thermocouples show high instability and temperature variations. This was due to the high development of degradation over time of fiber cement boards, especially after full development of the fire. The locations of the greatest temperature fluctuations in Figure 6 can be associated with cracking or detachment of external cladding elements.
