# Material Monitoring of a Composite Dome Pavilion Made by Robotic Coreless Filament Winding

**Abstract:** A hemispherical research demonstration pavilion was presented to the public from April to October 2019. It was the first large-scale lightweight dome with a supporting roof structure primarily made of carbon- and glass-fiber-reinforced composites, fabricated by robotic coreless filament winding. We conducted monitoring to ascertain the sturdiness of the fiber composite material of the supporting structure over the course of 130 days. This paper presents the methods and results of on-site monitoring as well as laboratory inspections. The thermal behavior of the pavilion was characterized, the color change of the matrix was quantified, and the inner composition of the coreless wound structures was investigated. This validated the structural design and revealed that the surface temperatures of the carbon fibers do not exceed the guideline values of flat, black façades and that UV absorbers need to be improved for such applications.

**Citation:** Mindermann, P.; Rongen, B.; Gubetini, D.; Knippers, J.; Gresser, G.T. Material Monitoring of a Composite Dome Pavilion Made by Robotic

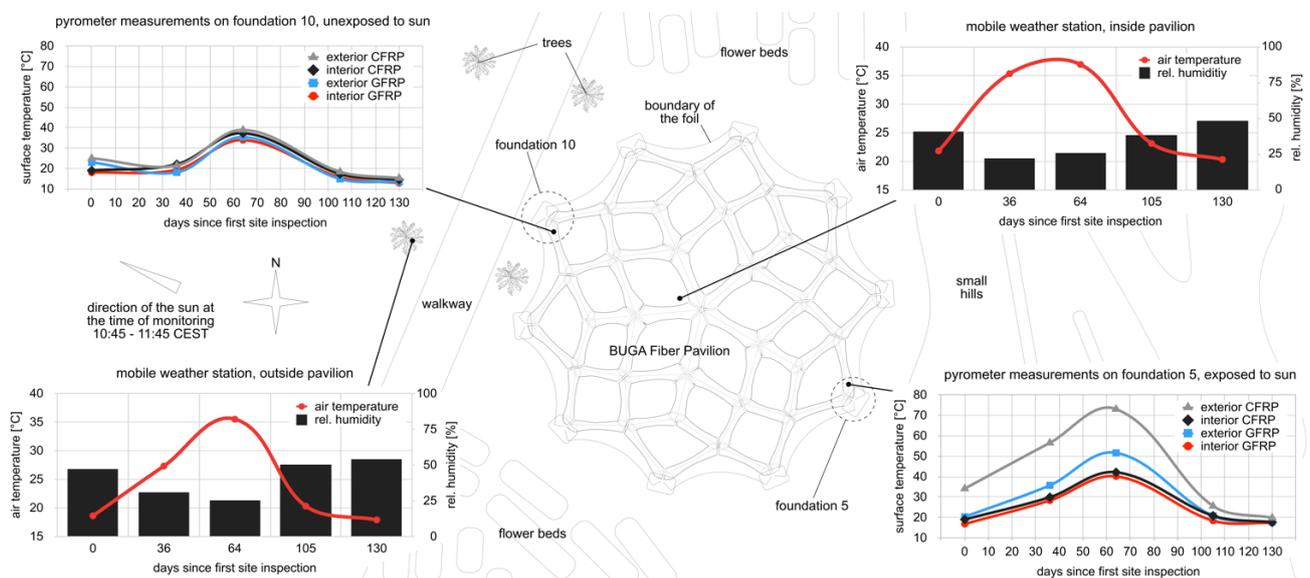
**Figure 4.** Floor plan of the BUGA Fiber Pavilion. The in situ measurements are indicated at their locations.

The surface temperature of the lower composite components was measured with a pyrometer, with reference points on the inner and outer sides of the component and on opposite sides of the pavilion (Figure 4). The temperature for glass fiber bundles ranged from  $12.9^\circ\text{C}$  to  $51.6^\circ\text{C}$  and from  $14.9^\circ\text{C}$  to  $73.0^\circ\text{C}$  for the carbon fiber bundles. For the components exposed to direct sunlight, surface temperatures between inside and outside differed by a factor of four; without direct sunlight, the temperatures were similar. The more intense the solar radiation, the greater the differences. The external carbon fiber

The highest temperature captured by the pyrometer during site inspections was 73.0 °C (Figure 4). It was measured at the exposed carbon reinforcement of foundation five on 26 July 2019. The outside air temperature was 35.5 °C and it was cloudless. By taking several pictures with the thermal camera and stitching them into a single frame, a vertical rise in temperature of  $2.5 \pm 2.0$  K was found for the carbon fiber reinforcement.
