Case Report Influence of Corrosion on Fatigue of the Fastening Bolts

Maciej B. Lachowicz ^{1,2} and Marzena M. Lachowicz ^{1,*}

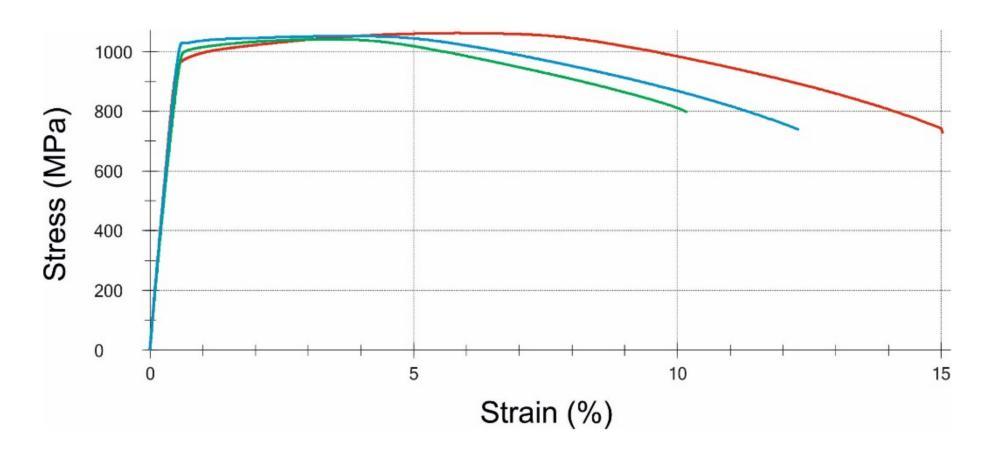
this is because the handle part would be too small to keep the bolt in the fixtures of the strength machine, and therefore it would not be possible to determine $R_{p0.2}$ and A. For the S1 bolt, the R_m value is oscillating at the limit of the requirements of the ISO 898-1 standard. The difference is rather small, and it has to be considered that the specimens were collected from a damaged bolt, and therefore local weakening of the material cannot be excluded. In terms of strength properties, the S2 bolt met the material requirements for bolts of 10.9 class according to ISO 898-1: 2013-06 (Figures 14 and 15, Table 2).

Figure 14. Stress-strain curves obtained for three specimens taken from the S1 bolt.

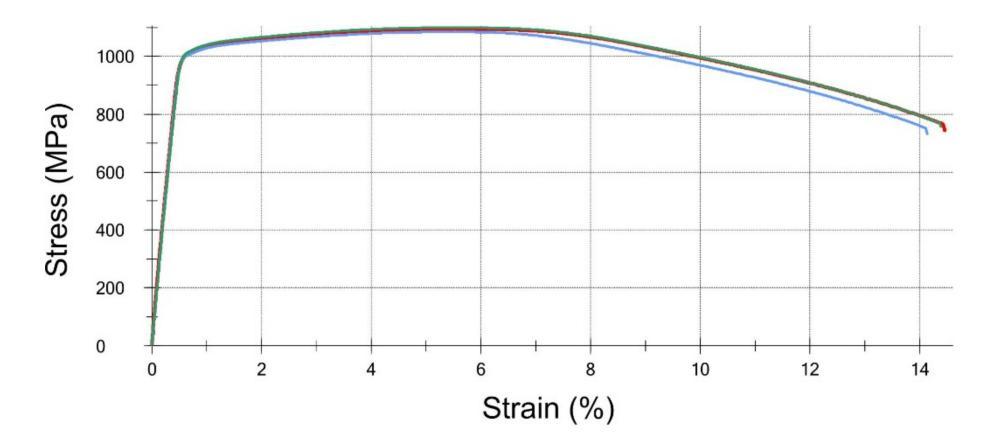
Figure 15. Stress-strain curves obtained for three specimens taken from the S2 bolt.
