# Rebuilding of Turbocharger Shafts by Hardfacing

**Abstract:** This paper presents the results of structural tests and hardness measurements of rebuilding coatings manually applied by the gas tungsten arc welding (GTAW) method on damaged surfaces of steel shafts of turbochargers of automotive engines. Single- and double-layer coatings were applied in an argon atmosphere by fusing a 1.2 mm diameter wire with a Fluxofil M58 flux core, using a current of 35A and an arc voltage of 8–9 V. The hardfacing resulted in coatings with a martensitic–bainitic structure with fine dispersed carbides rich in M23C6-type chromium. The hardness of the coatings on the rebuilt shafts averaged from about 740HV5 for the single-layer coating to about 770HV5 for the double-layer coating and was two times higher than the hardness of the tempered shafts without coatings.

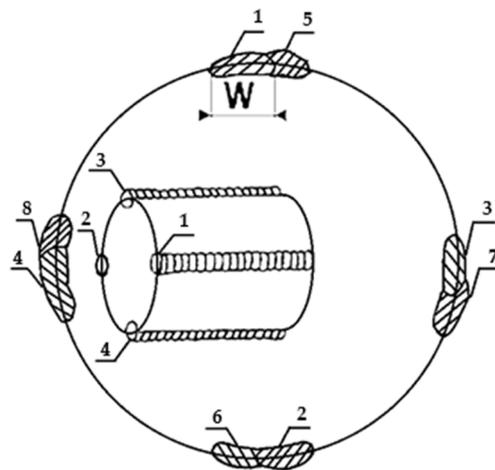
**Figure 4.** Laying sequence of the individual beads of the hardfacing coating (diagram). The numbers 1–4 in the internal diagram show the order in which the first stitches are laid on the damaged turbocharger shaft. The numbers 1–8 on the outer circle show the execution of the next stitches.

The rebuilding of the top layers of the shaft journals was carried out by hardfacing them with the GTAW method using argon as a shielding and plasma-forming gas at a flow rate of approximately 8 L/min, using a wire with a diameter of 1.2 mm and a flux core containing approximately 0.6% C, 1.9% Mn, 0.7% Si, 5.4% Cr, and the remainder being Fe. The hardfacing of the coatings was carried out manually using a current of about 35A and an arc voltage of 8–9 V. In order to cover the entire surface of the shaft journal, beads approximately 2.5 mm wide were laid lengthwise so that they overlapped each other by approximately 0.5 of their width ( $W$ ), according to the diagram shown in Figure 4.

The systematic arrangement of beads around the periphery of the shaft journal ensures that axiality is maintained despite the small diameter of the shaft. Similar to the single-layer coating, a two-layer coating was made on the shaft journal by longitudinally hardfacing

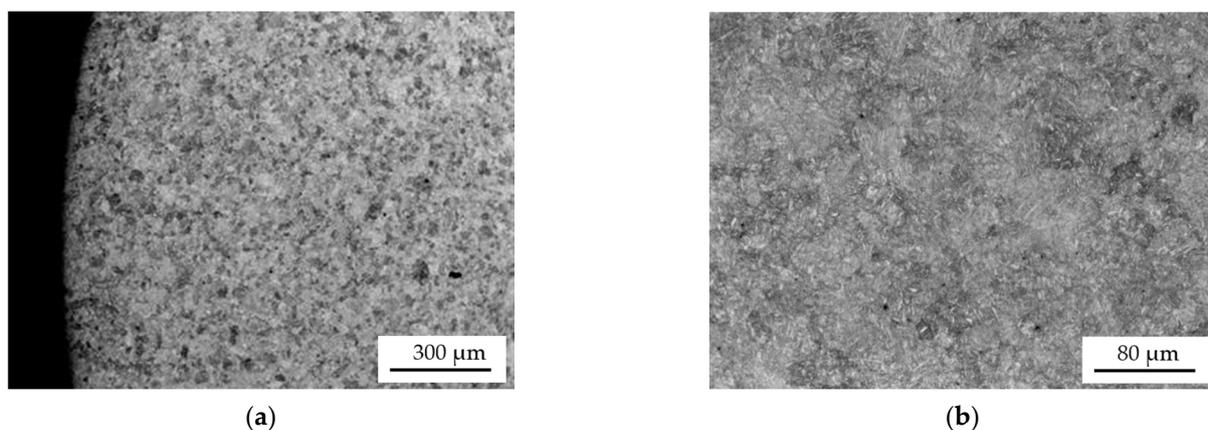
**Figure 8.** Microstructure of the new shaft journal (without coating). The specimen was etched with Kalling's reagent (a,b).

The microstructure of the two coatings arc-applied with a flux-cored wire is similar. Their microstructure, revealed by etching with Kalling's reagent (Figure 9c), is fine-grained. In contrast, the sub-coating zone and core of the single-layer hardfaced shaft is coarse-grained. The 100–150  $\mu\text{m}$  grains are coarse-grained tempered martensite. In the case of the double-layer coating, by reheating the core of the shaft journal during the application of the second coating, its structure was crystallized and it has a fine-grained structure similar to that of the new shaft journal (Figures 8a and 9b).

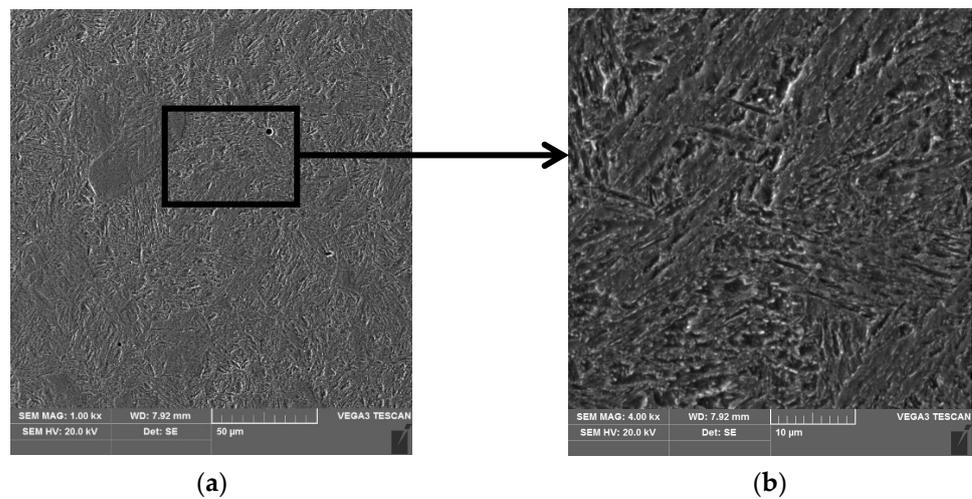
For the turbocharger shafts, a low-alloy structural steel for tempering was used with mark 42CrMo4 (acc. to PN-EN 10083-1, 1999) and the following chemical composition; 0.44% C, 0.94% Cr, 0.17% Mo, 0.17% Si, 0.73% Mn, and the remainder being Fe. The structure of the tempered shafts is fine-grained and is composed of highly tempered martensite (Figure 11).

**Figure 11.** Microstructure of the new shaft journal (without hardfacing) (a), detail from (a) visible fine grains of highly tempered martensite (b).

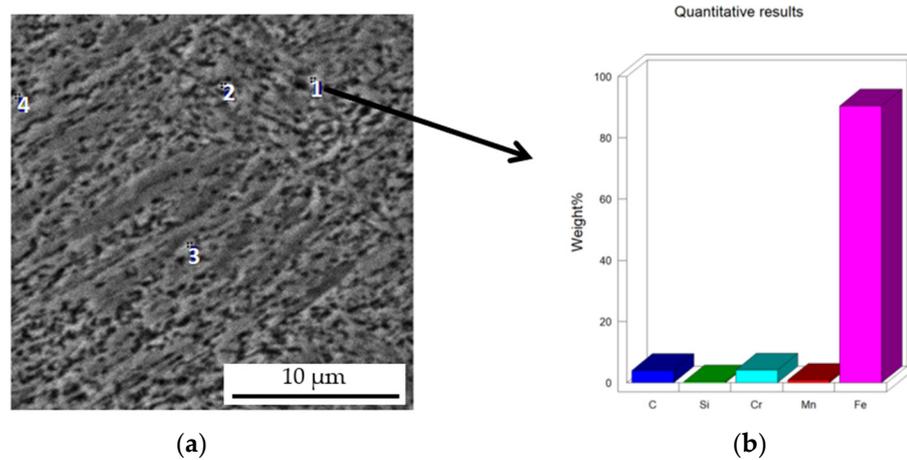
The place of performance of the spot X-ray microanalysis of the coating is shown in Figure 13a. The results are summarized in Table 1. Fine carbide separations, dispersively distributed between the lamellar–acicular martensite, were analyzed.

**Figure 13.** Microstructure of the flux-cored arc-hardfaced coating on the turbocharger shaft journal with micro-areas (points1–4) (a), bar chart of elemental content in micro-area 1 (b).
