Erosion–Corrosion Failure Analysis of a Mild Steel Nozzle Pipe in Water–Sand Flow

Abstract: Several leaks appeared in a mild steel (MS) pipe jet nozzle installed in a direct impact test rig after a few months of operation in erosive flow at the Centre for Erosion–Corrosion Research. The locations of perforation leaks were primarily upstream, but severe wall thinning was also noticed adjacent to the exit section. In this paper, a failure analysis was carried out on the leaking of a pipe jet nozzle, and the results are discussed in detail. The investigation carried out includes visual observation, scanning electron microscopy, 3D scanning, energy-dispersive spectroscopy, and laser profilometry measurements. In addition, numerical simulations based on computational fluid dynamics (CFD) and the discrete phase model (DPM) were conducted to investigate the root cause of the failure of leaks in the pipe jet nozzle. Further CFD-DPM simulations were performed on three different pipe jet designs for liquid–solid flow conditions, and were compared to find an alternative design to prevent the failure of the pipe jet nozzles. It was found that the increase in turbulence along with multiple imp

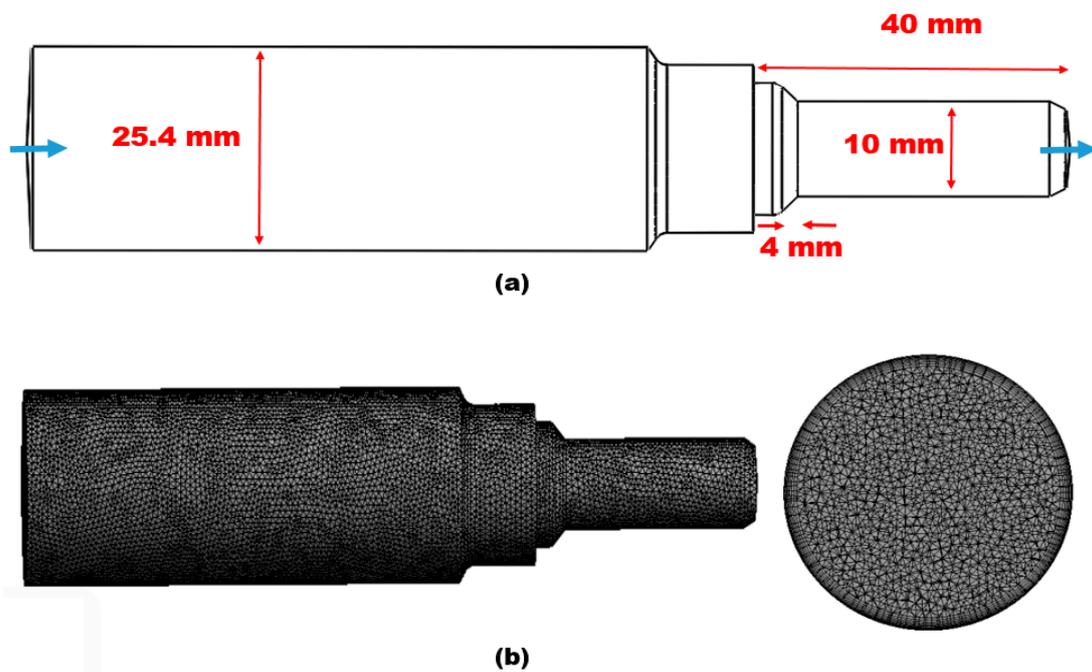
Figure 2. (a) Geometrical configuration; (b) computational mesh.

The Oka [32] erosion prediction model was selected to quantify the erosion rate, and the K-epsilon turbulence model was used to predict the behavior of the particle, which is fluid-flow-dependent. In order to capture the flow field near the wall and increase the calculation accuracy of CFD-DPM, boundary layer grids with 10 layers were set near the wall. To further improve the efficiency of numerical simulation while ensuring the optimal computation cost, verification of grid independence was carried out. The computational mesh used for CFD-DPM is a structured hexahedron with a total number of cells of 460,000; the pipe's geometrical configuration is shown in Figure 2.
