# Mechanical Properties and Fatigue Failure of Thermally and Thermochemically Treated C60 Steel

**Keywords:** heat treatment; oxidation; fatigue crack monitoring; C60 steel

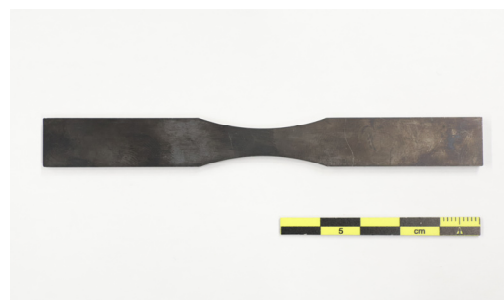
Following the thermochemical treatment, the samples exhibited a black tint over the entire surface, thereby highlighting the uniformity and efficiency of the oxidation process (Figures 5 and 6).

**Figure 6.** Sample after oxidation.

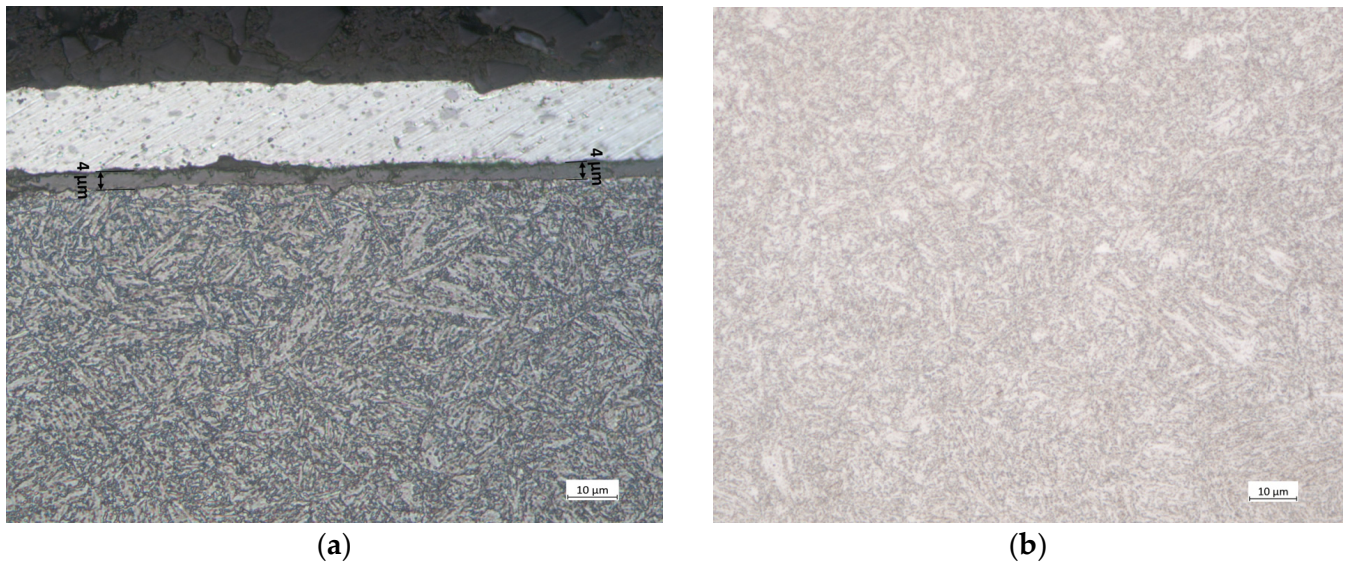
Figure 7a illustrates the microstructure of the sample that was thermochemically treated by oxidation. It is evident in the figure that an oxide layer of approximately 4  $\mu\text{m}$  in thickness has formed on the surface of the part. As illustrated in Figure 7b, the core of the part was maintained at a temperature of 500  $^{\circ}\text{C}$  for approximately 2.5 h, followed by a gradual cooling process. This resulted in the observation of an intermediate bainitic structure, which can be described as a mechanical mixture of supersaturated ferrite with carbon and carbides that have not yet reached the stage of cementite.

**Figure 7.** (a) Surface microstructure of C60 steel subjected to thermochemical oxidation treatment with an oxide layer of 4  $\mu\text{m}$ . (b) The core microstructure of the part, consisting of an intermediate bainitic structure.

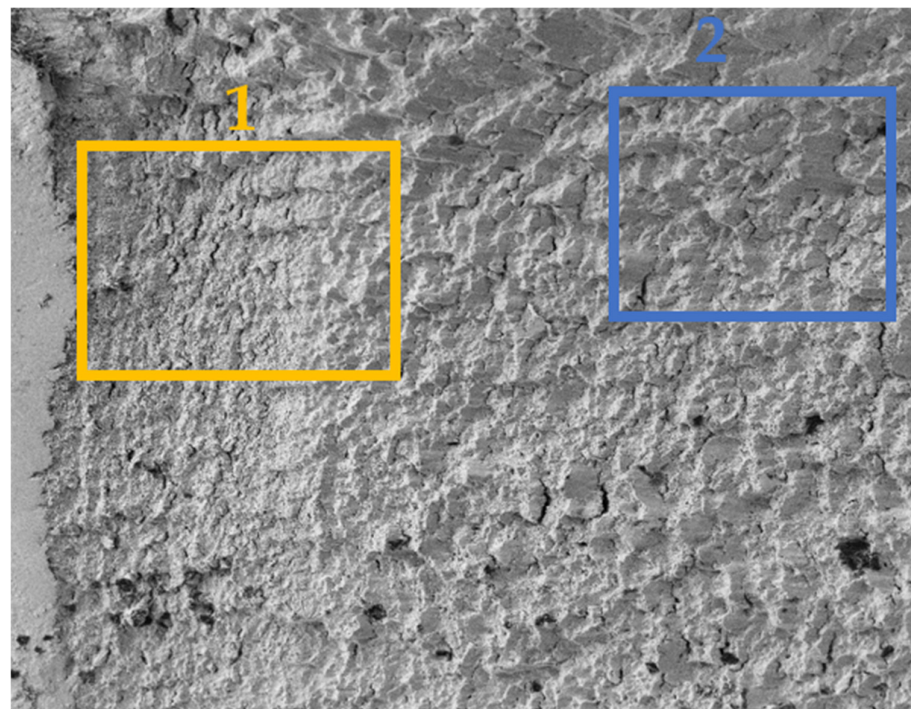
The oxidized layer was analyzed by scanning electron microscopy (SEM) in both secondary electron (SE) and backscattered electron (BSE) modes. The latter provided superior contrast between the base material and the surface layer (see Figure 8). In this region, two EDS spectra were acquired: Spectrum 1 corresponds to the oxidized layer, and Spectrum 2 corresponds to the base material. Spectrum 1 displays significant nitrogen (N) and oxygen (O) peaks, elements that are not present in the base material. This observation confirms the formation of a distinct oxidized layer.

**Figure 8.** SEM-BSE image of the oxidized layer with the EDS acquisition areas (Spectrum 1—oxidized layer; Spectrum 2—base material).

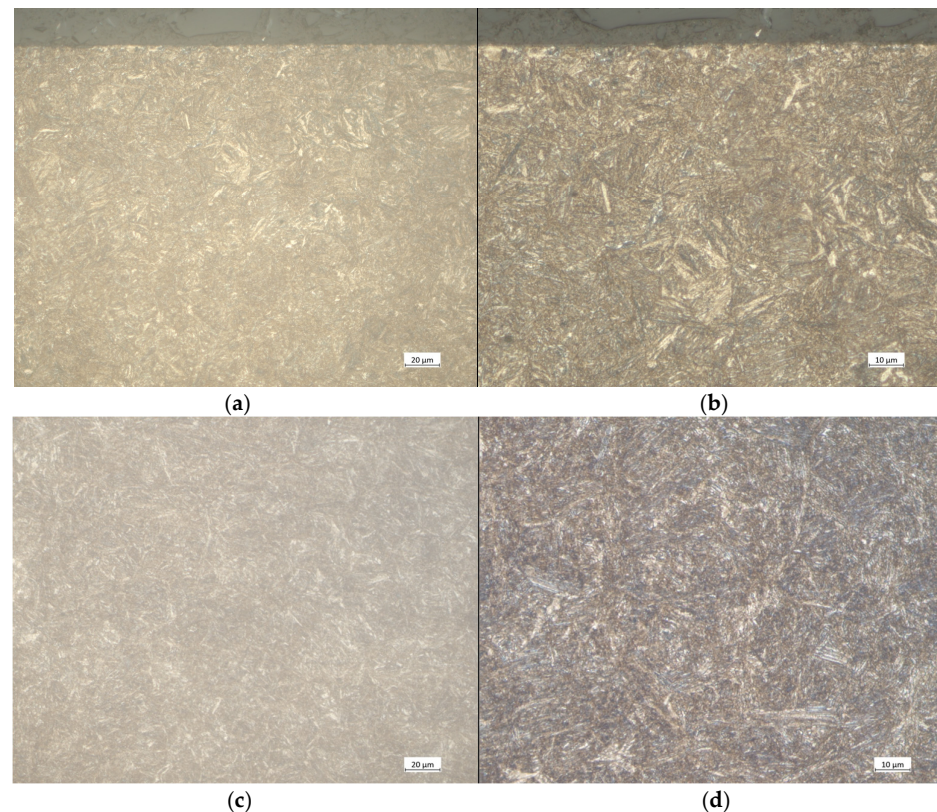
Metallographic analysis of the hardened and tempered material was conducted, revealing a sorbitic structure composed of a ferritic matrix with uniformly distributed iron carbides (cementite) (see Figure 10). The microstructure exhibited uniformity across the entire cross section, with no discernible discrepancies observed between the surface and the core.

**Figure 10.** Microstructure of C60 steel after hardening and tempering: (a) edge region at  $500\times$  magnification; (b) edge region at  $1000\times$  magnification; (c) core region at  $500\times$  magnification; (d) core region at  $1000\times$  magnification.

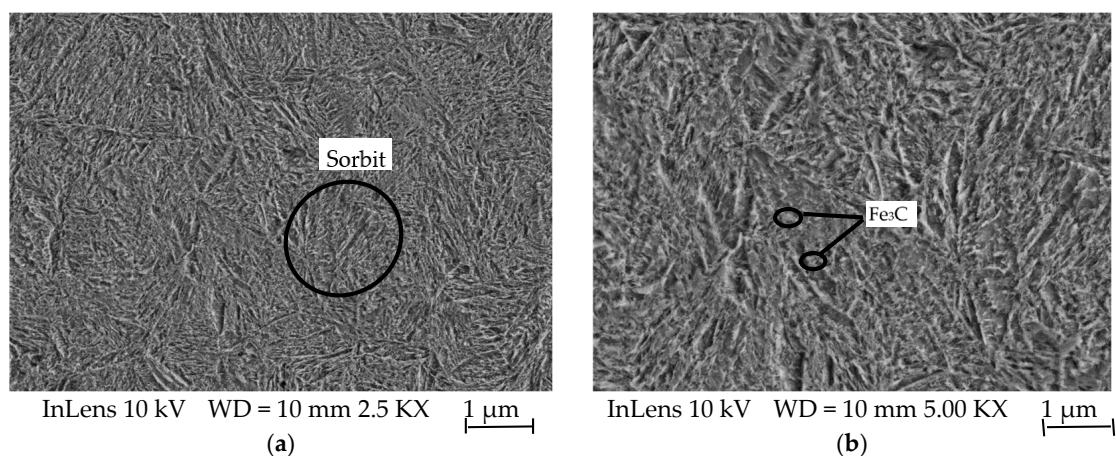
As illustrated in Figure 11a, the fine lath morphology of sorbite (large circle) is indicative of a 0.6% carbon content and the application of a hardening and tempering heat treatment. At higher magnifications, Figure 11b reveals the refined distribution of ferrite and finely dispersed cementite particles, which are characteristic of a well-tempered sorbitic structure.

**Figure 11.** Scanning electron microscopy (SEM) microstructure of C60 steel after hardening and tempering: (a) core region at  $2500\times$  magnification; (b) core region at  $5000\times$  magnification.

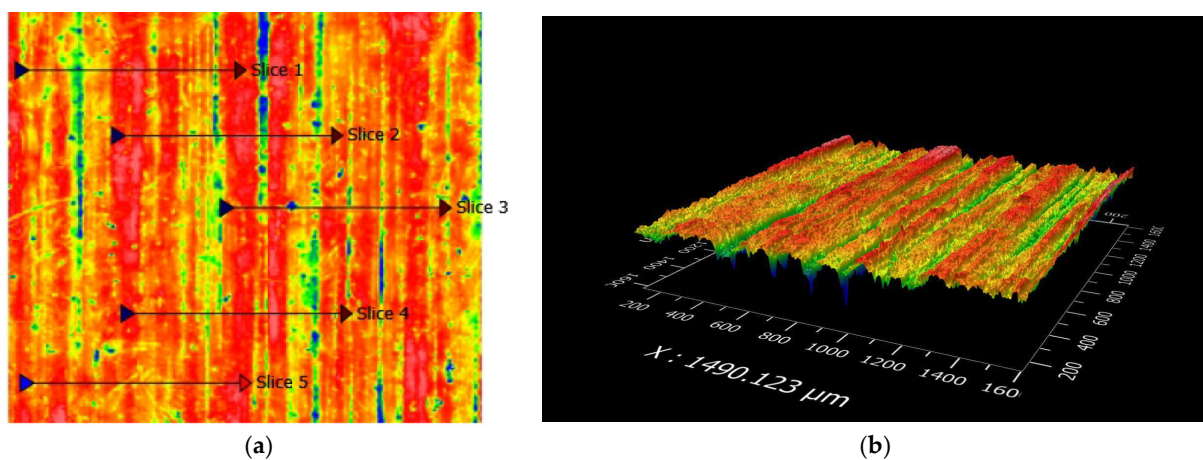
**Figure 12.** Surface profilometry of heat-treated sample:  $R_z = 0.794 \mu\text{m}$ : (a) five roughness measurements performed at distinct points across the surface; (b) three-dimensional topographical map of the surface.

The results of this study indicated a surface roughness of  $0.794 \mu\text{m}$  for the heat-treated samples and  $0.861 \mu\text{m}$  for the oxidized sample. While the roughness values were found to be relatively close, the hardened and tempered material exhibited slightly lower roughness,

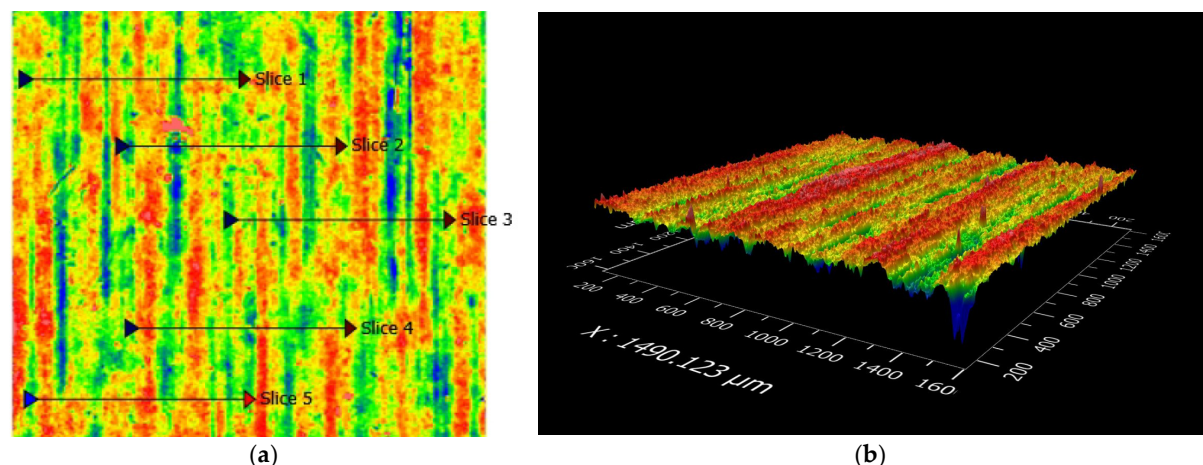
**Figure 13.** Surface profilometry of thermochemical oxidation sample:  $R_z = 0.861 \mu\text{m}$ : (a) five roughness measurements performed at distinct points across the surface; (b) three-dimensional topographical map of the surface.

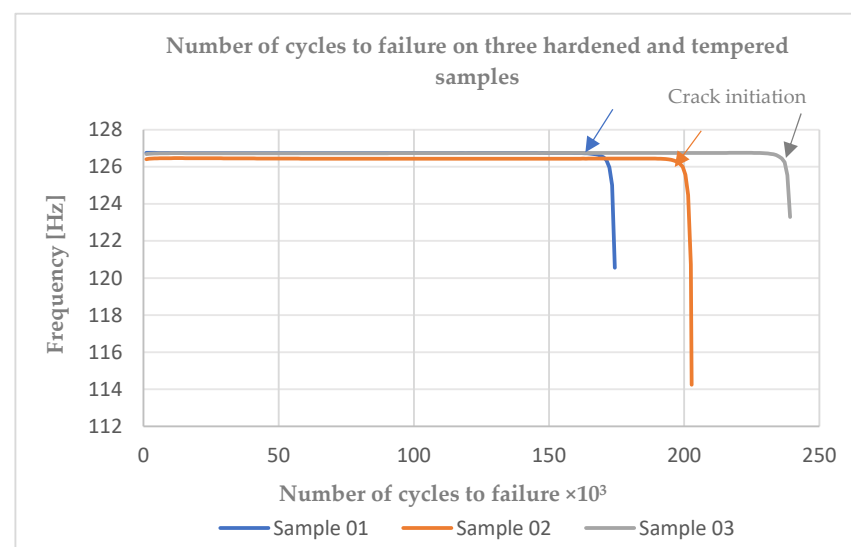
**Figure 15.** Failure diagram for hardened and tempered samples.

This decline in frequency is indicative of material degradation resulting from repeated stress cycles. The decline in frequency indicates that the material has reached an advanced state of fatigue, characterized by a significant deterioration in its resistance to repeated loads. This deterioration approaches the material's ultimate tensile strength, also known as the breaking point.

The diagram provides a clear insight into the behavior of the material under cyclic stresses, allowing its durability under fatigue conditions to be evaluated. As illustrated by the diagram, the frequency remains constant up to a certain number of cycles at the beginning of the test. Thereafter, it commences a decrease. The decrease in frequency was identified at 163,134 cycles for sample 01, 191,177 cycles for sample 02, and 233,013 cycles for sample 03.

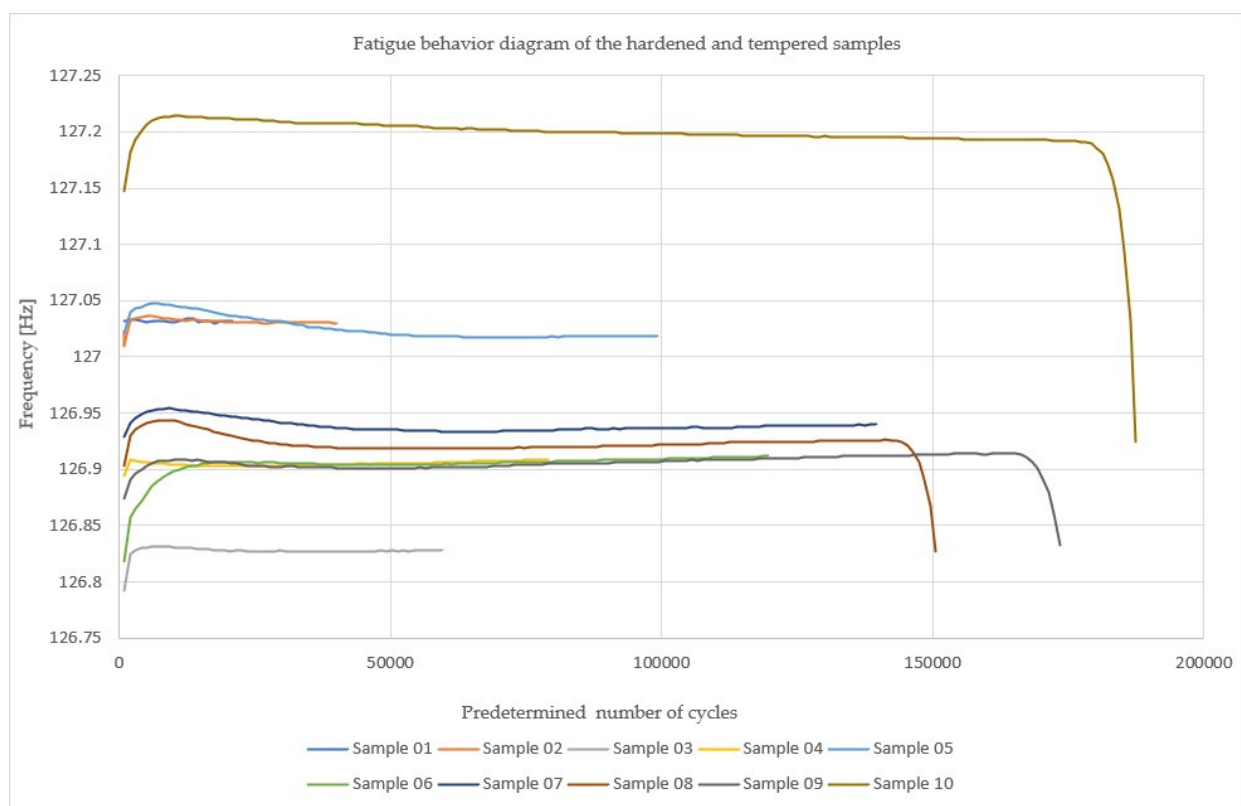
Table 10 presents the number of cycles established for each of the ten supplementary specimens and the frequency alterations that transpired during the experiment. Figure 19 illustrates a graph that superimposes the ten fatigue behavior curves of the hardened and tempered specimens that were subjected to a predetermined number of stress cycles. The graph presented here illustrates the variability in the fatigue behavior of the samples, thereby providing essential information for understanding how the material responds to cyclic stresses. During the testing phase, it was observed that the frequency remained constant for samples 1 through 7, exhibiting uniform behavior with minimal variation between them. However, a decrease in frequency was observed for samples 8, 9, and 10. The decrease in frequency was identified at 144,369 cycles for sample 08, 168,394 cycles for sample 09, and 174,113 cycles for sample 10.

**Figure 19.** Fatigue behavior diagram for the 10 hardened and tempered samples subjected to fatigue with a predetermined number of cycles.

These results indicate that the observed decrease in frequency can be considered a reliable criterion for detecting crack initiation and evaluating the fatigue behavior of the material under study. In light of the aforementioned findings, the subsequent stage of the study will entail conducting a CT analysis. This analysis will facilitate a comprehensive characterization of the cracks and their respective propagation mechanisms.

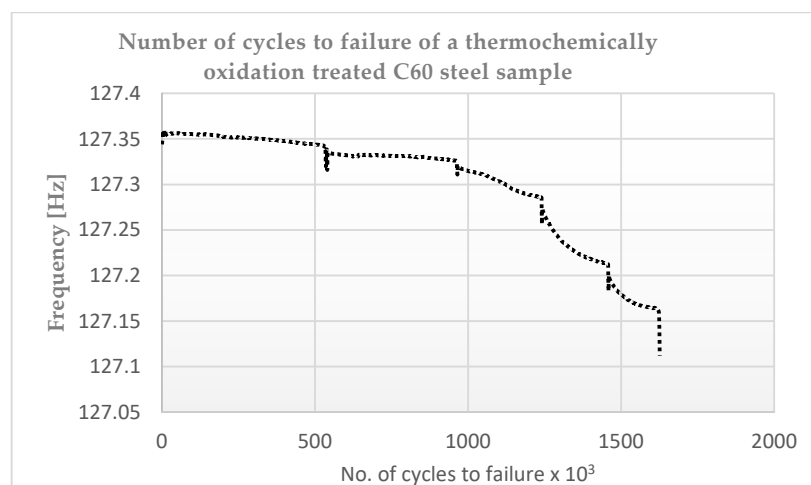
As illustrated in Figure 22, the failure diagram includes both frequency variation and the maximum number of stress cycles. It has been observed that the frequency remains constant up to 540,207 cycles, indicating that the material does not show significant damage. After this point, a slight decrease in frequency begins, signaling the appearance of the first microcracks in the material. The onset of microcracks invariably leads to a reduction in the material's stiffness. Subsequent to 965,144 cycles, the frequency persists in its decline, signifying a precipitous and imminent degradation of the material. At this stage, the microcracks have expanded significantly and have considerably affected the material structure. Ultimately, the material demonstrated complete failure after undergoing a total of 1,630,529 cycles, and the final recorded frequency exhibited a notably low value.

**Figure 22.** Failure diagram for thermochemically oxidation-treated sample.
