Analysis of Reasons for the Structural Collapse of Historic Buildings

Keywords: cultural heritage; damage to historic buildings; failure analysis; masonry structures

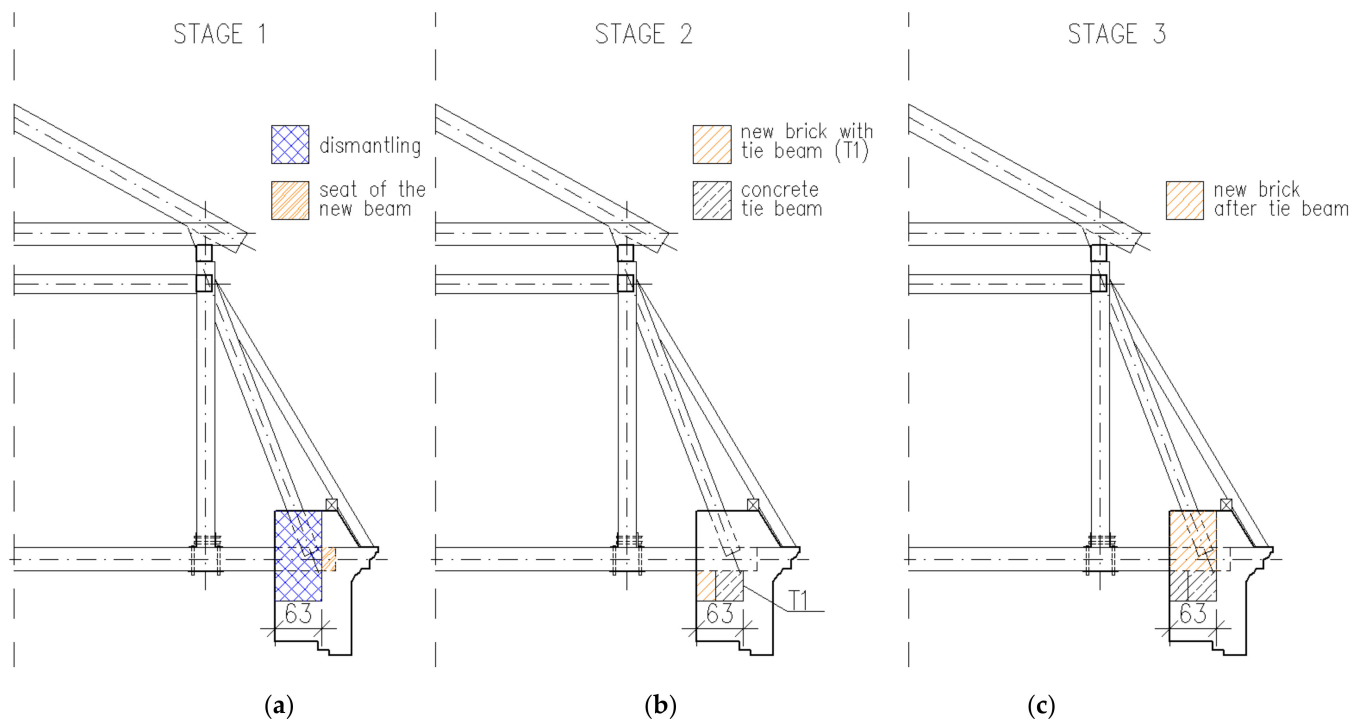
A design fault was the cause of the discussed damage. The secondary roof structure was set to be replaced with a restored version of the original shape, according to the design. The new structure was to be made partially from steel frames. The design of the tie beam supporting the steel elements was an important aspect. The tie beam was designed to be

constructed in three stages, as illustrated in Figure 10. In stage 1, the internal part of the cornice masonry was to be dismantled; in stage 2, the reinforced concrete tie beam was to be erected; the wall restoration between built-in steel frames was designed at stage 3.

Figure 10. The design stages of a steel frame for the new roof structure: (a) stage 1—dismantling of part of the cornice masonry; (b) stage 2—constructing the tie beam, laying additional bricks to the wall and placing steel girders; (c) stage 3—constructing the wall between steel girders.

The collapse occurred after the part completion of stage 1. Figure 11 shows the cornice geometry before and after dismantling. The center of gravity after dismantling was at the outer edge of the wall. The structural calculations were performed via the standard EN 1996-1-1 [25]. The characteristic bending strength of the wall in the failure plane parallel to the bed joints was equal to 0.1 N/mm^2 . Calculations showed that the bearing capacity rate for the model without cornice dismantling was 17.4%. In contrast, the ratio of characteristic forces was 107% (close to actual values) for the different dismantling options. However, the calculations did not include the dynamic impact of the manual jackhammers used for the dismantling works.

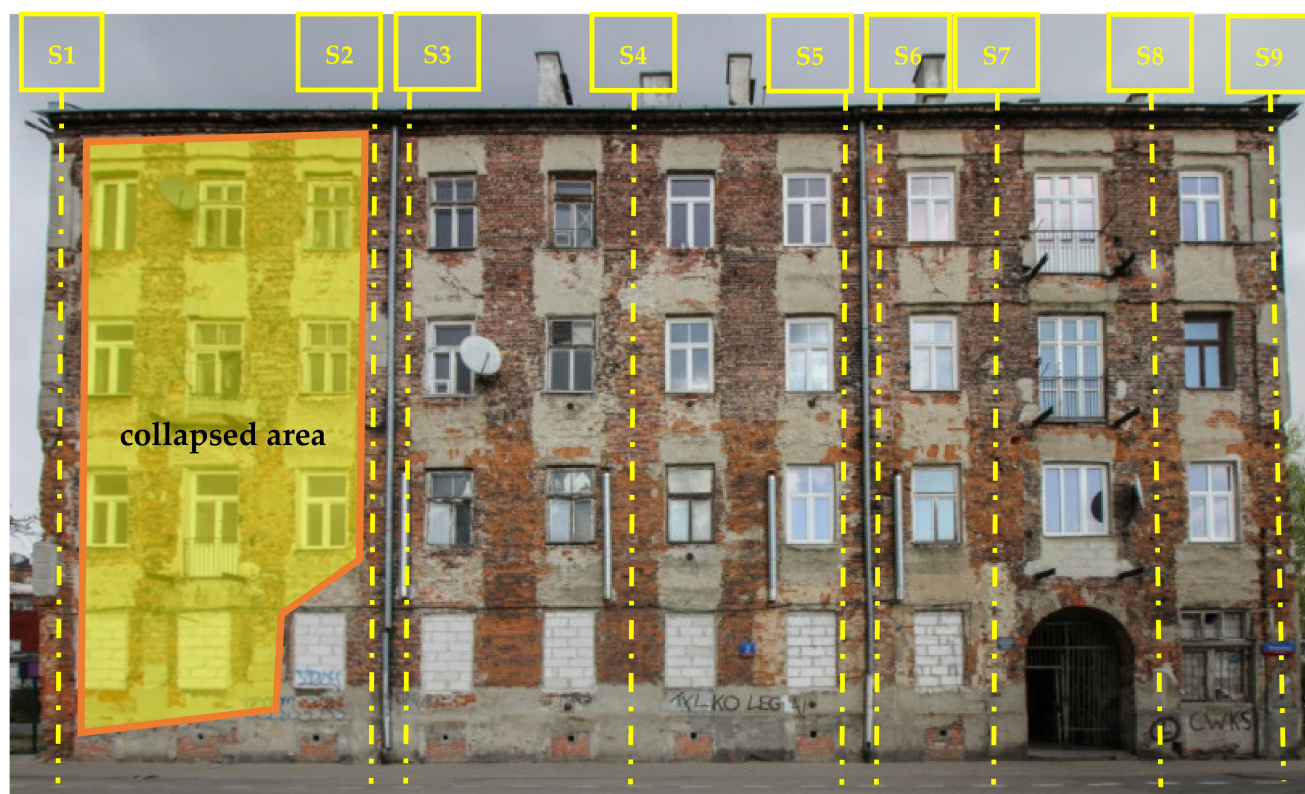
Geodetic measurements were taken for the front wall's drift after the collapse. Selected points in the building's façade, in the mullions, were measured with an accuracy of ± 1 mm (Figure 22).

Figure 22. Axes of geodetic measurements of front wall drift.

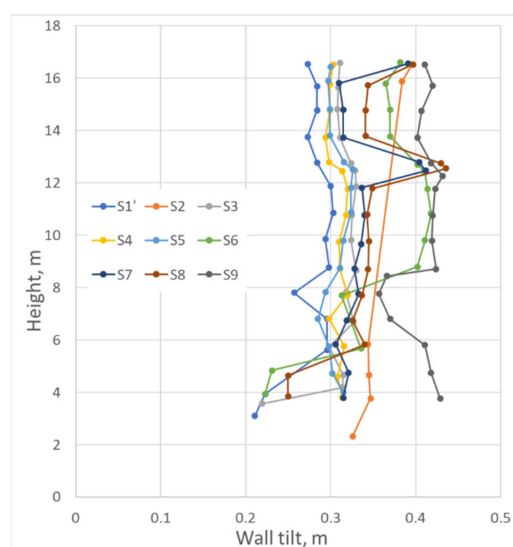
The measurement results are illustrated in the diagram in Figure 23. The measurement was referred to the virtual axis of the wall. The greatest drift—nearly 20 cm—was recorded between the axes S6 and S7 and 8. High drift values (ca. 10 cm) were also observed at the axes S1, S3, and S7. The standard PN-EN 1996-2 allows a maximum drift of 50 mm for a building's wall. This condition was only met in the measurements of two axes (S4 and S5). It should be emphasized that the façade had no cornice, which could interfere with the measurement result. Additionally, there was almost no plaster in the mullions. However, these results may be affected by the loss and surface distress of the masonry wall, and earlier rebricking works.

Figure 23. Diagram presenting wall drift at the measured axes.

However, this does not mean the scaffold itself could not have contributed to causing the damage. The fastening of the scaffold to the wall probably placed additional horizontal tensile forces on the wall–floors system, thus slightly contributing to the collapse. In the authors' opinion, the lateral drift of the wall was the most important factor, which created additional eccentricities in body forces (wall weight and floor reactions). The lateral drift of the wall in the collapse zone is itself unknown, but measurements taken after the collapse indicate that it was ca. 10 cm, and the greatest lateral drift (orientated symmetrically around the damage, on the other side of the façade) was as much as 20 cm. The chases (depth of 80 mm) applied for crack stitching could also have affected the damage.

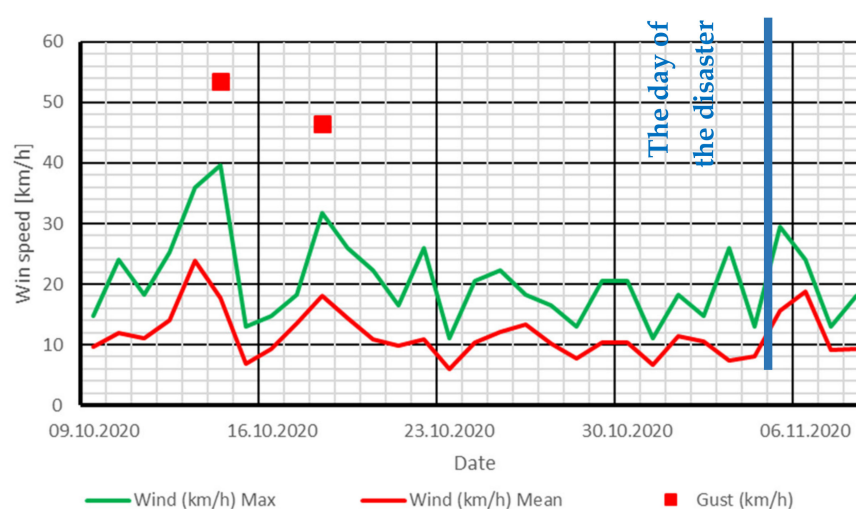
The cause of the wall collapse discussed was the exceedance of its bending strength in the buckling plane. Wind action should be excluded from consideration as a direct cause of the damage. On the collapse day, at ca. 10:15, the wind speed read at the weather station in south Warsaw was 2 m/s, reaching at most 3.5 m/s, which is less than 16% of the allowable value as specified in the standard EN 1991-1-4 [31]. Similar readings were taken at the measuring station at Okęcie airport. The recorded wind speed had been nearly three times higher (Figure 26) within the month before the collapse.

Figure 26. Diagram of the wind speed within a month before the collapse.

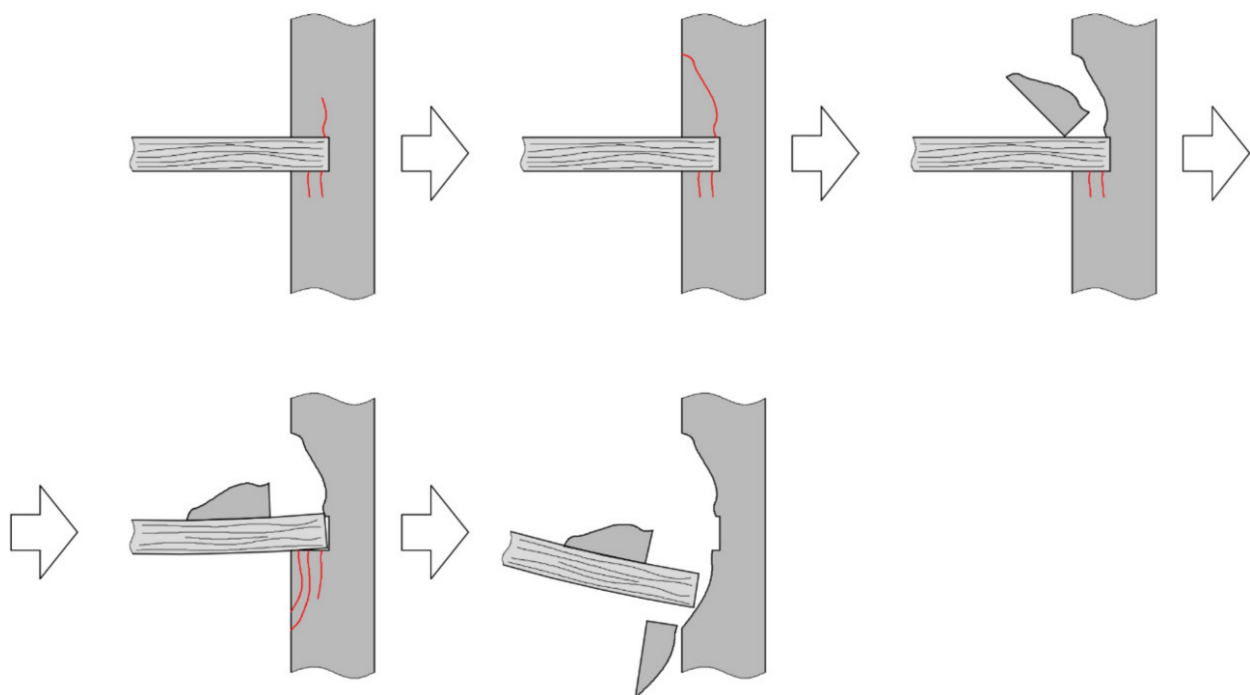
Hypothesis 1 (H1). *The collapse was caused by superficial cracking inside the masonry wall in the wall–floor node and the bursting failure of the wall edge above the floor. As a result of this, the ceiling beam could freely rotate, and the edge loading increased in the beam support on the wall. This loading resulted in the debonding of the wall below the ceiling beam, and the collapse of the floor fragment (first stage of the damage). The collapsed floor loaded onto the lower story, which triggered the collapse. Figure 27 presents the schematic course of the collapse proposed by Hypothesis 1.*

Figure 27. Failure mechanism according to Hypothesis 1.

Hence, the collapse was caused by the debonding of the wall fragment and the collapse of the floor (according to Hypotheses 1 and 2, illustrated in Figures 27 and 28, respectively). It was thus the contractor who was responsible for this collapse. According to the design, all the floors at each level should have been propped prior to the commencement of construction works, which was not done. The design also suggested protecting the external wall with angle braces, which also was not done. Propping and protecting the building could probably have prevented the collapse.

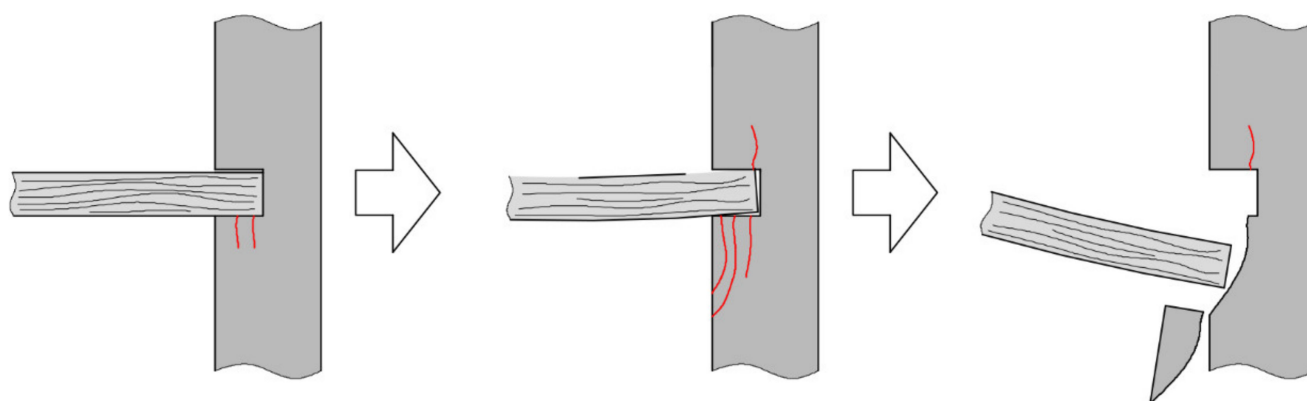
Hypothesis 2 (H2). The collapse was caused by superficial cracking inside the masonry wall in the wall–floor node, and the bursting failure of the wall fragment below the floor (due to edge stresses). Then, the wall below the ceiling beam debonded, and the floor fragment collapsed (first stage of the collapse). The collapsed floor loaded onto the lower story, which triggered the collapse. Figure 28 presents the schematic course of the collapse following Hypothesis 2.

Figure 28. Failure mechanism according to Hypothesis 2.

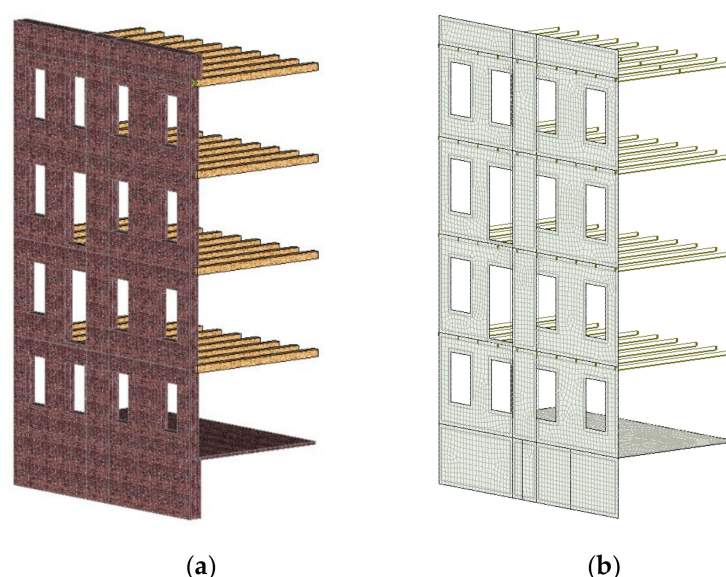
The spatial model (Figure 32) was prepared for a fragment of the front wall subjected to failure. The window openings were modeled following their original location and dimensions. The later bricking up of the ground level was neglected. Openings had already been made in the loaded structure, and their connection with other elements did not allow load transmission. The thickness of the wall's cross-section was adjusted in each section according to the design documents, the photo documents, and the results of the inspection of the building after failure. The model did not take into account geometrical imperfections and other deviations in the wall's structure. However, the spatial shell model did not correctly represent all the wall section details as they were presented in the panel model.

Figure 32. Three-dimensional model of the building: (a) rendered view; (b) FEM mesh view.

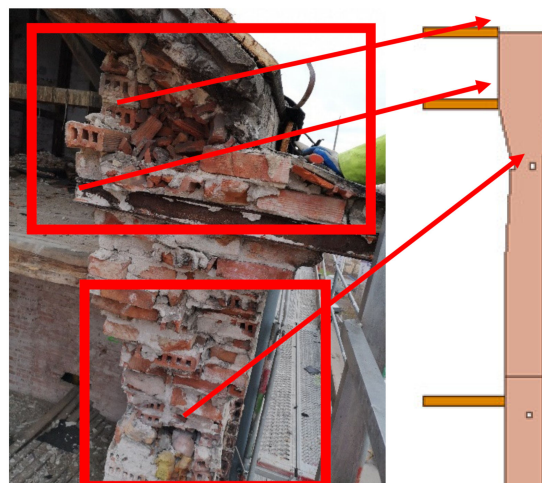
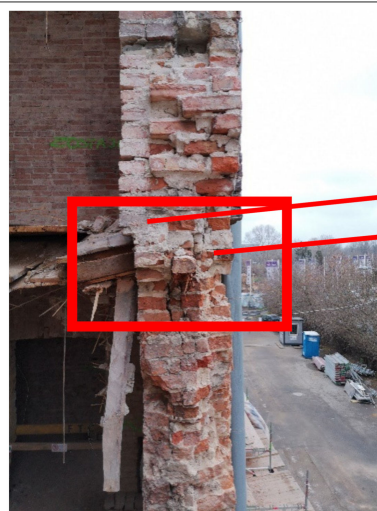
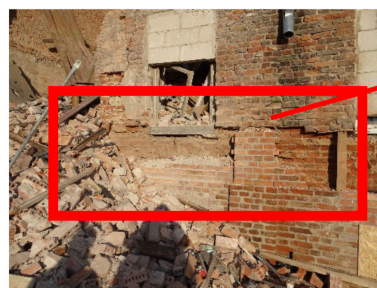
Figure 33. The geometry of the panel model (right) compared to the actual geometry.

The panel model was constructed for the wall section whose width corresponded to the width of the mullion. The weakening of the wall was considered to be caused by timber elements in the middle of the wall section. Narrowing and other changes in the wall width were also modeled (Figure 33).

- Lateral support by the roof structure (wall plate between full trusses).
- Lateral support by the bottom beam of the entire truss.
- Narrowing wall thickness, gaps at the window level (remains of the timber/steel beam), crushed/loose brick in the wall face.

- Wall discontinuity caused by timber beam joints.
- Crack induced by the weakening of the timber element.
- Lateral support of the wall through the timber-framed floor.
- Abrupt change in wall thickness (narrower in the bottom part).

- Narrowing of the wall section caused by preparation works for the rebricking of the wall face at the ground level.

Two plane models were prepared. Model No. 1 was without interior damage, and model No. 2 included local damage at the narrow section of the knee wall, below the bottom beam of the roof structure. As seen in Figure 33, a joist pocket for a timber or steel beam was modeled in both models. Model No. 2 also included the possible damage to or loosening of the outer wall layer (face), composed of a single layer of hollow clay bricks. The disturbance of this structure is illustrated in Figure 33.

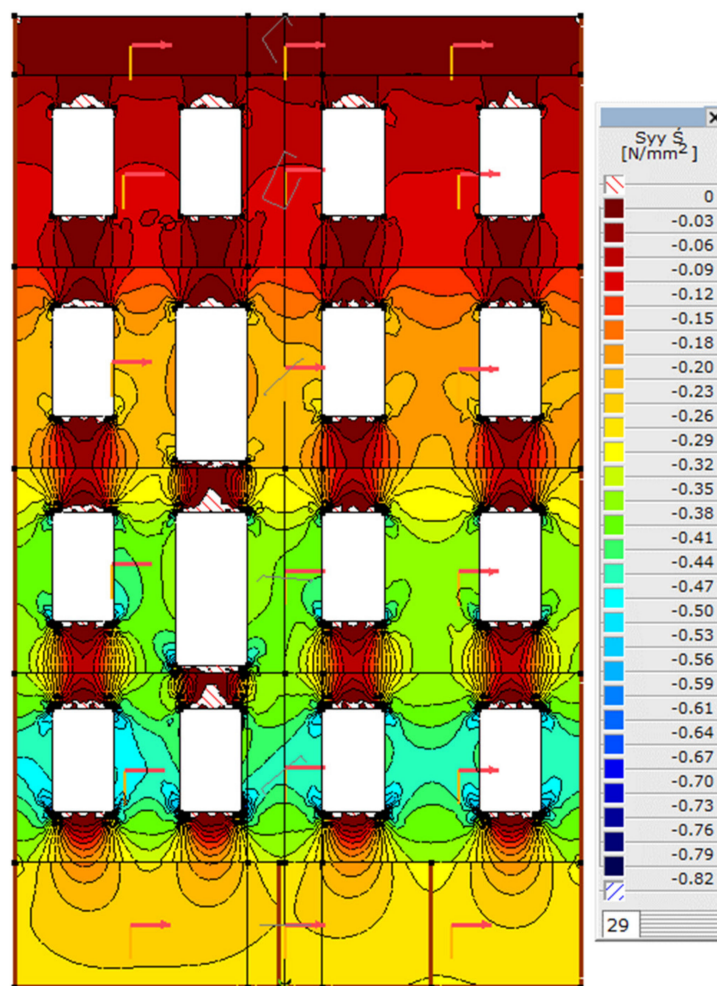
Figure 34. Map of vertical stresses, S_{yy} .

The highest compressive vertical strength calculated for the spatial model was 0.47 MPa (Figure 34), which constituted 57% of the minimum ultimate strength of the masonry unit. The calculation confirmed that the global collapse of the wall could not occur as a result of exceeding its compressive strength.

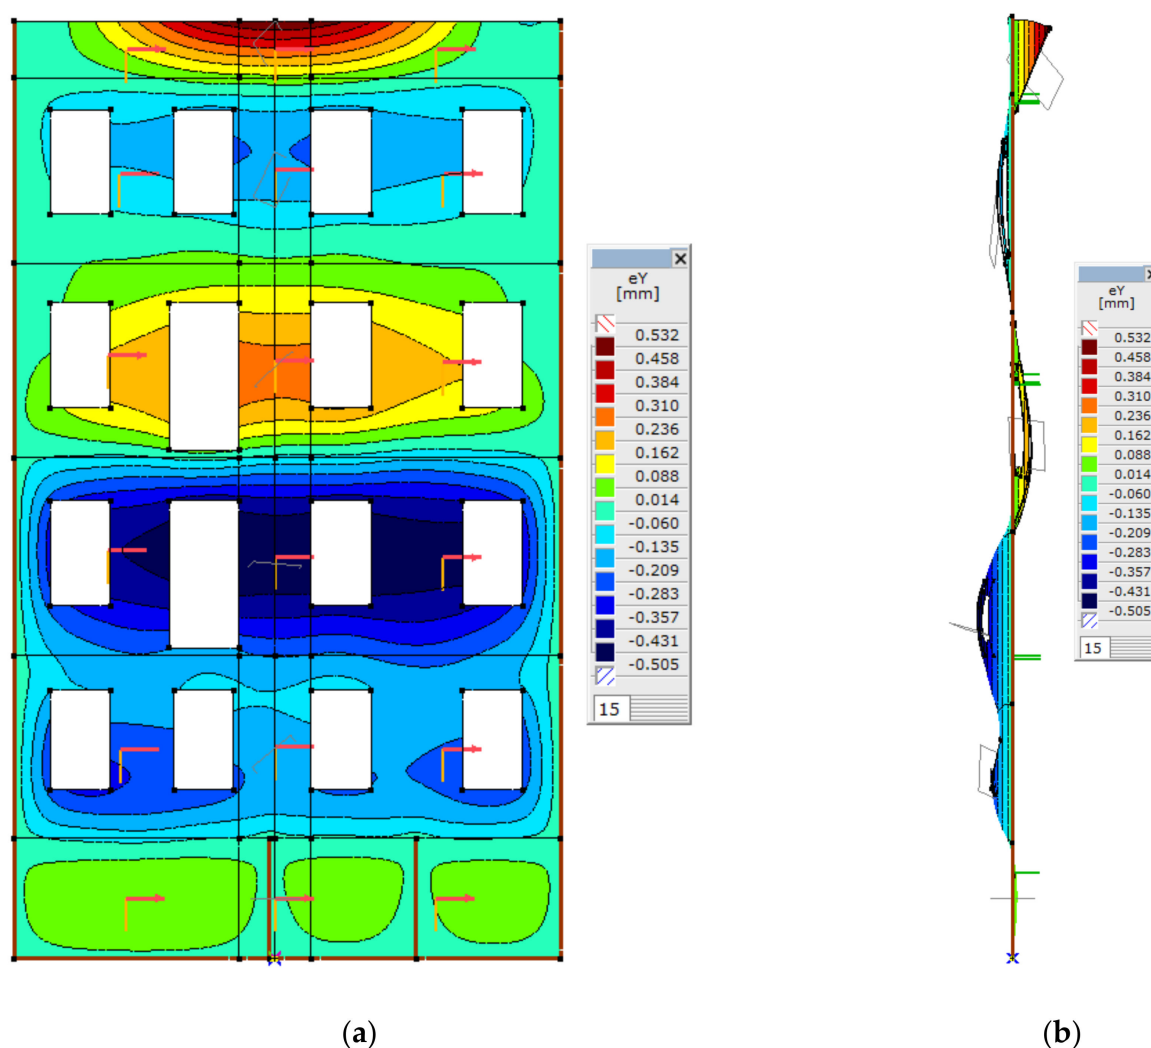
Figure 35. Deformation of the spatial model: (a) front; (b) section.

Significant tensile stresses were noticed in the spandrel and header area of the model. They caused cracks to develop above and below the windows. These cracks led to the separation of the main mullions from the spandrel area, and consequently reduced their stiffness. The deformation image shows the lateral drift of the knee wall towards the inside of the building (Figure 35). The maximum drift values did not exceed 0.53 mm for the calculations made within the elastic range, neglecting the imperfections in masonry unit thickness. The vertical stresses at the bottom stories were used to verify the panel model described later in the text. The results agreed at the level of 87% with the higher stress values in the panel model, because the additional reduction in the thickness of the masonry units was taken into account.

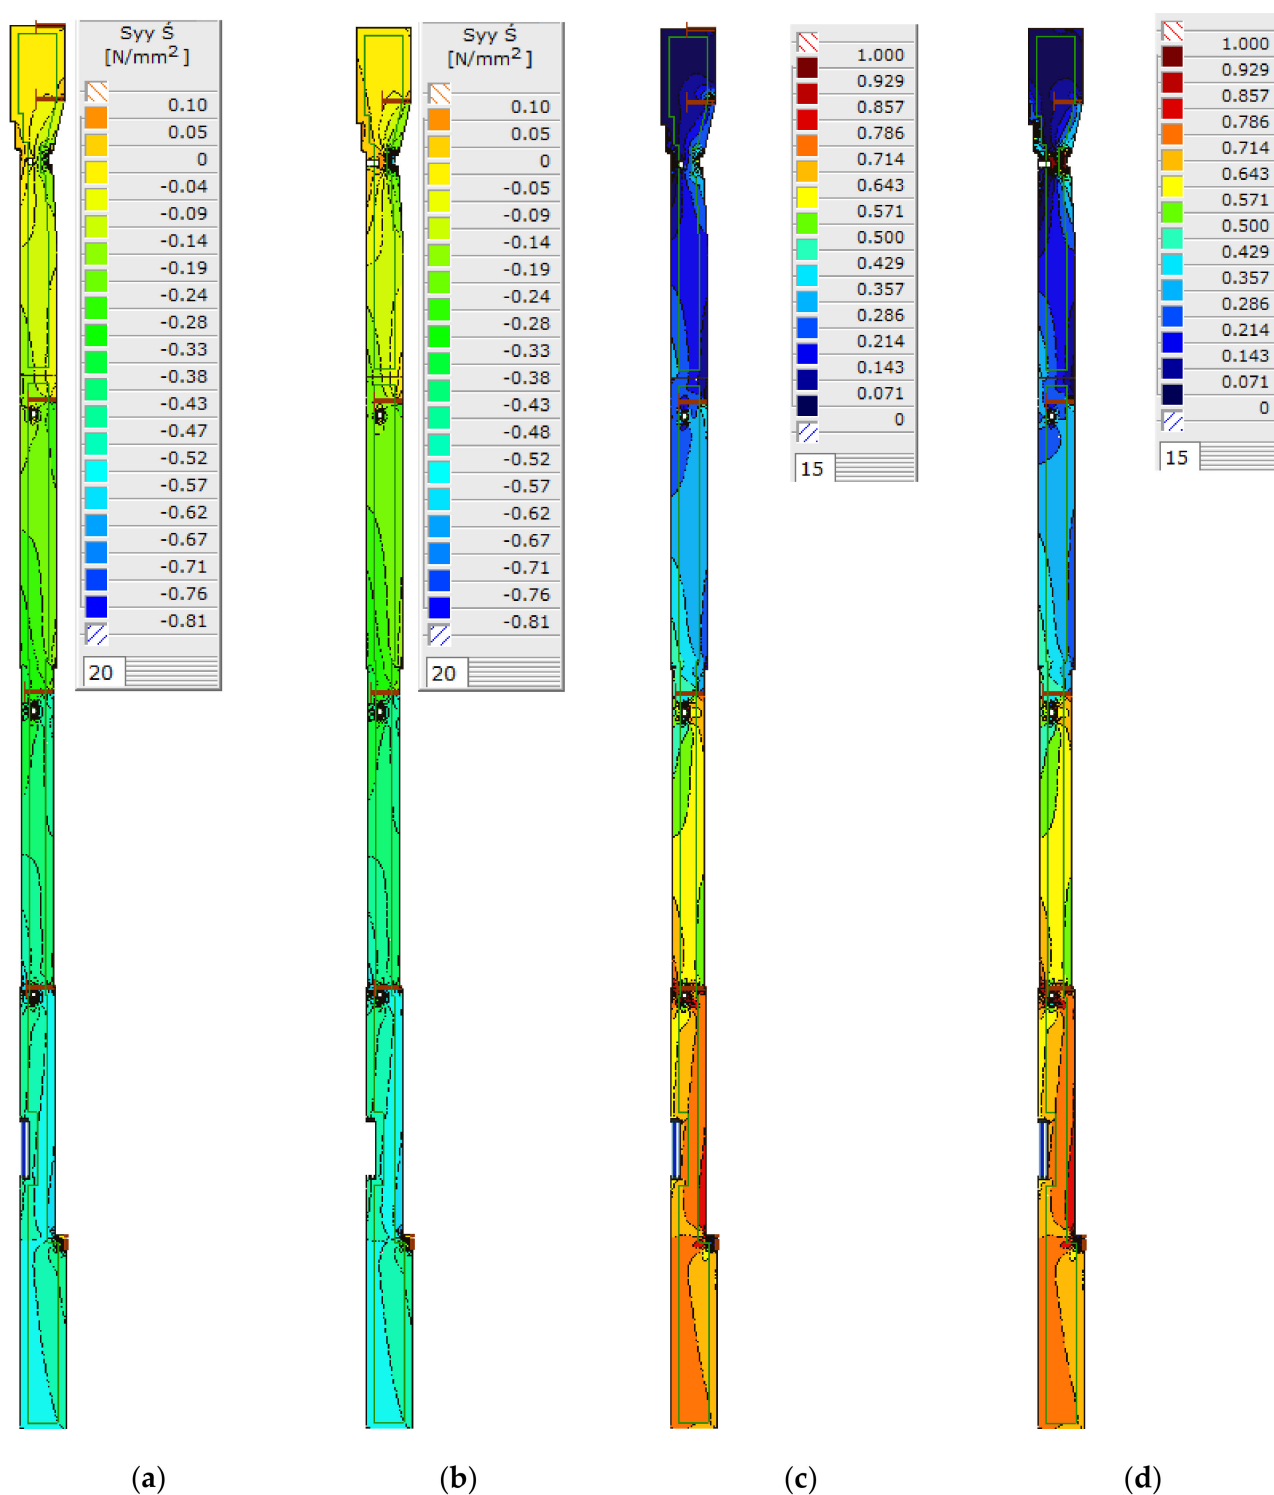
Figure 36. Maps of vertical stresses, S_{yy} , at the mullion level: (a) vertical stresses—model No. 1, (b) vertical stresses—model No. 2; (c) bearing capacity mobilization—model No. 1; (d) bearing capacity mobilization—model No. 2.

The vertical stresses at the narrow section of the ground floor were ~ 0.54 MPa (compared to 0.47 MPa in the spatial model), and the equivalent stresses, which included their complex state, gave a stress ratio lower than 75% of the loading capacity of the element (Figure 36).

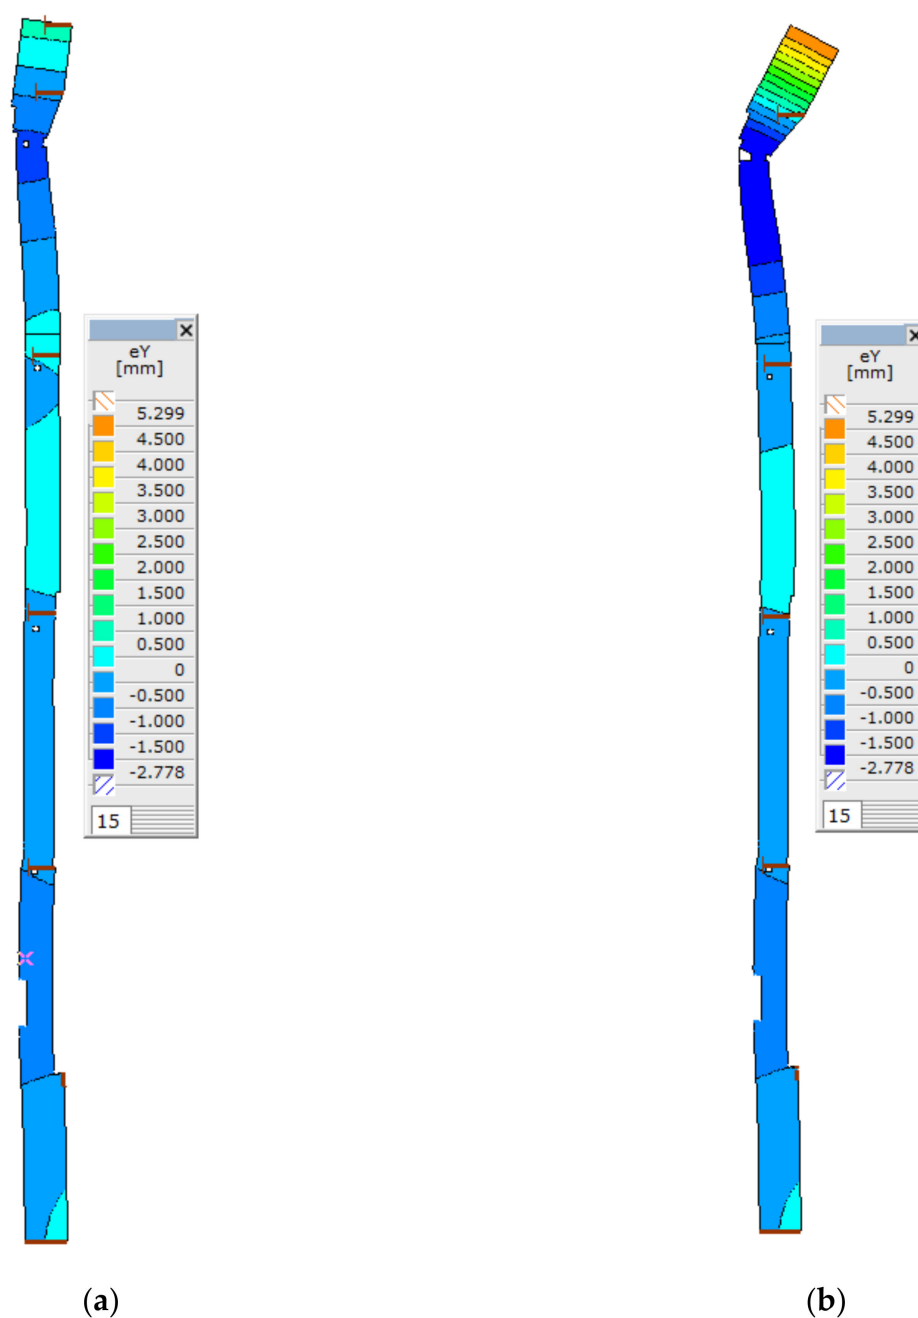
Figure 37. Map of horizontal deformations, eY (at the knee wall level: (a) model No. 1; (b) model No. 2.

The nature of the deformations in both panel models was used to define the hypothetical sequence of failure as described in hypothesis 4. The values of deformations in the bottom parts of the model agree with the calculations made for the spatial model (Figure 37).

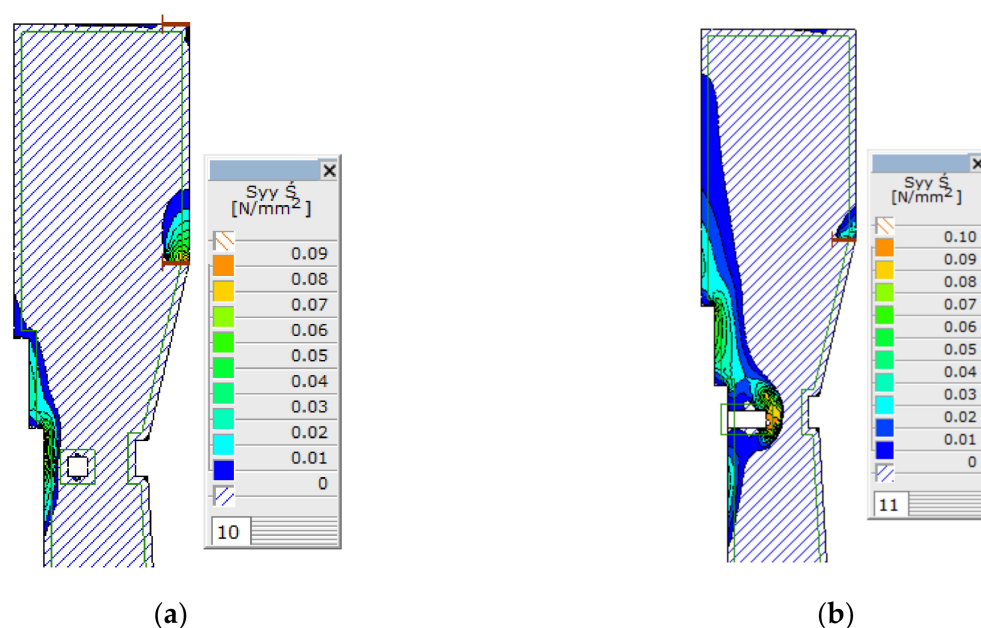
Figure 38. Maps of vertical stresses (tensile), S_{yy} , at the knee wall level: (a) model No. 1; (b) model No. 2.

A thorough analysis of the knee wall and the narrowing below the floor beam indicate that this was the wall fragment with the highest stress ratio. There were vertical tensile stresses in the non-reduced section (model No. 1) equal to 0.09 MPa (Figure 38a) at the standard tensile strength at bending of 0.10 MPa. Significant tensile stresses were observed in the wall face, particularly at the section between the outer edge and the opening caused by the setting of the beam over the lintel. Assuming lateral support was provided by the roof structure, this model did not reach its strength limit.

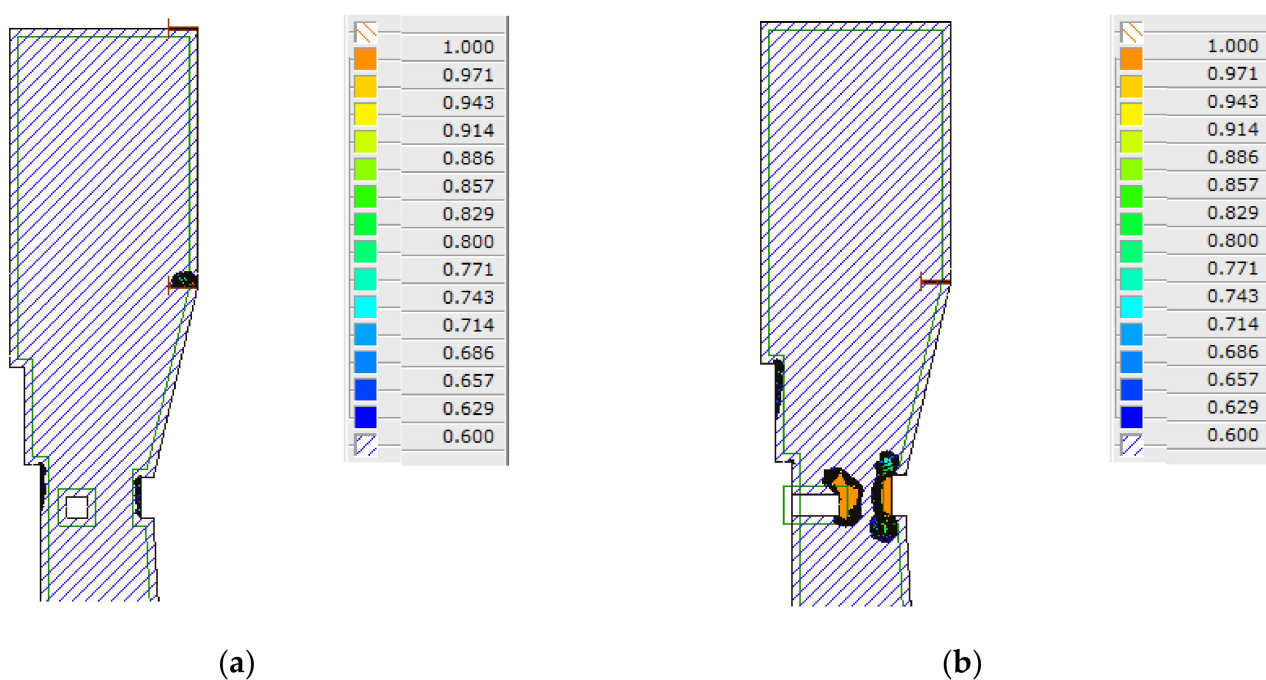
Figure 39. Bearing capacity mobilization at the knee wall level: (a) model No. 1; (b) model No. 2.

The equivalent stresses, including the complex state of stresses, resulted in a stress ratio lower than 70% of the loading capacity of the element (Figure 39a). The change in narrowing geometry and the release of the lateral support at the level of the wall coping led to a definite change in the stress state. The maximum vertical tensile stresses reached the value of 0.10 MPa (Figure 38b) in one-third of the wall's remaining (reduced) section, and exceeded the tensile strength limit at bending.

The analysis of equivalent stresses showed that the maximum stress ratio was caused by tension (from the face side) and compression (from the inside of the building), as the effect of bending was observed for two-thirds of the remaining section of the masonry unit (Figure 39b). It is assumed that loosening of or damage to the wall facing could cause

the bending of the knee wall towards the inside of the building. The failure of the knee wall could result in the loss of support of the floor beams in the attic. The collapse of a substantial part of the knee wall onto the floor below and the scaffold, and the falling of the floor beams (except for the beams in the full girder), could lead to stability failure in walls at lower levels, which could result in further failures in the front wall or damage to the floors below the attic level, and finally in the loss of the lateral supports and vertical stability of the front wall.

In summary, the calculations indicate that the wall collapse (first stage of damage) was probably initiated in the support zone of the attic floor. As mentioned above, the calculations were only qualitative, and they should be regarded as a kind of approximation. Therefore, the second analyzed area, the section of the floor support, cannot be excluded as the initiation area of the collapse.

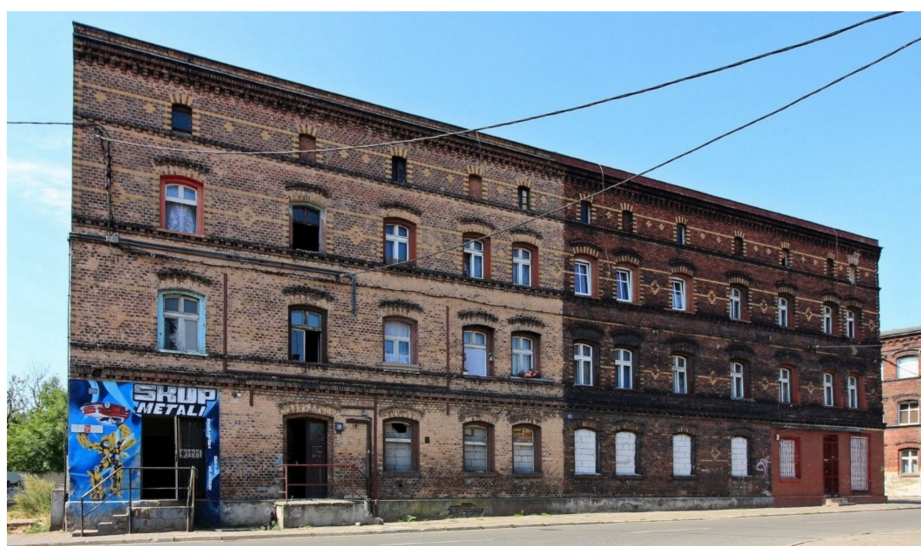
This collapse occurred in a tenement at 1 Maja 13 Street in Katowice. This tenement was erected at the end of the 19th century as a masonry building made of solid brick. The ceiling above the basement was constructed from arched brick floors with steel beam over cellars and timber floors at the aboveground levels. The building has a rafter and purlin roof structure.

It is a three-story building with an attic and a full basement. The building's shape is near rectangular, and its dimensions are 11.0 × 19.95 m. It is a residential building with three commercial units at the ground level. Figure 40 illustrates the discussed building.

Figure 40. Photo of the analyzed building.

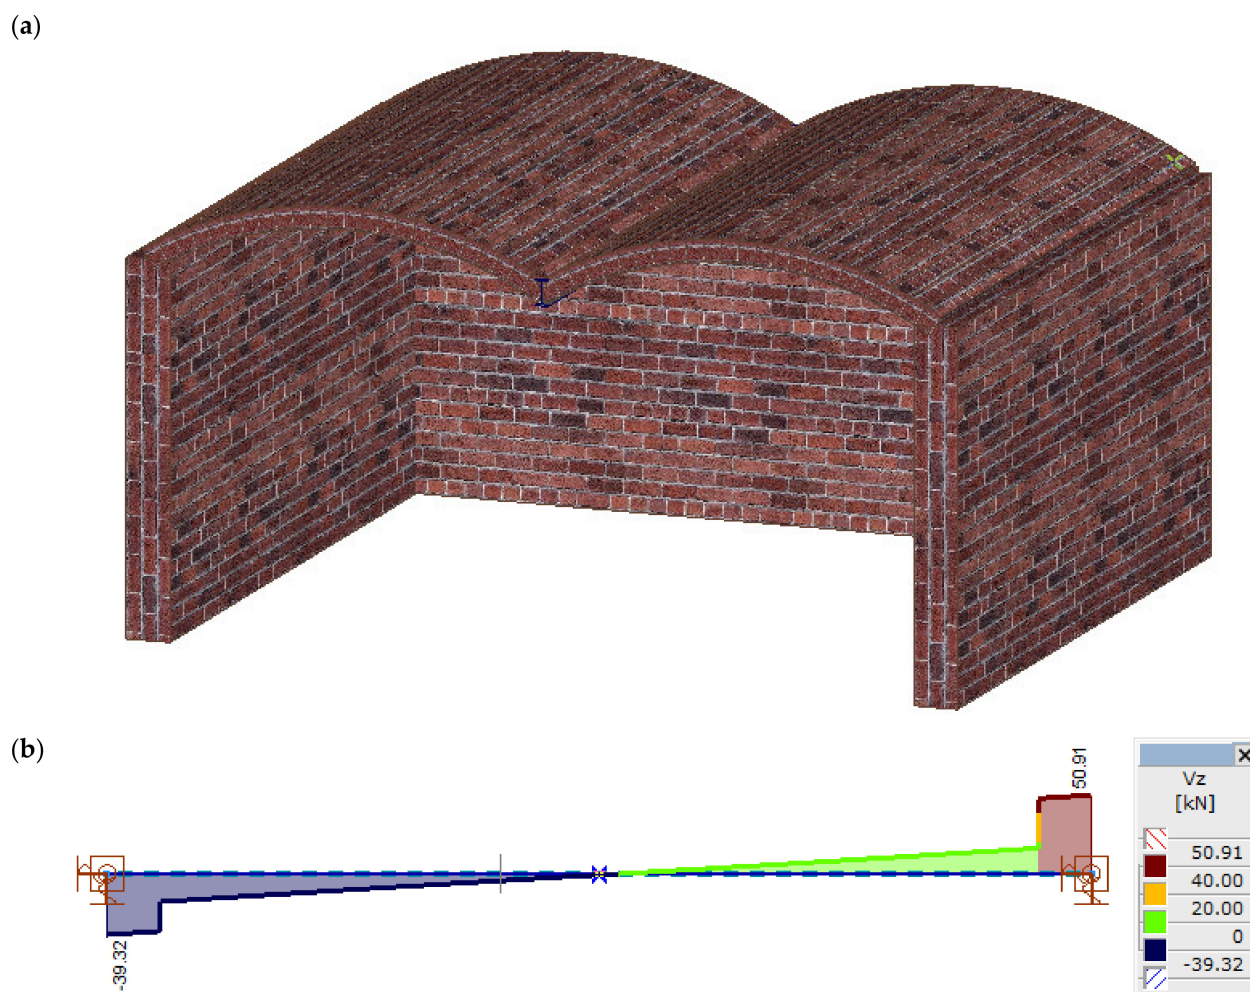
Figure 46. Three-dimensional model of the slab: (a) cross-sectional view; (b) shear forces in the beam.

The collapse was caused by the overloading and poor conditions of the corroded steel beam. The collapse developed in two stages. Stage 1 was shearing, and in stage 2, the floor collapsed as the beam—without any support on one side—bent (Figure 44). Details of the beam failure are illustrated in Figure 45.

The verifying structural calculations were conducted in accordance with the standard EN-1993-1-1 [32]. Loads were determined after the field inspection. The main loads were heavy refrigerators located above the supports. The unloading area was also located above the support. This load arrangement determined the collapse. If the load were evenly distributed (verified by calculation), failure could only occur due to beam bending at the center of the span. If there had been no corrosion damage, the bearing capacity rate (determined by characteristic loading) would be 99% for bending and 45% for shearing. Having considered the reduced thickness of the section, the shear bearing capacity rate was 102% in the support area, and the bending bearing capacity rate was 120% in the central area. Thus, the beam failure should have been caused by bending, and not shearing. The shear could have been caused by local loosening of the masonry units and a higher moisture content in the vaults in the support area. The property manager was responsible for this collapse, as his failure to perform necessary repair works led to the severe moisture content in the basement walls and the corrosion of the leading steel beam. The location of heavy equipment and the goods receiving zone near the support significantly contributed to the occurrence of shear (Figure 46) failure rather than bending in the steel beam.
