The Carmine Maggiore Bell Tower: An Inclusive and Sustainable Restoration Experience

Keywords: cultural heritage; bell tower; restoration; seismic safety; masonry; sustainable project

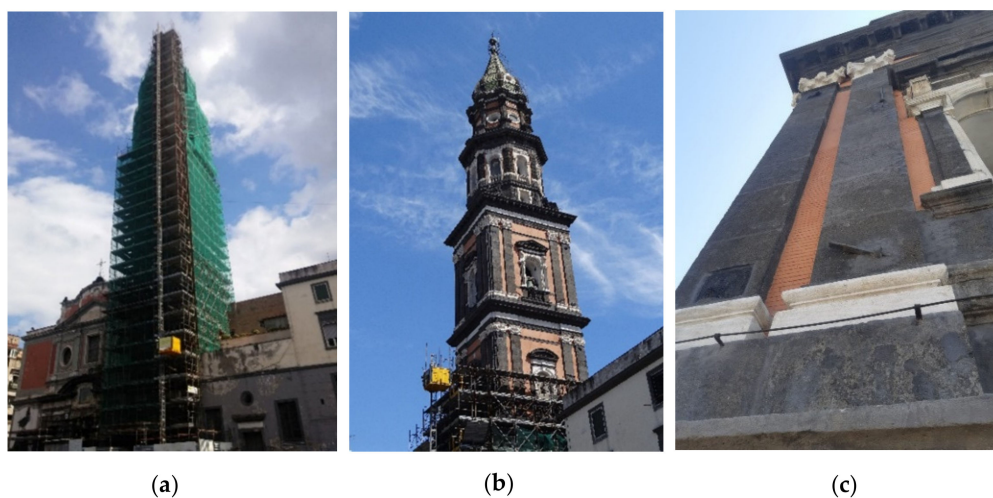
Figure 2. The bell tower with the scaffolding (a), during the dismantling of the scaffolding (b) and after completion of works (c).

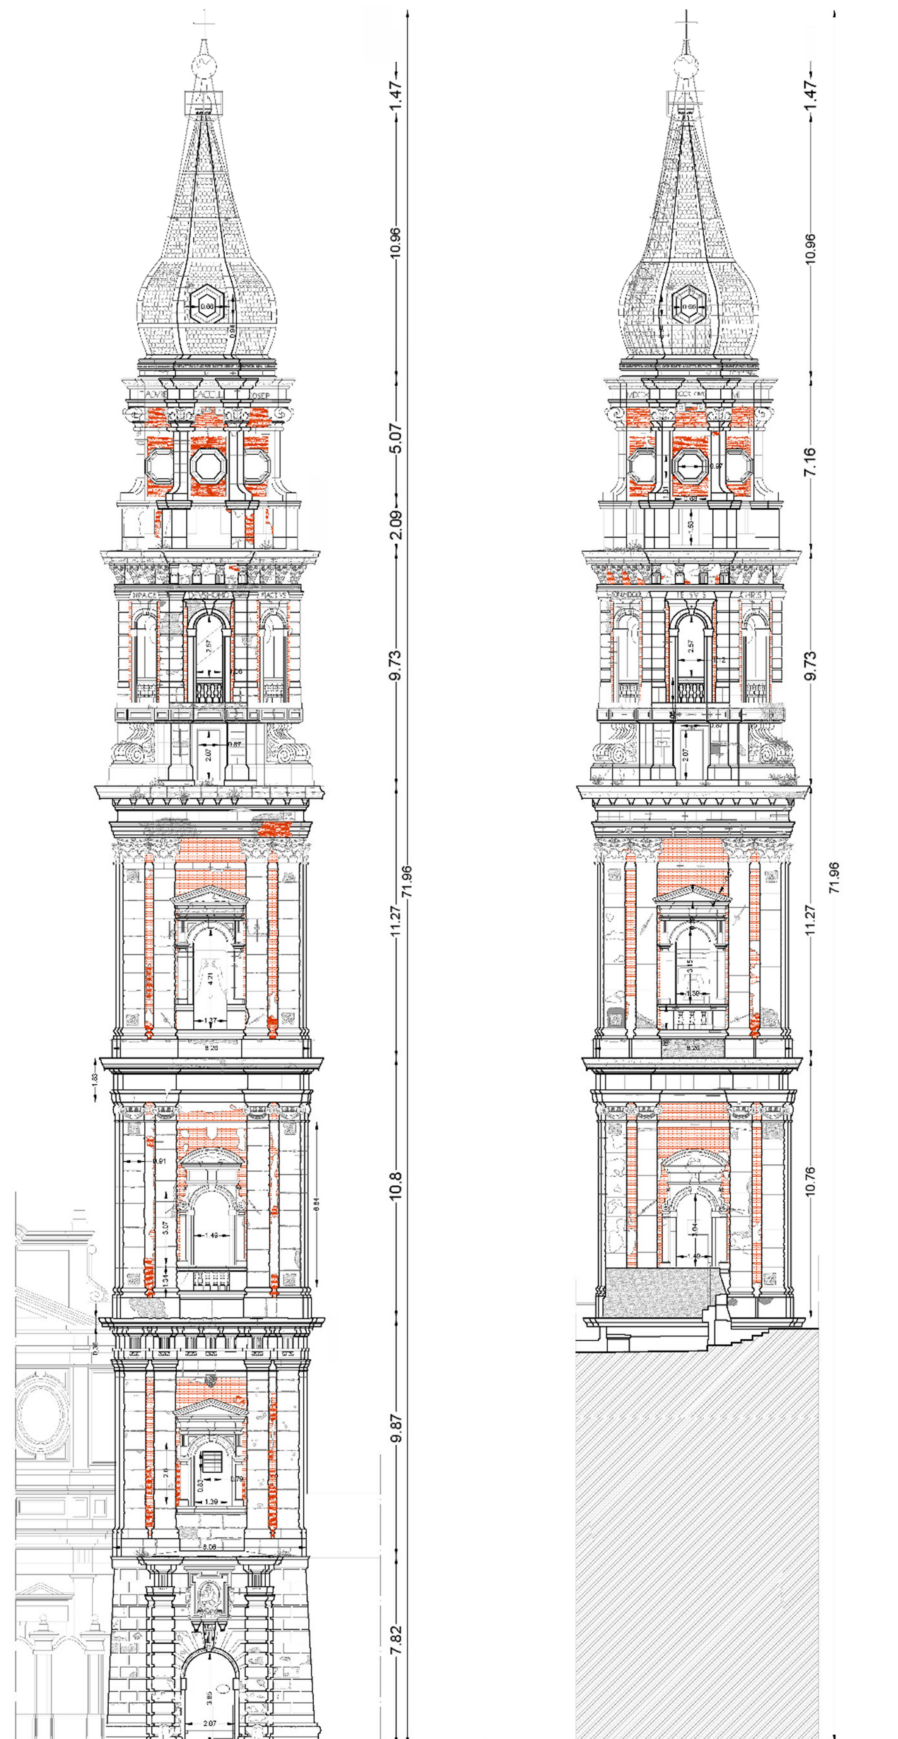
Figure 3. Bell-tower: west and east façade.

This traditional construction technique, which arranges more resistant and heavier materials at the base, can also be found in later structures. In particular, an extraordinary example of this “Vanvitellian School” is the bell tower of the Corpus Christi Basilica of Maddaloni: it was built using increasingly lighter materials from the base to the roofing pear [34], providing a pyramidal structural behavior to the bell tower [18]. It cannot be excluded that the original building typology of the “Carminio Maggiore” bell tower had similar characteristics to the Maddaloni bell tower, considering the numerous tampering that it underwent over time (Figures 3 and 4).
