# Post-2023 Kahramanmaraş Earthquake Assessment of Masonry Mosques and Minarets in Türkiye: Field Observations and Numerical Earthquake Analysis

Hatay (Ancient Antioch), one of Türkiye's most historically significant and seismically active provinces, experienced extensive damage during the 6 February 2023 Kahramanmaraş earthquake sequence ( $M_w = 7.7$  and  $M_w = 7.6$ ) and its aftershocks. Among the affected structures, masonry mosques and minarets suffered critical damage, revealing significant seismic vulnerabilities. This study provides a comprehensive evaluation of the seismic performance and structural vulnerabilities of masonry mosques and minarets in Hatay following the devastating 2023 Kahramanmaraş earthquake sequence. By integrating extensive field observations with advanced numerical analysis, the research documents widespread damage to both traditional kiosk-style and classical minarets, identifying critical factors such as poor local soil conditions, insufficient material strength, and lack of engineering services that contributed to structural collapses, including that of the historic Habibi Neccar Mosque. Through finite element analysis (FEA) using ABAQUS, the st

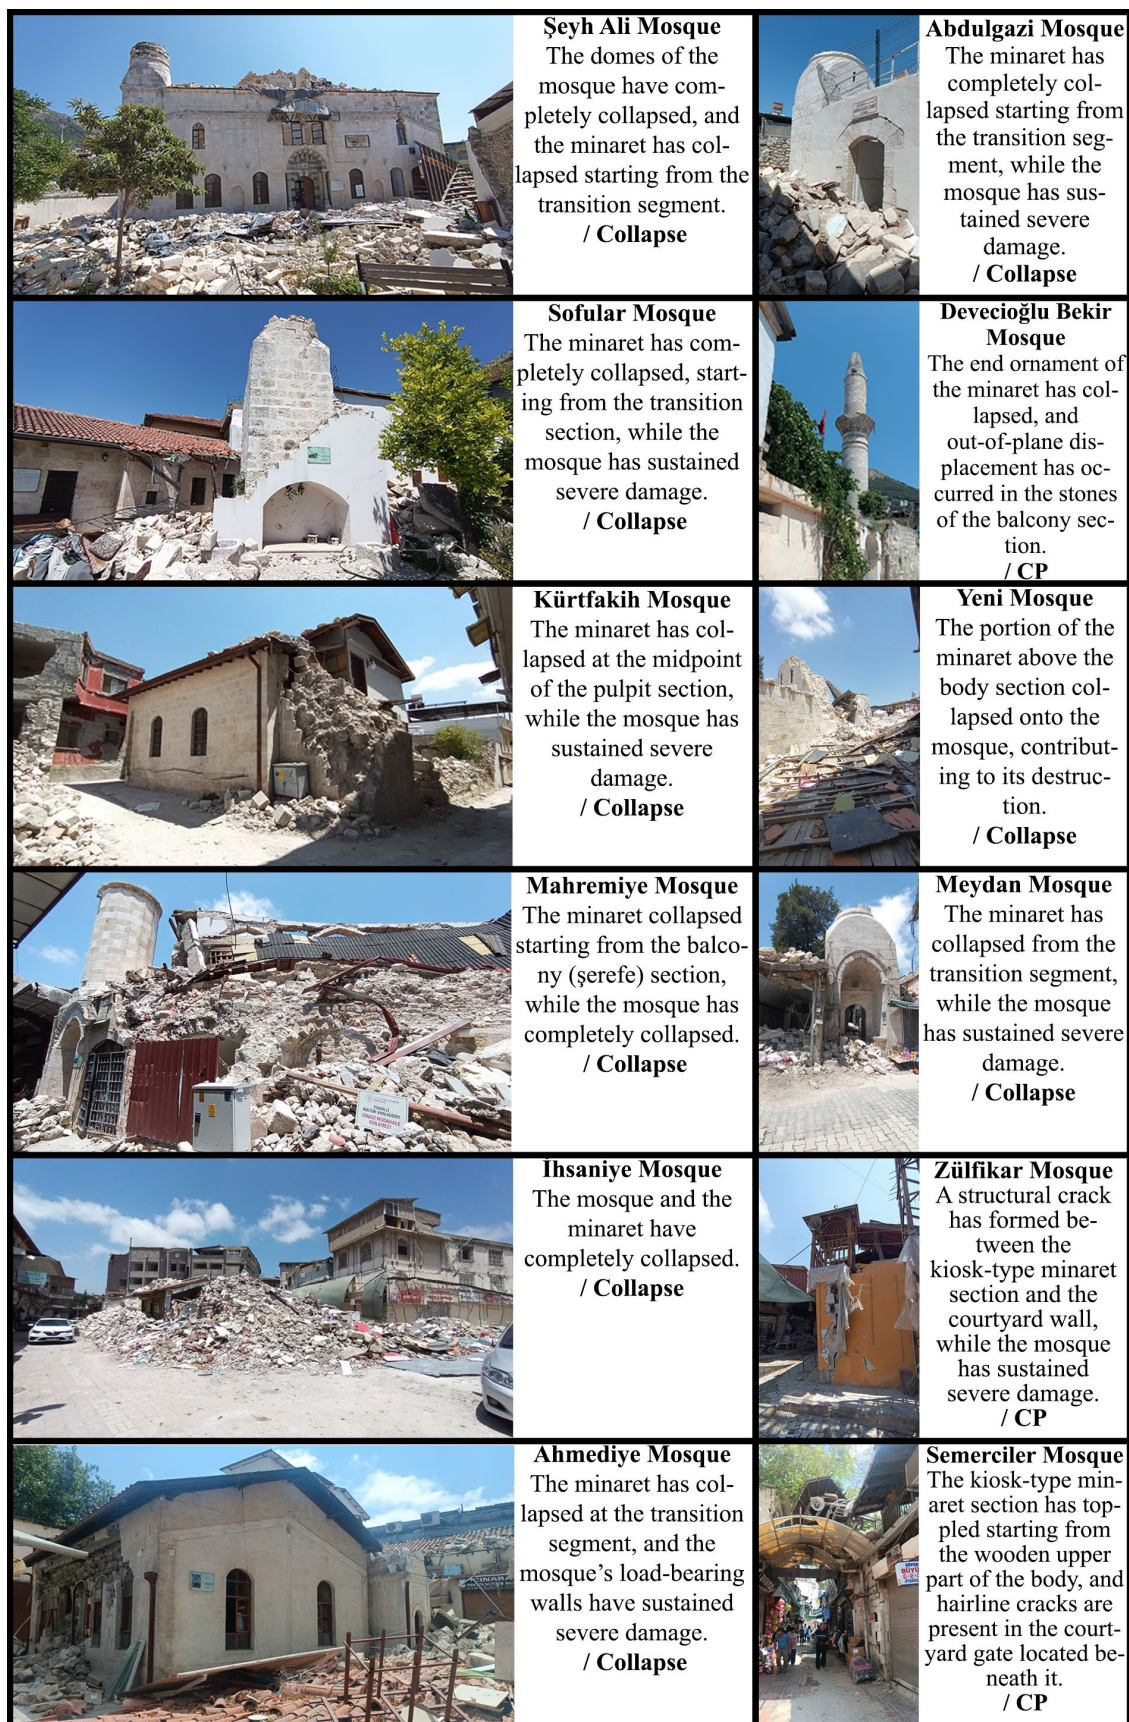
Figure 10. Cont.

In addition to the Habibi Neccar Mosque, many other masonry and reinforced concrete mosques and minarets were damaged during the earthquake. These damages reveal the seismic vulnerability of both traditional and modern structures. The examined structures were assessed for their seismic performance following the Earthquake Risk Management Guide for Historical Buildings (TYDRYK-2017) [53], issued by the General Directorate of Foundations in Türkiye. Figure 9 presents the performance levels specified in this guide. The specific damages to these mosques and minarets in Hatay are presented in Figure 10.

Minarets are generally constructed by local craftsmen without any engineering services. As a result, their tall and slender design, coupled with the use of materials with low strength, directly impacted the level of damage in both the minarets and mosques. In terms of faulty design, damage occurred in the minarets due to an inadequate connection in the transition from the square to the circular form.

| | <p><b>Şeyh Muhammed Mosque</b></p> <p>The minaret has collapsed from the transition segment, while the mosque has sustained severe damage.</p> <p>/ Collapse</p> | <p><b>500 Konutlar Mosque</b></p> <p>Cracks have formed in the walls of the mosque, accompanied by plaster detachment, and the minaret has completely collapsed starting from the transition segment.</p> <p>/ Collapse</p> |
| | <p><b>Hünkar Mosque</b></p> <p>The minaret, built in the kiosk style, sustained minor damage, while the mosque itself has partially collapsed due to the adjacent construction.</p> <p>/ CP</p> | <p><b>Kırıkhan Ulu Mosque</b></p> <p>The reinforced concrete (RC) minaret has completely collapsed starting from the transition segment.</p> <p>/ Collapse</p> |
| | <p><b>Tütüncüoğlu Mosque</b></p> <p>The mosque has completely collapsed, while the minaret has collapsed starting from the transition segment.</p> <p>/ Collapse</p> | <p><b>Sarimiye Mosque</b></p> <p>The minaret has undergone collapse at the transition segment, while the mosque has sustained severe damage.</p> <p>/ Collapse</p> |
| | <p><b>Hacı Rahma Gülseren İpek Mosque</b></p> <p>The mosque sustained significant structural damage as a result of the minarets collapsing onto its main building.</p> <p>/ Collapse</p> | <p><b>Yukarıbucak Mosque</b></p> <p>The minaret collapsed starting from the balcony. Out-of-plane and inplane displacement damages were observed in the mosque's load-bearing walls.</p> <p>/ CP</p> |

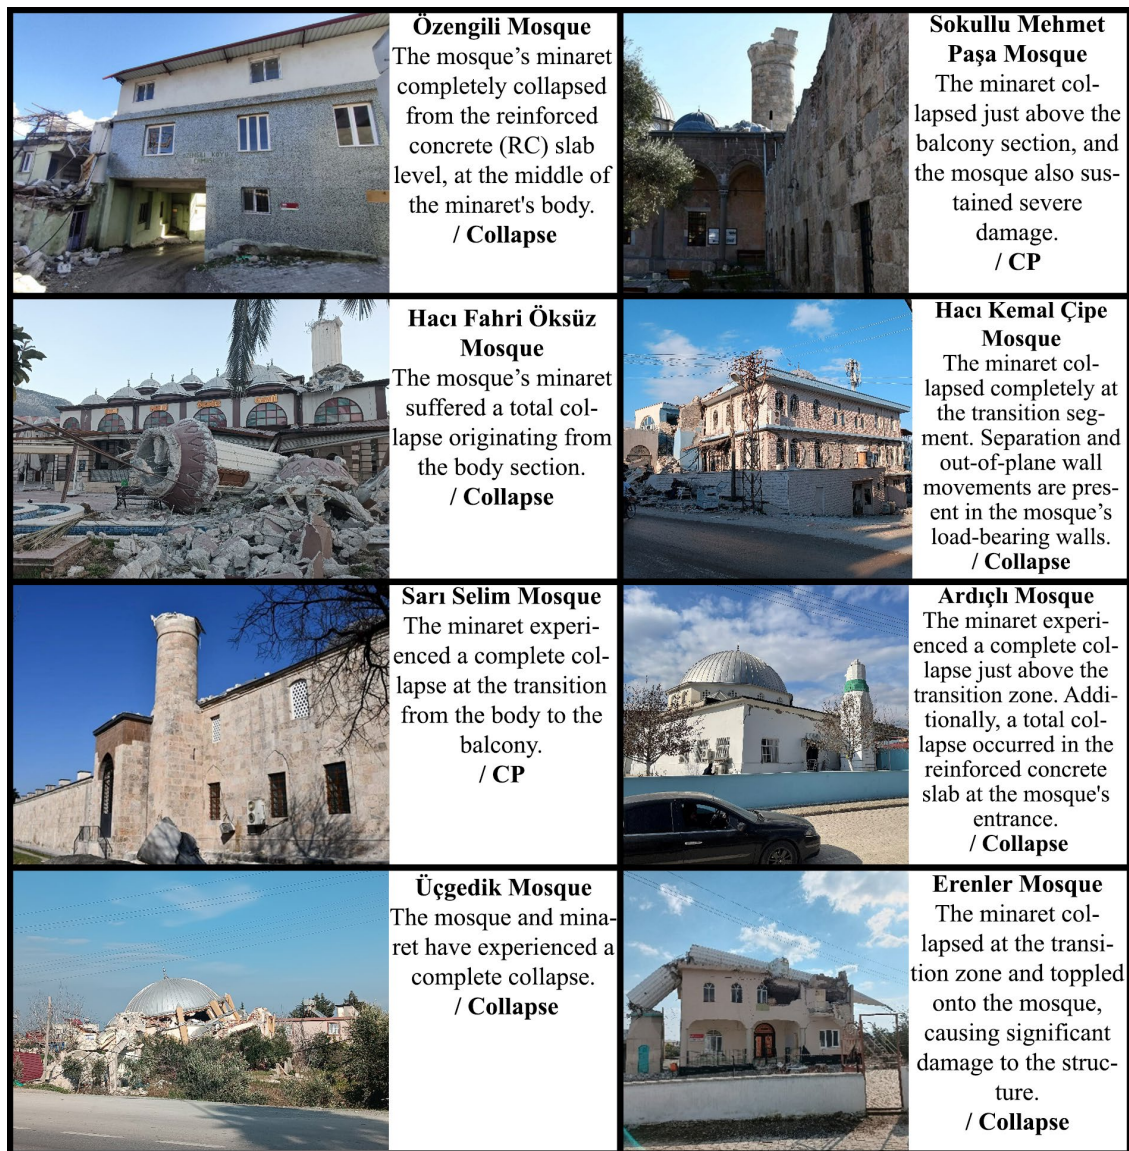
**Figure 10.** Earthquake-Induced Damages to Masonry and Reinforced Concrete Mosques and Minarets in Hatay (photos by the authors).

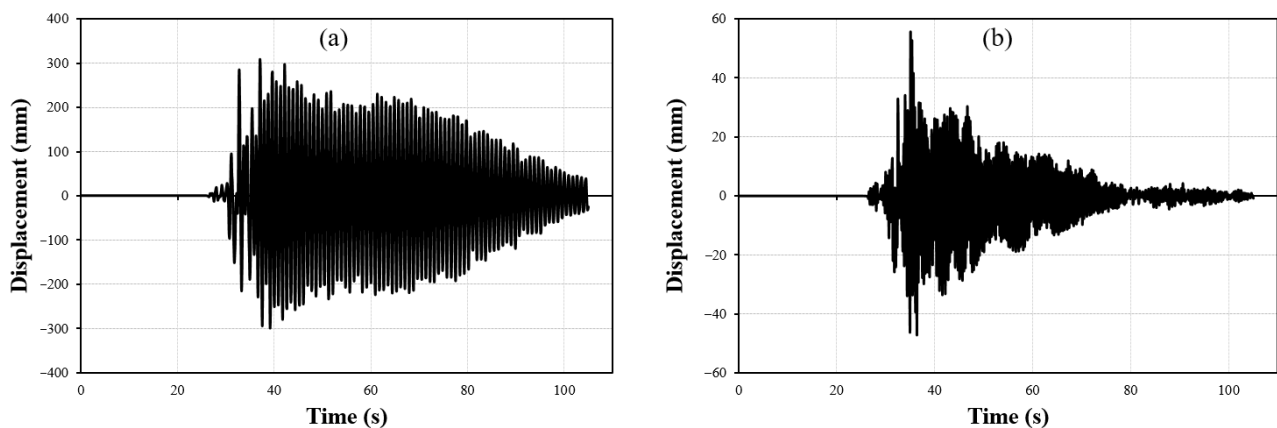
Based on the time history analysis performed using the applied acceleration records, it was determined that the minaret constructed with cut stone masonry reached a maximum lateral displacement of 306.43 mm at the 37th second, while the minaret constructed with C25 concrete reached a maximum lateral displacement of 55.59 mm at the 35th second, as shown in Figure 19.

**Figure 19.** Lateral displacement at the top of the minaret based on its materials: (a) cut-stone, (b) C25 concrete.

The most striking result from the time-history analysis is the dramatic difference in lateral displacement at the top of the minaret (Figure 18). The cut-stone minaret experienced a maximum lateral displacement of 306.43 mm at 37 s, compared to just 55.59 mm for the C25 concrete model at 35 s. This six-fold difference in displacement highlights the vulnerability of traditional masonry structures, particularly those with high slenderness ratios, to seismic excitation.

The relationship between the displacement-based dynamic analysis results and the observed damage distribution has been revised within the framework of the performance criteria defined in the Türkiye Earthquake Risk Management Guide for Historic Buildings (TERMFHB-2017). According to the guideline, seismic performance is defined based on three fundamental objectives: (i) no damage to structural and non-structural elements under low-intensity earthquakes (Damage Limitation performance level), (ii) limited and repairable damage under moderate-intensity earthquakes (Controlled Damage performance level), and (iii) controlled damage with limited permanent structural damage under severe earthquakes (Prevention of Collapse performance level). For the Damage Limitation performance level, the earthquake-induced drift ratio should not exceed 0.3% (82.2 mm). For the Controlled Damage level, the drift ratio should remain below 0.7% (191.8 mm), and for the Prevention of Collapse performance level, it should not exceed 1% (274 mm). These displacement limits were calculated considering the total height of the minaret, which is 27.4 m. Within this scope, the maximum displacement demands obtained from the dynamic analyses were compared with the limit values defined for the corresponding performance levels. It is observed that the cut-stone minaret exceeds the PC performance level limits, whereas the concrete minaret satisfies the Damage Limitation performance level criteria.
