Watch Out for the Tailings Pond, a Sharp Edge Hanging over Our Heads: Lessons Learned and Perceptions from the Brumadinho Tailings Dam Failure Disaster

Abstract: A catastrophic tailings dam failure disaster occurred in Brumadinho, Brazil on 25 January 2019, which resulted in over 270 casualties, 24,000 residents evacuated, and a huge economic loss. Environmental concerns were raised for the potential pollution of water due to tailings waste entering the Paraopeba River. In this paper, a detailed analysis has been carried out to investigate the disaster conditions of the Brumadinho dam failure using satellite images with different spatial resolutions. Our in-depth analysis reveals that the hazard chain caused by this failure contained three stages, namely dam failure, mudflow, and the hyperconcentrated flow in the Paraopeba River. The variation characteristics of turbidity of the Rio Paraopeba River after the disaster have also been investigated using high-resolution remote sensing images, followed by a qualitative analysis of the impacts on the downstream reservoir of the Retiro Baixo Plant that was over 300 km away from the dam failure origin. It is believed that, on the one hand

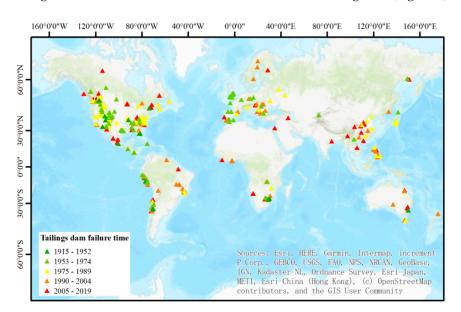
There are about 3500 active tailings ponds in the world, among which 2000 experience about two to five known "major" failures, and 35 "minor" failures annually [30]. During the period from 2007 to 2017, there were at least 10 very serious mine tailings dam failures involving multiple loss of life, with approximately 20 lives per incident, a release of at least 1 million cubic meters of waste each time, and a travel of 20 km or longer every waste movement [31]. Based on the world mine tailings failure data with more than 300 records during the period from 1915 to 2019 [14], a global spatial geographic database of tailings dam failure was made using ArcGIS. Using the "Natural Break" classification method, the tailings dam failure records could be divided into five categories (Figure 4).

Figure 4. Tailings dam failures (1915–2019) with their occurrence times.

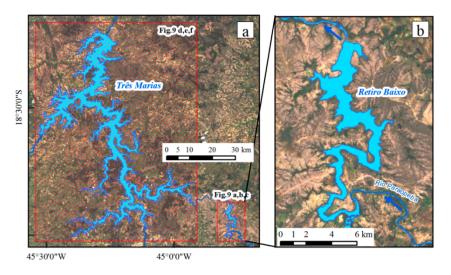
Using the Atmospheric Correction Module, it can be accurately compensated for atmospheric effects. In this study, the atmospheric correction using the FLAASH model [34,35,68] was performed and Landsat 8 images were fused using the Gram—Schmidt Pan Sharpening method [69–72]. After calculating the NDWI using the images after atmospheric correction and image fusion, zero was used as the segmentation threshold to extract the water body, and the manual editing was used to complete the extracted water body boundaries in the ArcGIS software. Figure 9 shows the boundaries of two reservoirs, Retiro Baixo and Três Marias.

Figure 9. (a) Retiro Baixo and Três Marias reservoirs. The larger reservoir on the left is Três Marias, and the smaller one in the lower right corner is Retiro Baixo (b).

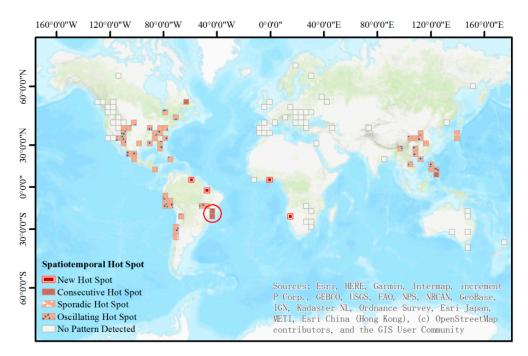
Using the emerging spatiotemporal hot spot analysis method, it can be found that the Brumadinho dam disaster in Brazil belongs to the Consecutive Hot Spot area (Figure 11). This disaster happened 3 years and 2 months after the Mariana dam disaster (5 November 2015), which was considered the worst environmental disaster in Brazil [74,75]. The Brumadinho and Mariana dam disasters both occurred in Minas Gerais, Brazil, and the two dams were both owned by Vale, a Brazilian multinational corporation engaged in metals and mining. Furthermore, based on the world mine tailings failure records [14], tailings dam failures have been recorded several times in this area. As a result, this area belongs to the Consecutive Hot Spot area, and the risk of tailings dam failure in this area would be relatively high if the necessary pond's management and the engineering safety measures were not carried out.

Figure 11. Spatiotemporal hot spot analysis of tailings dam failures. The location of Brumadinho dam disaster is marked with red circles.

According to Figure 11, New Hot Spots appear in Africa and South America which belong to developing regions, where the mining industry has been an important economic pillar in recent years [76,77]. Consecutive Hot Spots mainly lie in Eastern South America and Western Pacific islands where there are a lot of tailings left by mining, but due to poor management, tailings failure is easy to occur. The Sporadic Hot Spot is in Southwest South America and Oscillating Hot Spots mainly lie in Asia and America. China has many Oscillating Hot Spots and there have been some particularly serious tailings failure disasters, such as the 8 September 2008 dam break accident in Shanxi [78]. Different hot spots have different characteristics of disaster occurrences. These characteristics can be influenced by the mining history, mining features (e.g., man-made or natural), etc. [79-81]. The recommendation is that different hot spots should be treated differently. The areas of New Hot Spots and Consecutive Hot Spots are the ones that deserve the most attention. Local governments should adopt appropriate risk management strategies to monitor and change the trend. The risk assessment and monitoring of tailings reservoirs should be adopted and implemented. In this regard, some risk assessment and monitoring methods of mountain disasters can be used as references [82–85].
