# Water Inrush Hazards in the Chaoyang Tunnel, Guizhou, China: A Preliminary Investigation

**Abstract:** This paper reports on a water inrush hazard, which occurred during the construction of the Chaoyang tunnel in Libo County, Guizhou Province, China. On 10 June 2018, a continuous water inflow of about 57 thousand m<sup>3</sup> of water within 40 min took place at the tunnel excavation face, resulting in three casualties. The objectives of this study are to investigate and discuss the water inrush process of this atypical case. Further, an inclusive description of the implemented emergency responses will be provided. The principal causes of this tunneling incident include the karst geological condition at the construction field, hydraulic conductivity induced by the connection between karst water system and surface water body, and effects of excavation and precipitation. Moreover, based on a preliminary investigation and analysis, three main control measures to overcome similar incidents in the future are proposed: (1) Performing “water inrush risk grading” in areas prone to water inrush; (2) undertaking comprehensive geological forecast for a synthetic analysis; and (3) employin

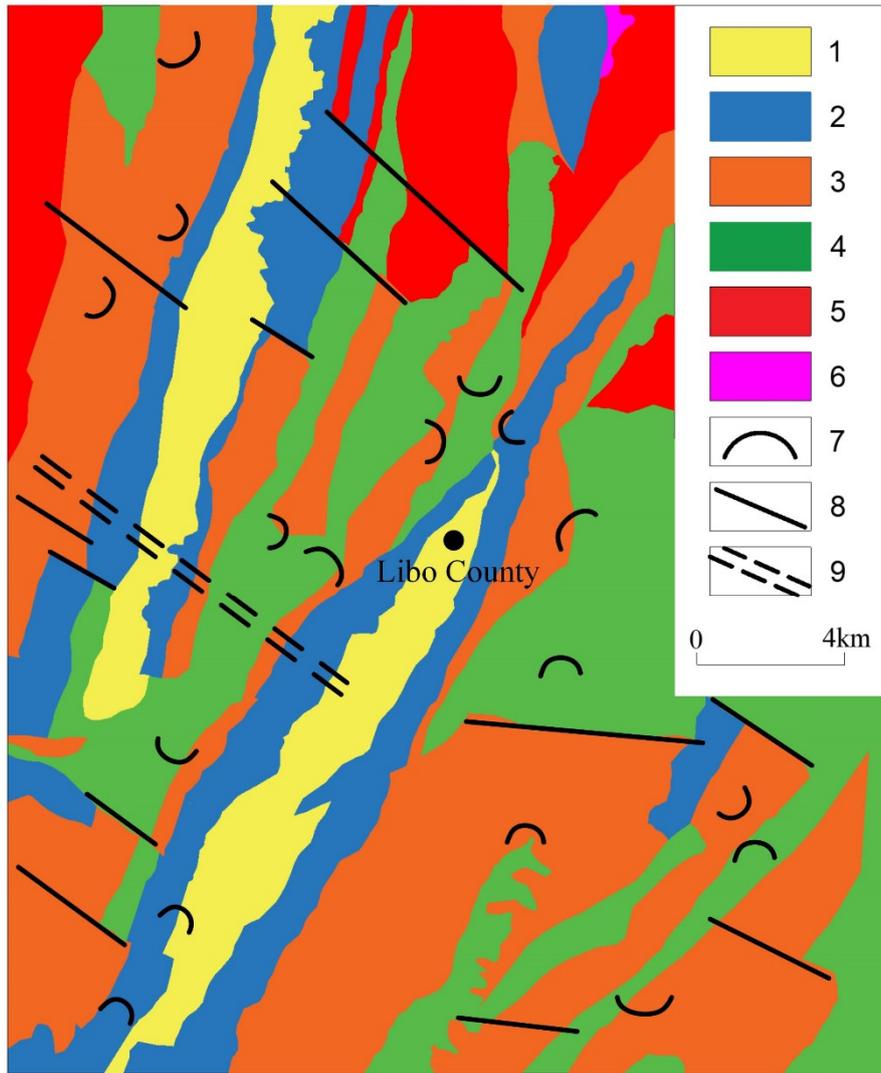
Figure 5. Geological map of Libo County (recreated based on [39]).

The incident point is covered by the terrain of karst depression with a buried depth of about 230 m. Figure 5 shows the geological map of Libo County. The tunnel passes through a medium-low mountainous area with peak bushes and low-lying valleys. The site is covered by soft layers of silty clay with average depth of 0–2 m, and the bedrock of Permian Qixia Formation limestone, limestone with intercalation of shale, Carboniferous Mapping Formation limestone, and limestone interlayered with dolomite. Figure 6 shows the sectional view of geological conditions along the tunnel alignment. The incident occurs when excavation in the contact zone of limestone and limestone interlayered with shale, which is water softened and is easy to disintegrate when exposed to air.

which often induce several hazards and a variety of engineering construction accidents. In terms of the effect of fissures on the corrosion of karst caves, it is found that the faults and fractures play an important role in karst corrosion [40,41]. The analyses indicated that the karst fractures increase the area of contact between water and carbonate rock, which helps to increase the limestone erosion, and has a clear effect on the stabilization of tunnel rock. The adverse geological formation of the site is believed to be the origin of the water inrush incident in Libo County.

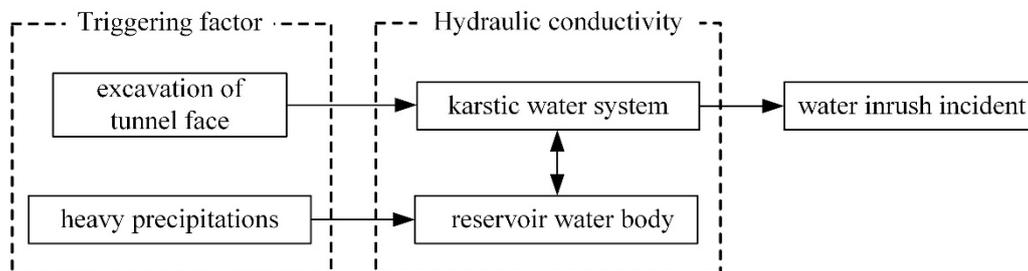
Figure 8. Schematic flowchart of water inrush incident.

When the tunnel excavated the altered zone (limestone with intercalation of shale), the main equilibrium of materials and mechanics in the altered area was suddenly collapsed. On one hand, once the free surface of the karst cave was disturbed, the leakage pressure dramatically increased through a very short time. Under the influence of groundwater leakage pressure and gravity, the karst cave instantaneously collapsed, resulting in a large-scale inrush event. High pressure groundwater flew through the tunnel along weak frames and structural components. Then, the flowing water constantly eroded and transported the loose soil in the altered area. On the other hand, tunnel excavation has caused disturbances and redistribution of pressure in the surrounding rock masses. In this project, the tunnel passed through altered limestone layer, which represents a common soluble rock that provide the place for groundwater flow and migration. This type of rock with highly soluble rock is likely to induce water inrush [42,43]. At the same time, the construction of tunnel in karst caverns broke the balance of the original ecology. Moreover, the level of groundwater was high which resulted in a series of geological hazards, including water inflow and inrush. This groundwater played a major role as a driving force for the water inrush process. The condition became even worse owing to groundwater recharged by surface water body, which is detailed in the following sections.

but 2018 reveal that the precipitation reached 250.4 mm, which is more than twice as the monthly average rainfall of 103.7 mm. Moreover, Libo County was stricken by a heavy rainfall on 4 June. The precipitation reached the astonishing value of 53.6 mm, as shown in Figure 7b. The intense rainfall is one of the critical triggering factors since it resulted in the increase of surface water which became the main recharge source of underground karst water system. Consequently, the unfavorable situation was further aggravated because of the triggering factor of heavy rainfall and tunnel excavation. Figure 8 shows a schematic cause-and-effect diagram of the water inrush incident.
