# Assessment of Restorative Maintenance Practices on the Infiltration Capacity of Permeable Pavement

Mari E. Danz <sup>\*</sup>

U.S. Geological Survey—Upper Midwest Water Science Center, 8505 Research Way, Middleton, WI 53562, USA; wrselbig@usgs.gov (W.R.S.); nbuer@usgs.gov (N.H.B.)

Received: 15 April 2020; Accepted: 27 May 2020; Published: 30 May 2020

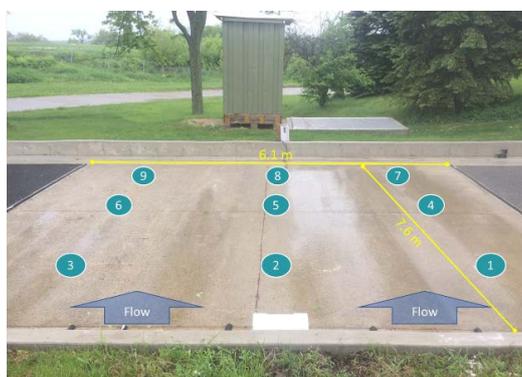
**Figure 3.** Layout of discrete test locations for a surface infiltration test at the permeable pavement test site (pervious concrete shown; numbers indicate the designated label for each discrete location).
