A Comprehensive Investigation on Abnormal Impoundment of Reservoirs—A Case Study of Qionglin Reservoir in Kinmen Island

Yin-Chun Hung 1,*, Tung-Tsan Chen 2, Tsai-Fu Tsai 2 and Hao-Xi Chen 3

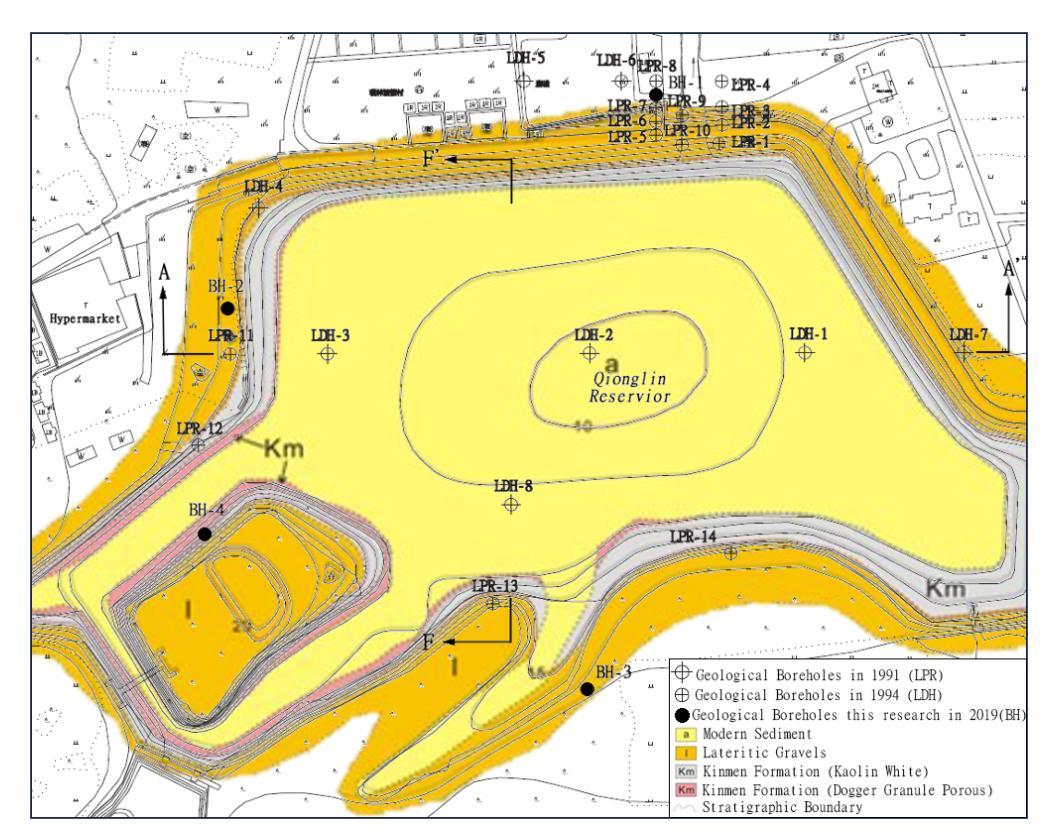
Figure 2. Geological map of Qionglin Reservoir/Drilling locations of Qionglin Reservoir over the years.

The field drilling was adopted for the base investigation, and a total of 4 holes numbered BH-1 to BH-4 were drilled, with a total drilling depth of 60 m, as shown in Figure 2 drilling locations of Qionglin Reservoir over the years. The field standard penetration test was carried out to all holes to calculate the blow counts (SPT-N value) penetrating into the strata, and the field permeability test was conducted. Split spoons and thin wall tubes were provided for laboratory test.

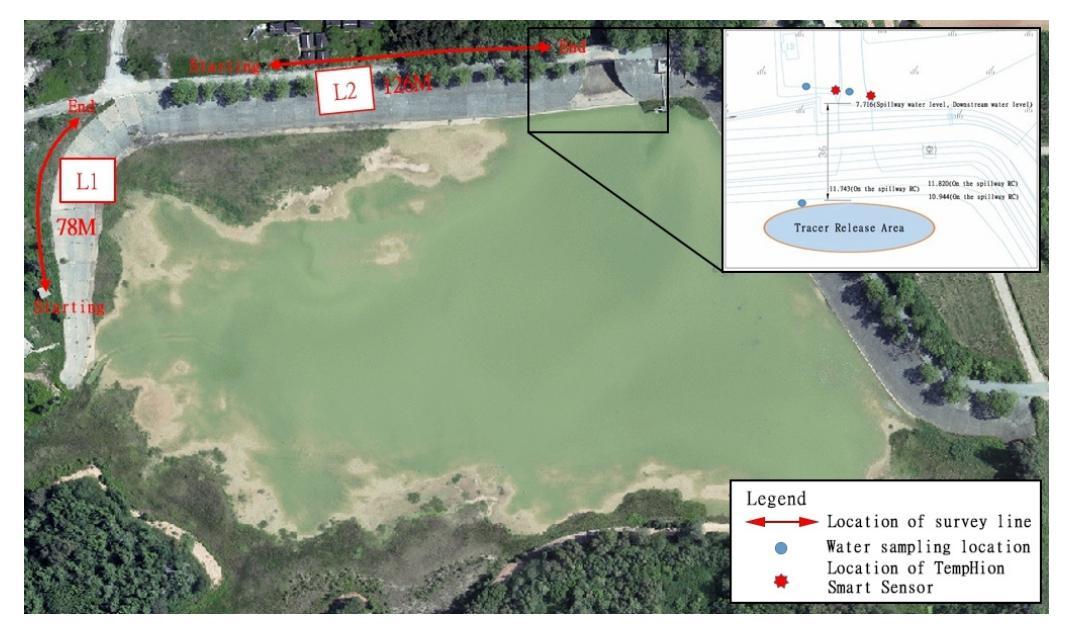
Figure 4. Diagram of electrical resistivity tomography survey line layout. /Tracer application area, sampling points and Temphion smart sensor setting points.

In this study, 2 testing lines were laid out around Qionglin Reservoir, as shown in Figure 4. Of the 2 testing lines, L1 was on the west side of the dam, with a length of 78m and the electrode spacing of 3 m, and L2 was on the north side of the dam, with a length of 126 m and the electrode spacing of 3 m. The Wenner–Shlumberger array was adopted in field measurement for data collection.

In this study, sodium bromide was mainly used as the tracer, and placed near the spillway above the stilling basin of the reservoir in the form of a solution. Then, the sensor was placed on the left bank (the stilling basin outside the reservoir) and the right bank (inside the reservoir area) of the stilling basin to detect the changes of sodium bromide ion concentration. In addition, water samples were respectively collected in the reservoir and stilling basin for the ion chromatography (IC) to analyze the common ions, so as to confirm the test results again. Figure 4 shows the tracer application area and sampling points and the points of sensors.
