# Assessment of the Breaching Event, Breach Parameters and Failure Mechanisms of the Spillway Collapse in the Swa Dam, Myanmar

**Abstract:** The spillway of the Swa earthen dam, constructed in Yedashe Township, Bago Region, Myanmar, collapsed suddenly on 29 August 2018 and resulted in a huge flood to downstream areas causing fatalities and the displacement of thousands of localities. This study aimed to assess the spillway breaching process in terms of the breaching parameters such as the average breach width, failure time and peak outflow, and failure mechanisms. We analyzed the event from the changes in the study site before and after the event and used water discharge conditions from satellite data and water level records during the event. We compared the breaching parameters using empirical equations from past failed events with tested scenarios for failure mechanisms, such as overtopping and piping. According to satellite data, 97% of the storage from the reservoir was discharged, and the peak breach outflow rate was 7643 m<sup>3</sup>/s calculated from the water level records. The selected empirical formulas were applied, and the estimated average breach widths, failure time

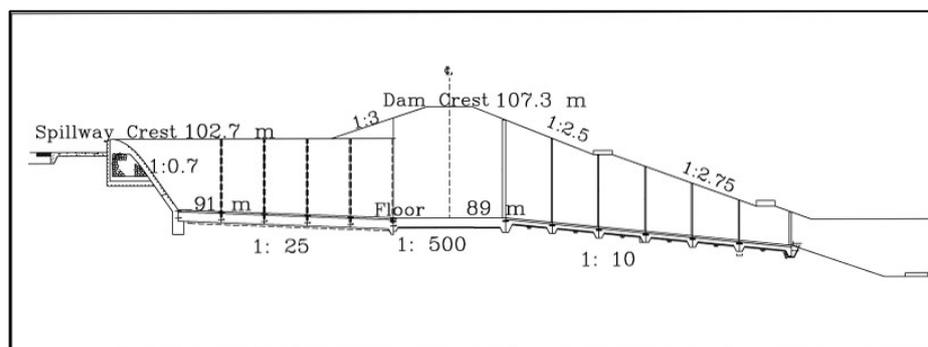
The spillway is a reinforced concrete bath tube (duckbill) type ogee spillway, which has a 122 m total overflow length, and is 171 m long; the width of spillway is 36.6 m at the bottom and about 64 m maximum at the crest of the main dam. The height of the spillway at the dam crest is 13.7 m. The longitudinal gradient of the spillway is 1:0.7 in the mouth of the duckbill, 1:25 in the floor of the duckbill, 1:500 in the transition and 1:10 in the chute portion, as shown in Figure 2. The floor of the spillway is covered by 15 cm-thick lean concrete over 0.3 m-thick reinforced cement concrete at the duckbill part and 1.2 m-thick mass concrete at the transition and chute portions. The foundation test for the spillway was performed by 7 test holes at the transition portion (left and right), Duckbill and chute portion and the bulk density is from 1.52 to 1.67 t/m<sup>3</sup>, the moisture content is from 18.49 to 24.53% and the bearing capacity is from 3.26 to 4.2 kg/cm<sup>2</sup> (2.98 T.S.F to 3.84 T.S.F), and the largest values are found to be under the left side of the transition portion. Based on the rainfall data from the Yedashe Township station, projected floods in the Swa catchment for different return periods (20 years to 1000 years) were prepared by the IWUMD, as shown in Table A1 (Appendix A). The peak flood ( $Q_p$ ) ranged from 1758 to 3491 m<sup>3</sup>/s with respect to the return periods. The spillway was designed to tolerate a flood that happened once in a 200-year period (2693 m<sup>3</sup>/s), and the overflow length of 120 m was designed for that flood.

**Figure 2.** Longitudinal section of Swa Dam's spillway (before collapse) (IWUMD).

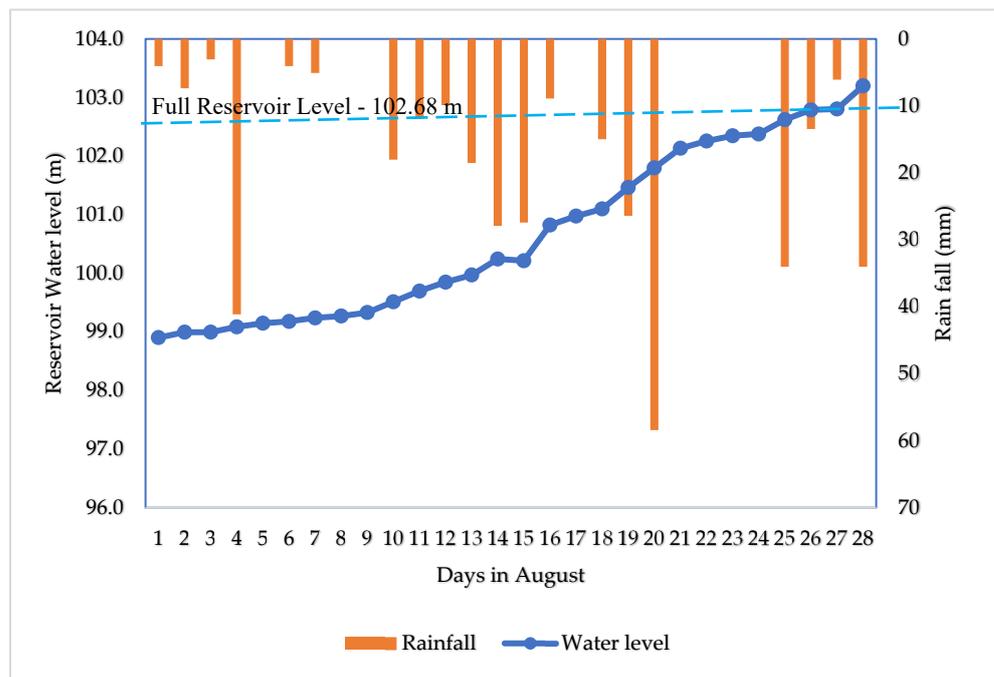
Before the breach event, 20 rainy days were observed in August; on 20 August, a maximum rainfall of about 60 mm was observed, according to the records of the Hydrology branch of the IWUMD. According to the records, starting from 25 August 2018, rainfall had continued for four days, and the spillway began to overflow on 26 August, as shown in Figure 3. The estimated outflow from the spillway was about 213 m<sup>3</sup>/s on 26 August. From 25 to 28 August 2018, the total rainfall was about 88 mm, and the water level in the reservoir was raised to R.L 103.2 m, 0.5 m above the full reservoir level (R.L 102.68 m). When the water level in the reservoir rose to R.L 103.1 m, the estimated outflow from the spillway changed to about 1911 m<sup>3</sup>/s on 28 August. In addition, the water level of the reservoir rose from 99 m (1 August) to 103.2 m (28 August), according to the records of the Hydrology branch of the IWUMD.

**Figure 3.** Reservoir water level and rainfall condition of Swa Dam before the breach event (1–28 August 2018) (record by the IWUMD).

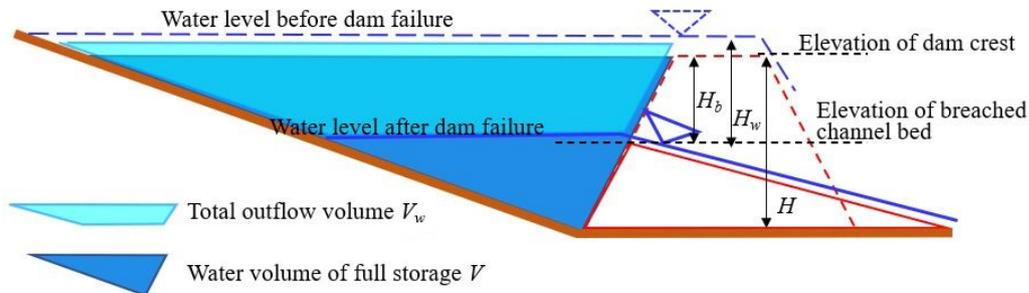
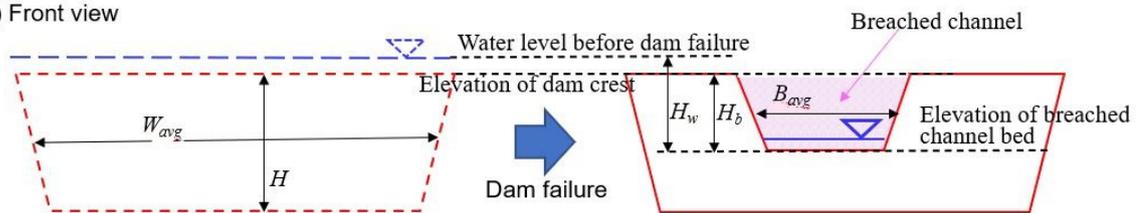
**Figure 6.** Schematic illustration of the dam breaching parameters (a)  $H_b$ ,  $H_w$ ,  $H$ ,  $V_w$  and  $V$  in longitudinal view (b)  $W_{avg}$  and  $B_{avg}$  in Front view.

The height of the water surface from the breach inverted ( $H_w$ ) is the vertical extent of the water measured from the top of the water surface before dam failure to the bottom of the breach, whereas  $V_w$  is the volume of water with respect to  $H_w$  [17–26]. In previous studies, if there was no information for the breach water height ( $H_w$ ) and its corresponding water volume ( $V_w$ ), the dam height ( $H$ ) could be assumed as  $H_w$  in some cases such as overtopping cases, and the full storage water level and full storage reservoir,  $V$ , could be taken as parameters in other cases such as piping cases. For the Swa Dam case,  $H_w$  was measured from the overflow water surface (R.L 103.2 m) before the breach day to the final breach bottom elevation (R.L 81 m), which was 22.2 m. This height was applied as  $H_w$  in the empirical calculation.

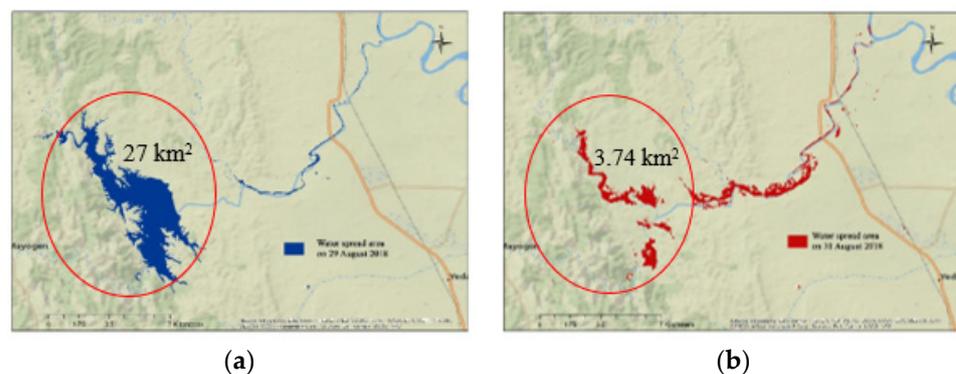
Using SAR data from Sentinel 1, water area changes in the study site before and after the dam breach were analyzed, as shown in Figure 9. Before the breach happened, the reservoir water area of the Swa Dam and along the Swa creek was about 27 km<sup>2</sup>, according to a satellite image on 19 August 2018 (Figure 9a). The water area at the Swa Dam was reduced to 3.74 km<sup>2</sup> after the breach with respect to a 31 August satellite image (Figure 9b). The water area indicated that the water level after the breach was around 84.5 m. According to the height–volume relationship of the Swa Dam, the total volume of discharged water was estimated at around 259 million cubic meters, indicating that 97% of the full storage was discharged. The calculated water volume above the elevation of the spillway floor (R.L 89 m) was 39 million cubic meters.

Figure 9. Water spread area (a) before (blue) and (b) after (red) the breach of the Swa Dam.

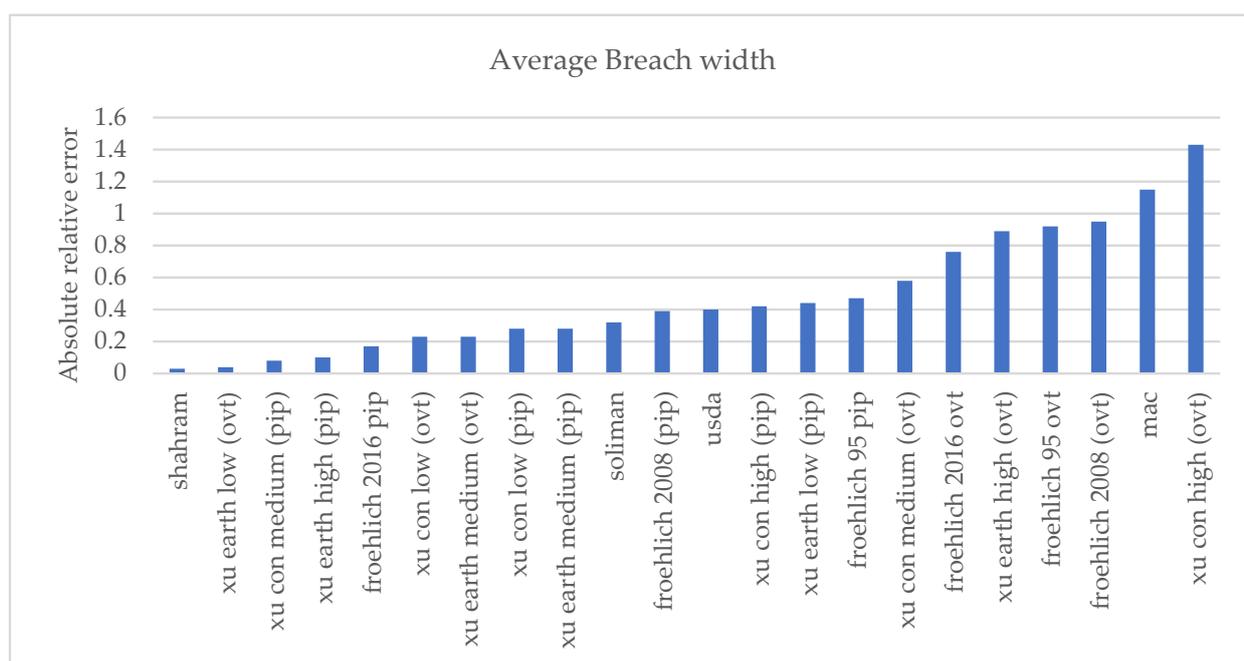
Here, we calculated the absolute relative errors for all empirical equations applied to the 22 cases to evaluate the performance of these equations as shown in Figure 11. The least error value (0.03) was found in Shahram’s equation, and Xu and Zhang’s equation for concrete-faced dams with medium erodibility (piping scenario) has a minimum error value (0.08) for the calculated average breach width. The error values ranged from 0.03 to 1.43 as shown in Figure 11.

**Figure 11.** The absolute relative errors for the empirical formulas calculated for the average breach width.

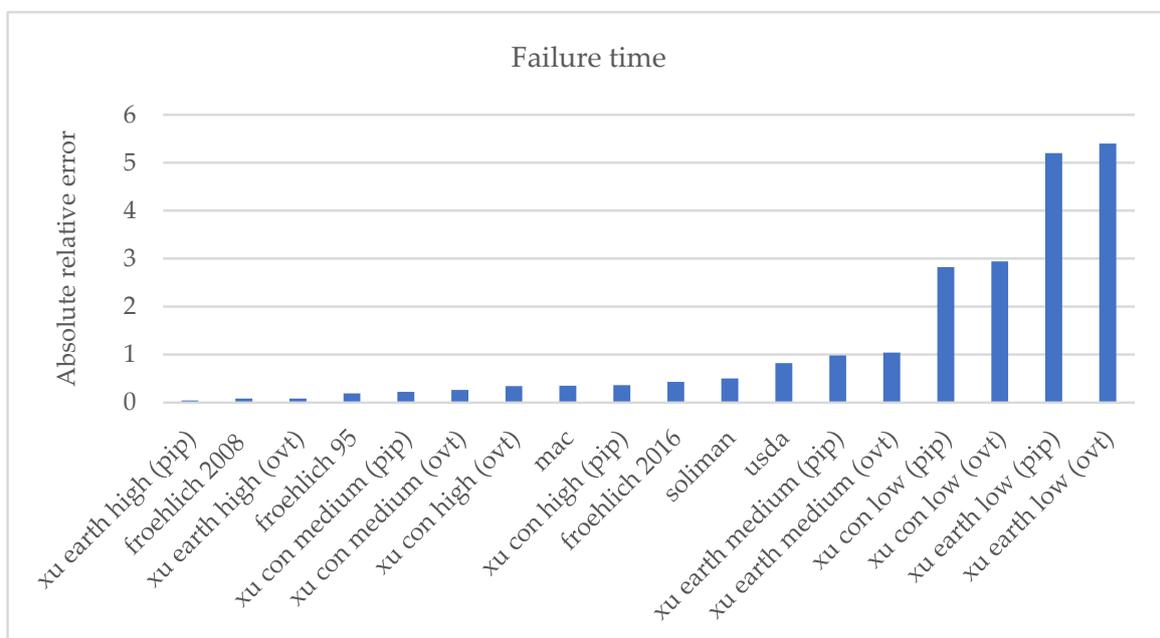
We calculated the absolute relative errors for all empirical equations applied to 18 cases to evaluate the performance of these equations as shown in Figure 12. Froehlich's 2008 equation has a minimum error value (0.08) and Xu and Zhang's equation for a concrete-faced dam with medium erodibility (piping scenario) has a minimum error value (0.22) for the calculated failure time. Xu and Zhang's equations for concrete-faced and earth dams with low erodibility for both scenarios are found to have very high relative errors. The error values ranged from 0.04 to 5.4 as shown in Figure 12.

**Figure 12.** The absolute relative errors for the empirical formulas calculated for the failure time.

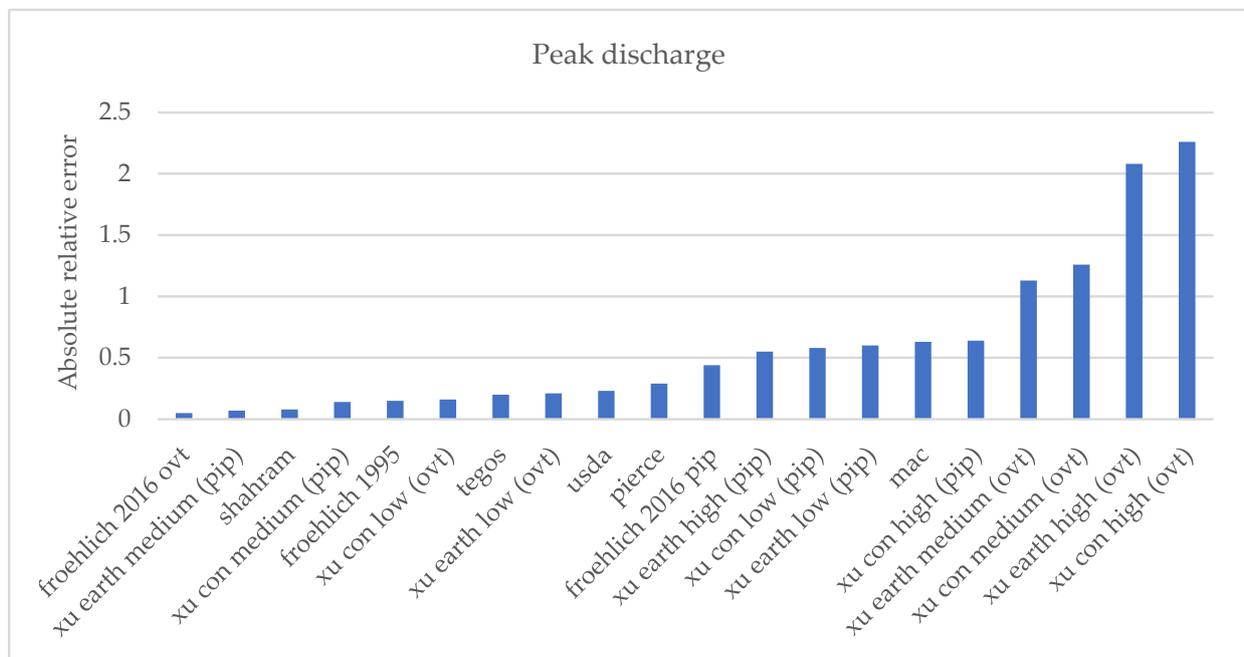
We considered the absolute relative errors for all empirical equations applied to 20 cases to evaluate the performance of these equations as shown in Figure 13. The least error value (0.05) was found in Froehlich’s 2016 [25] equation for a piping scenario, and Xu and Zhang’s equation for a concrete-faced dam with medium erodibility (piping scenario) also had a minimum error value (0.14) for the calculated peak outflow. Xu and Zhang’s equations for concrete-faced and earth dams with medium and high erodibility for the overtopping scenario are found to have high relative errors. The error values ranged from 0.05 to 2.26 as shown in Figure 13.

Figure 13. The absolute relative errors for the empirical formulas calculated for the peak discharge.
