Visual Exploration of the Spatiotemporal Evolution Law of Overburden Failure and Mining-Induced Fractures: A Case Study of the Wangjialing Coal Mine in China

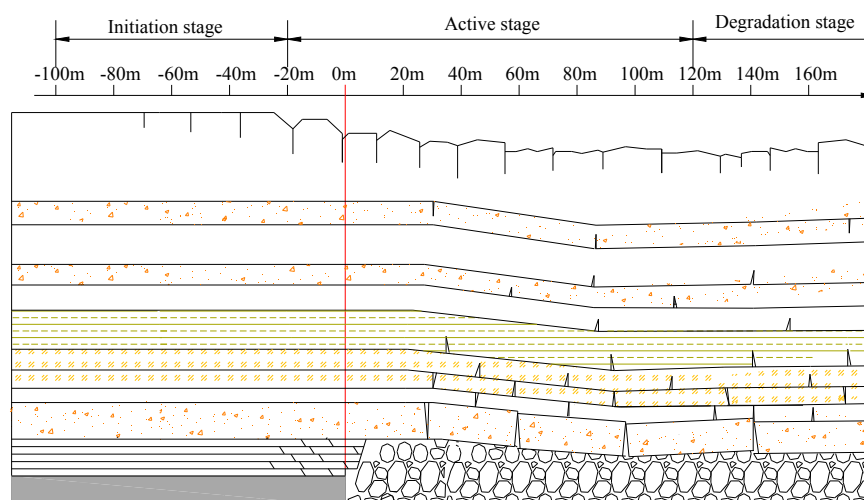
Figure 15. Three stages of the overburden movement.

the movable basin area exceeded the mined-out area. Based on the differences of surface subsidence velocity, extent of strata movement and propagation of fractures, the whole process can be divided into three stages (Figure 15):

- (c) **Degradation stage:** This stage started when the working face was 120 m past the borehole. During this stage, the movement of the overburdened strata degraded (there was a slow subsidence due to gravitation). The bed separation and fractures that had developed in the overburden strata were partially closed to compaction and the rate of surface deformation slowed down. Surface cracks and step subsidence were partially mitigated.

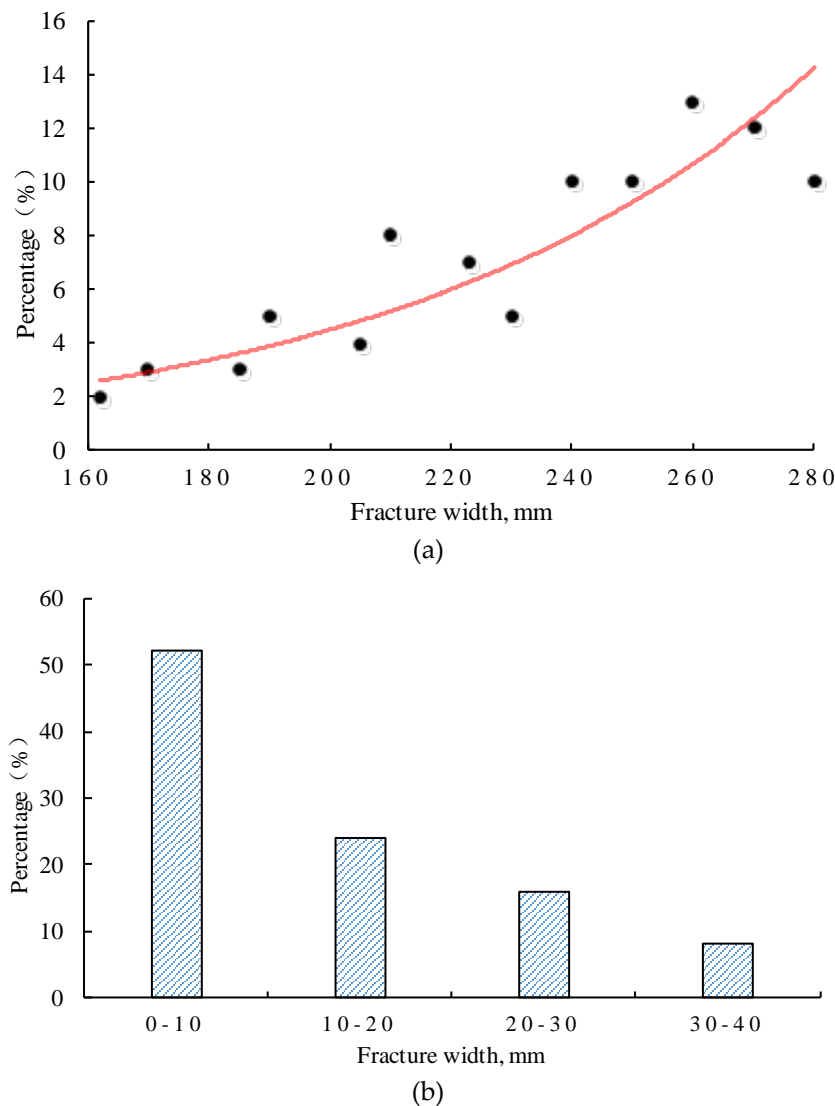
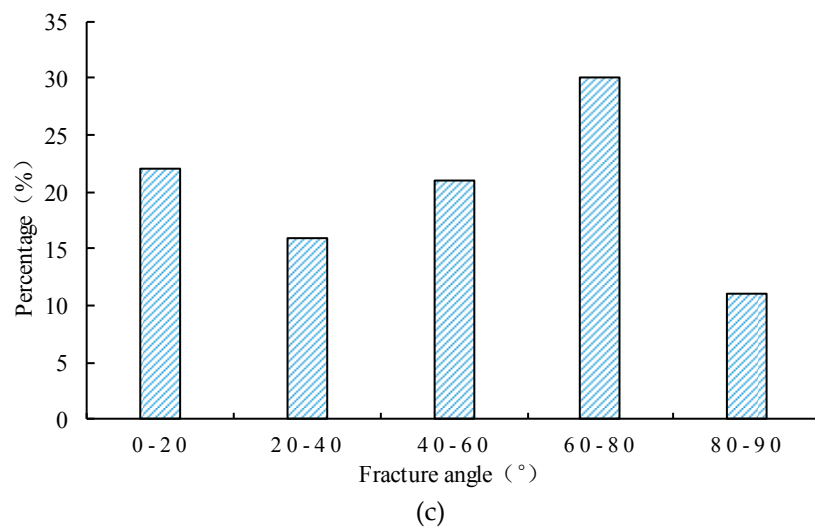
Figure 16. Fracture attributes: (a) number of fractures versus borehole depth; (b) proportion of fractures versus fracture width; (c) proportion of fractures versus fracture angle.

The number of mining-induced fractures can reflect the degree of influence by mining to the rock mass. As shown in Figure 16a, with the increase of drilling depth, the degree of mining influence deepening, fracture number has increased dramatically. The width of fractures reflects the propagation degree. As seen in Figure 16b, the fracture number decreased with the increase of width. Fractures with width between 0 and 20.0 mm account for 76% of fractures, which proves that fractures are mainly of low width. As shown in Figure 16c, the number of fractures at all orientations was relatively average, the interval of 40° – 90° accounted for 62%. It can be concluded that most of the mining-induced fractures are vertically oriented.

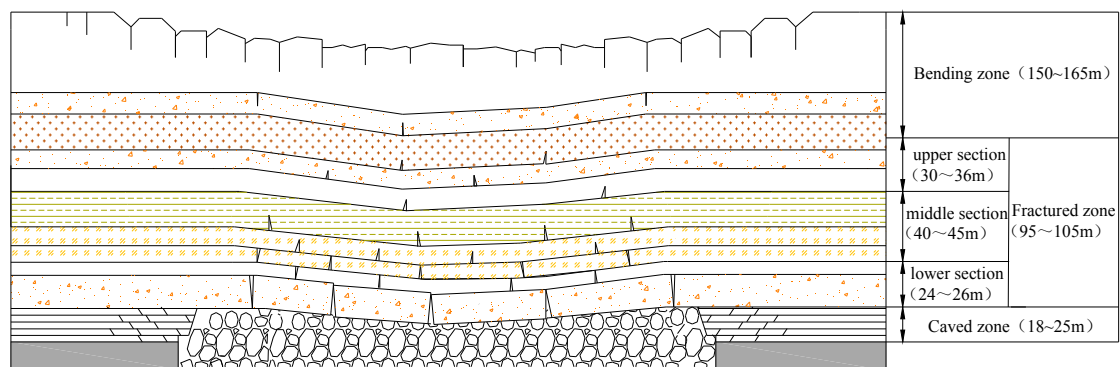
Figure 17. Distribution of fractures in the overburden strata.

The fractured zone can be divided into three parts: rock blocks, through-going vertical fractures and horizontal fractures caused by bedding layer separation. According to the different attributes, with the field observations, we confirm the range of the three parts (see Figure 17). In most cases, fractures in the bending subsidence zone exhibited small apertures. However, fractures with large apertures were also observed due to the limited tensile strength of certain strata, especially those near the ground surface (large fractures and step subsidence).
