# Failure Analysis of a Cylindrical Roller Bearing Caused by Excessive Tightening Axial Force

**Abstract:** The premature failure of a cylindrical roller bearing took place during service, with a total operation time of 100 h. The failure cause was analyzed by macroscopic and microscopic observation, metallographic analysis, hardness testing, tightening axial force influence analysis, and test verification. The results show that failure modes of the bearing are contact fatigue spalling, wear, and fatigue fracture. The outer ring, inner ring, rollers, and cages all have suffered relatively heavy damage in the sides corresponding to the bearing side with laser marking. Excessive load, induced by the excessive tightening axial force, derived from the lock nut, is the cause of the bearing failure. The failure mechanism is that excessive tightening axial force caused a great deformation and cylindricity increase of the inner ring raceway, which induced high local contact stress between one side of the ring raceways, as well as the corresponding ends of the rollers, resulting in the bearing failure. At last, measures for prevention of this failure are put forward as follows: controlling

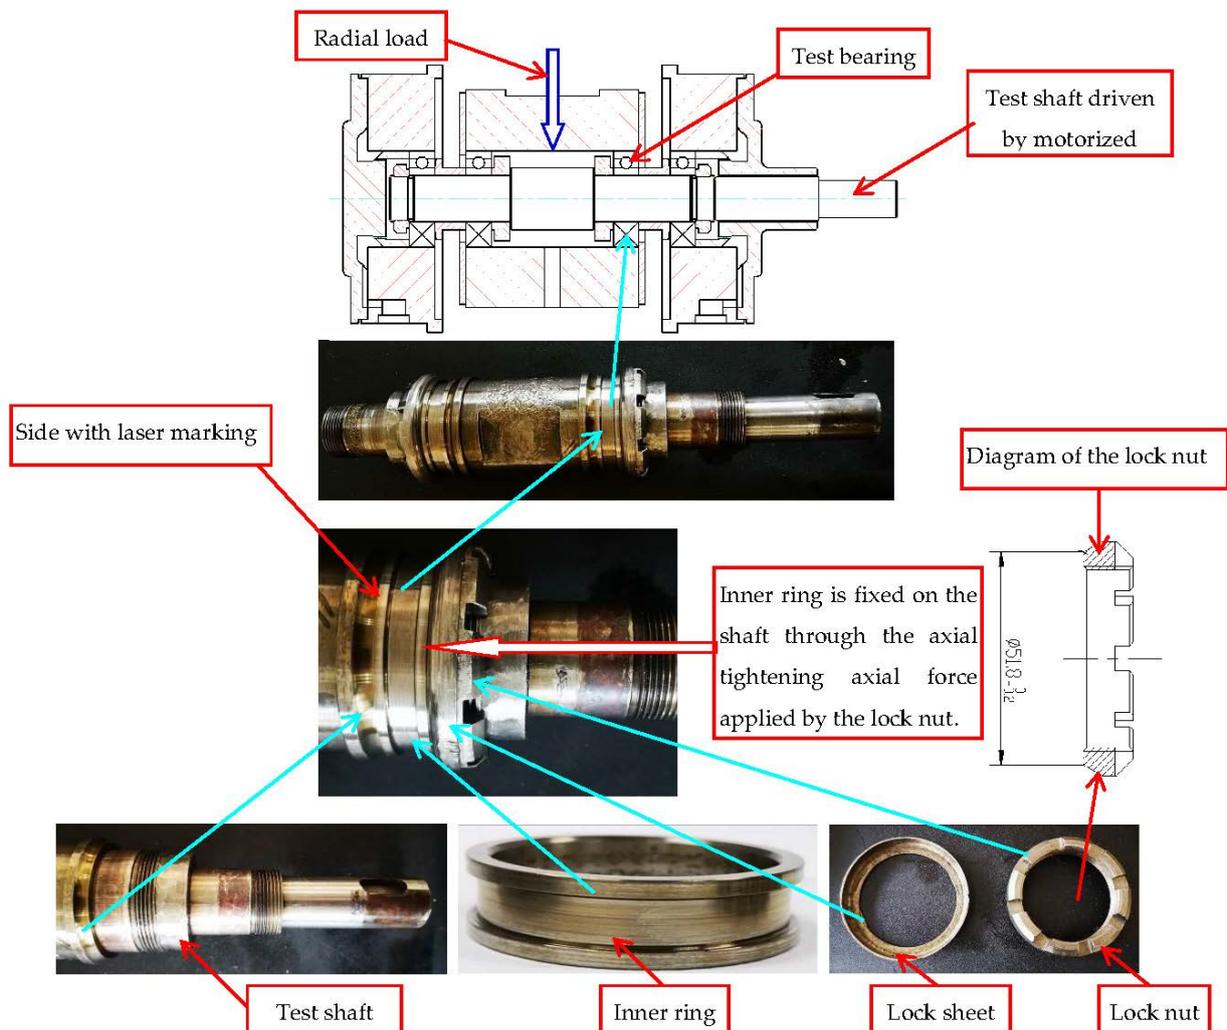
Figure 3. Installation morphology of the inner ring and assembly schematic diagram of the bearing on the test rig.

According to the installation structure of the inner ring, as shown in Figures 2 and 3, the inner ring raceway will deform and form high cylindricity on one side (causing the sloped shape of the inner ring raceway, due to the different diameter increase of the raceway

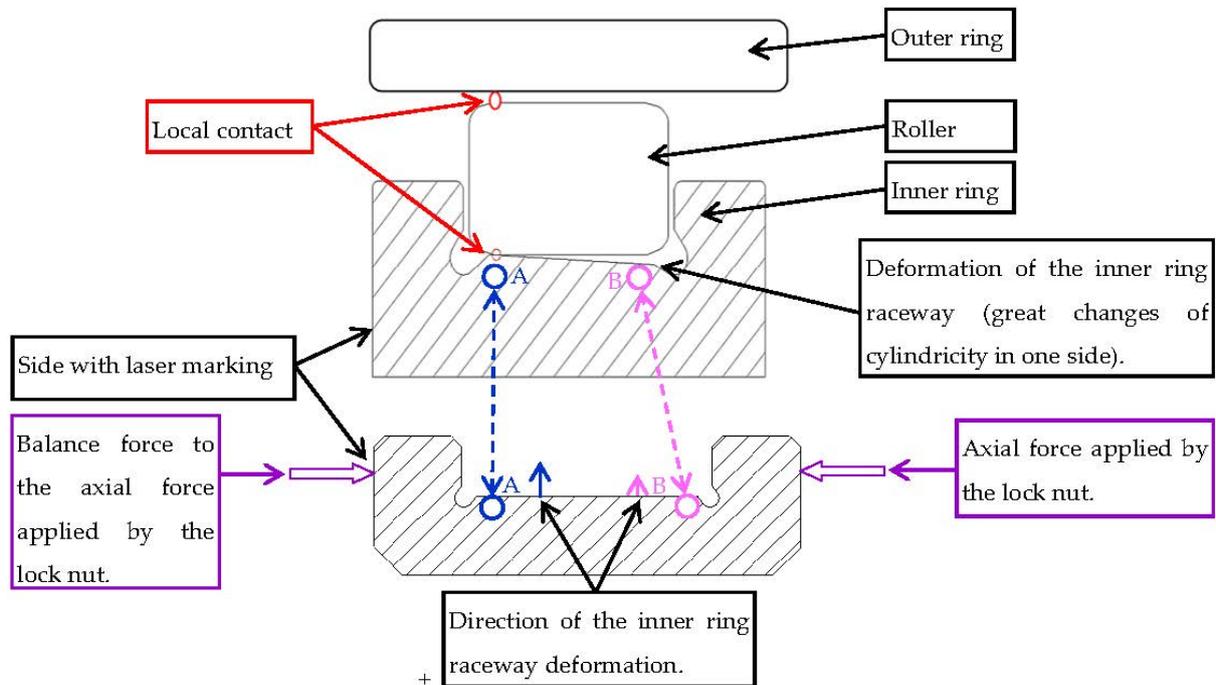
surface at two ends, such as locations A and B in Figure 4) under excessive tightening axial force; in this situation, it is very easy to cause the single side clearance between the rollers and ring raceway, because it is too small during the service of the bearing, resulting in local contact between one side of the ring raceway and one end of the rollers, as shown in Figure 4. This may cause uneven load distribution with high local contact stress, resulting in contact fatigue spalling and wear, eventually leading to failure of the bearing.

Figure 4. Schematic of unilateral local contact between inner ring raceway and roller.

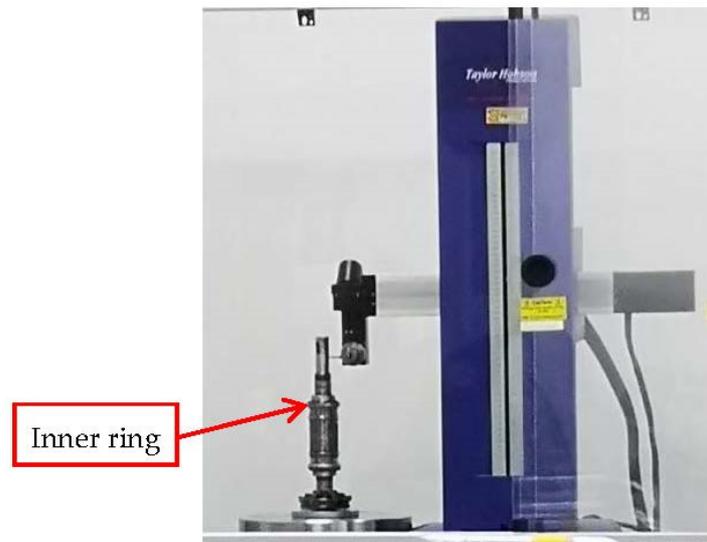
The influence of the tightening axial force on the inner bearing was analyzed by studying the relationship between the tightening torque of the lock nut and cylindricity variation of the inner ring raceway. The technical required axial tightening torque of the inner ring is 338~372 N·m. Additionally, the minimum axial tightening torque (338 N·m), tightening torque approximately in the middle axial tightening torque of the technical requirements range (350 N·m), and maximum axial tightening torque (372 N·m) were selected to study the relationship. The cylindricity of the inner ring raceway was measured via a cylindricity measuring instrument, both before and after being fixed on the shaft, with different tightening torques. The cylindricity of the inner ring fixed on the shaft was to be measured as shown in Figure 18.

The tightening torque of the lock nut, as well as the comparable cylindricity of the inner ring raceway, are shown in Table 6. After the tightening torque was applied, the cylindricity of the inner ring raceway was generally greater than it was before the tightening torque is applied. The cylindricity increased, which indicates that the distortion and deformation of the inner ring raceway had been formed by the tightening torque. Additionally, the cylindricity of the inner ring increased with the increase of the tightening torque of the lock nut.

Figure 18. Cylindricity of the inner ring fixed on the shaft is to be measured.
