# Maintenance of Arc Occurrence at the End of the Stator Slot in a High-Voltage Motor

**Abstract:** This study investigates the critical issue of arc-induced partial discharge in high-voltage motor stator windings and proposes a cost-effective, targeted maintenance approach to mitigate these effects. Diagnostic techniques, including insulation resistance tests,  $\tan \delta$  measurements, partial discharge analyses, and UV camera inspections, were employed to identify and assess fault points. A novel partial maintenance method involving felt-pad insulation reinforcement was implemented to address the arc discharge issues. Post-maintenance diagnostics confirmed a significant reduction in partial discharge levels, with an average decrease of over 80%, demonstrating the effectiveness of the proposed approach. Compared to traditional rewinding methods, this technique offers substantial savings in time and cost while enhancing motor reliability. The findings underscore the importance of precise diagnostics and tailored interventions in extending the lifespan and operational stability of high-voltage motors, providing practical insights for industrial maintenance strategies.

This stu

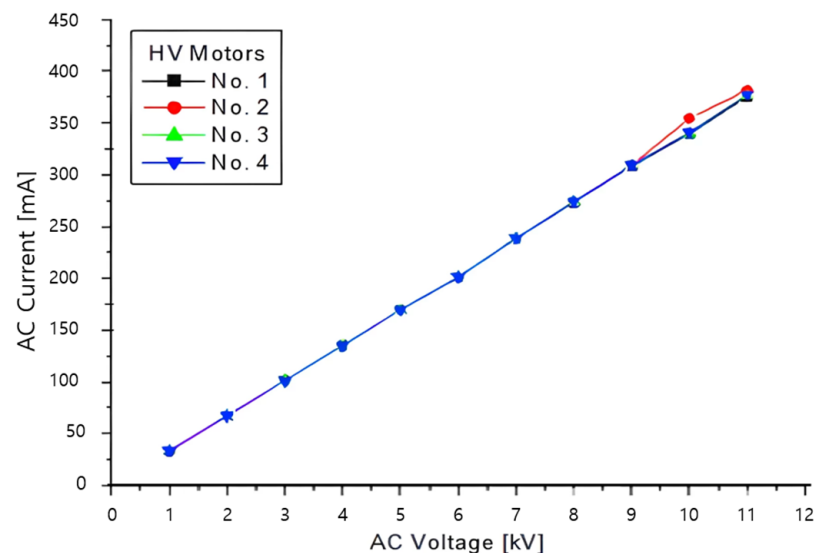
**Figure 7.** Characteristics of AC current–voltage in the high-voltage motor.

Figure 7 presents the results of the AC current–voltage tests conducted on four high-voltage motors. The test involved measuring current variations while gradually increasing the AC voltage applied to the stator winding in three phases, starting from 1 kV up to the rated voltage of 11 kV in 1 kV increments. As shown in the graph, the AC current–voltage characteristics exhibit a consistent increase without any noticeable changes in the trend. This indicates that the AC current–voltage test results show no abnormalities.

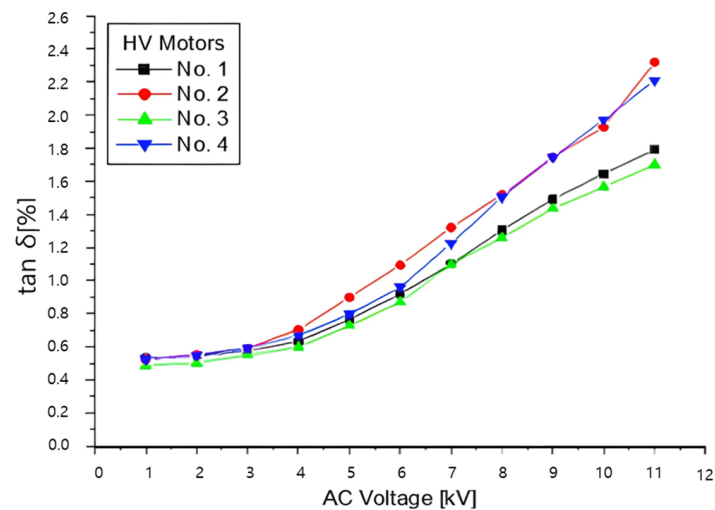
**Figure 8.** Voltage-dependent characteristics of the dissipation factor ( $\tan \delta$ ) in the high-voltage motor.

As shown in Figure 8, the dissipation factor ( $\tan \delta$ ) of the high-voltage motor stator winding was assessed by gradually increasing the three-phase AC voltage from an external power supply, starting at 1 kV and rising in 1 kV increments to the rated voltage of 11 kV. At the rated voltage, the  $\Delta \tan \delta$  values for motors 1 through 4 were calculated at 1.244%, 1.585%, 1.199%, and 1.661%, respectively, and were deemed satisfactory. Typically, a high  $\tan \delta$  measurement signals significant damage to the stator winding of a high-voltage motor, but the relatively low  $\tan \delta$  values, in this case, indicate that contamination had not notably impacted the dissipation factor.

The  $\tan \delta$  generally shows a gradual increase from 1 to 3 kV but rises more sharply above 3 kV. This trend suggests that the onset of partial discharge can be expected around 3–4 kV.

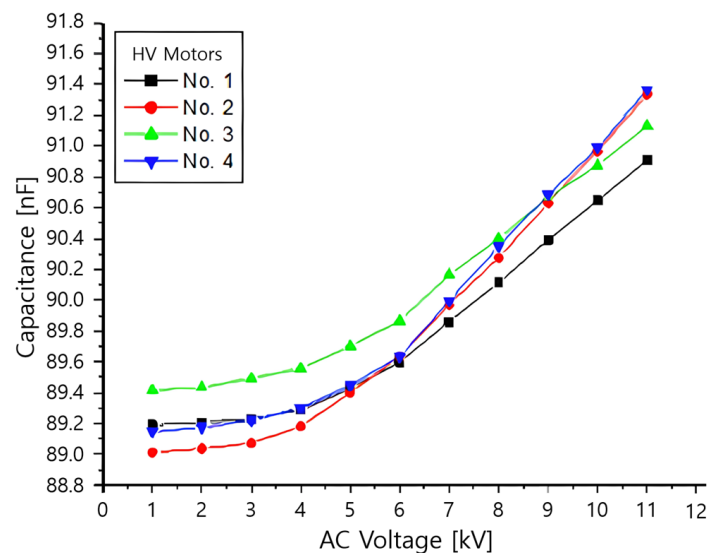
**Figure 9.** Voltage-dependent characteristics of stator winding capacitance in the high-voltage motor.

As shown in Figure 9, the stator winding capacitance was measured by gradually raising the three-phase AC voltage from 1 kV to the rated 11 kV in 1 kV steps using an external power supply. The capacitance increased steadily from 1 to 3 kV, then more sharply above 3 kV. This pattern closely resembled the dissipation factor ( $\tan \delta$ ) trend observed as the voltage rose. Similar patterns were observed when comparing the capacitance–voltage and dissipation factor–voltage profiles. At 11 kV, the  $\Delta C$  values for motors 1 to 4 were 1.93%, 2.61%, 1.92%, and 2.49%, respectively.

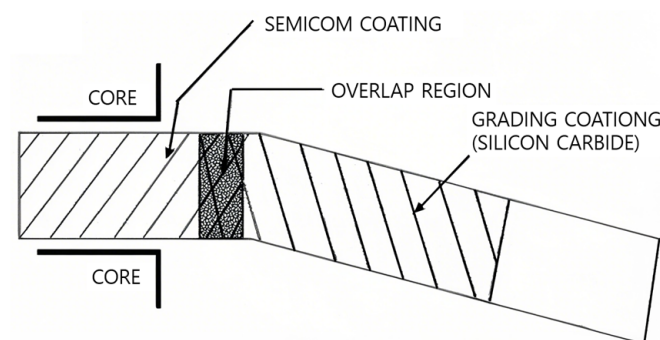
**Figure 14.** Insulation treatment of stator end coil.

The first suspected cause is the degradation at the boundary between the semiconductive and grading coatings. A rapid increase in the potential gradient on the surface of the coil insulation at the slot end, where the core ends, can make it vulnerable to corona generation and insulation breakdown [21]. To prevent this, curved surface design, overlap insulation, and grading coatings are applied during manufacturing. Figure 14 illustrates the insulation treatment applied at the stator coil ends to prevent corona generation [9].

The boundary where the stator winding exits from within the slot into the air is a location of high electrical stress. Over time, as degradation progresses, the grading coating loses its grounding function, leading to spark generation [9].

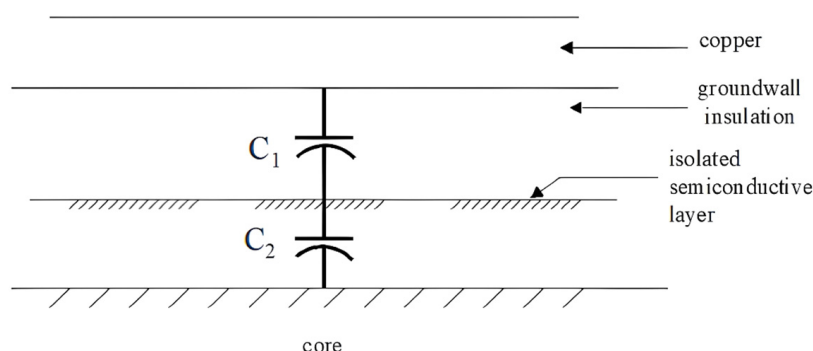
**Figure 18.** Characteristics of slot discharge.

Furthermore, if the semiconductive layer on the insulation surface becomes worn and damaged due to relative movement between the coil and the slot on the stator winding surface, slot discharge may occur, as shown in Figure 18.

If the semiconductive layer is damaged, resulting in charge accumulation on the winding surface and causing slot discharge between the core and the winding, insulation reinforcement is deemed necessary.

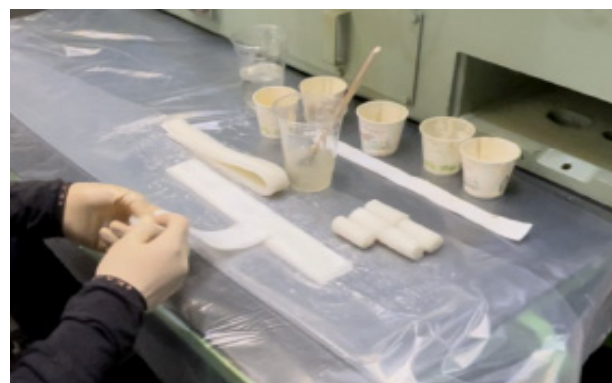
**Figure 20.** Preparation of polyester (HP21) insulation reinforcement material.

As confirmed in the text, partial discharge values resulting from corona discharge at the stator winding end were identified as primary contributors to the observed partial discharge levels, with arc discharge occurring specifically between the edges of some press fingers and the adjacent insulation layers. The high partial discharge measurements recorded were largely attributed to the peak values generated by these arc discharges; hence, it was expected that removing the arc discharge source would lead to a noticeable reduction in partial discharge levels.

As a maintenance approach to prevent arc discharge, the insulation was reinforced at points between the finger plates and the insulation layer, and varnish was selectively applied and left to dry naturally to enhance insulation durability. The specific insulation reinforcement technique is illustrated in Figure 20, where polyester (HP21, felt pad) material was precisely cut to fit between the press finger and insulation. This material was soaked in varnish, carefully inserted at the identified arc discharge points, and allowed to dry naturally, ensuring a robust and effective reinforcement layer.

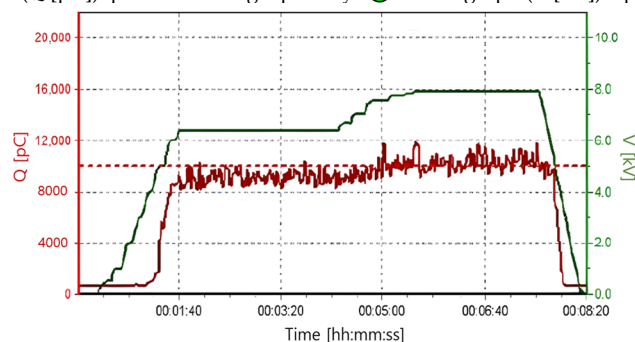
**Figure 26.** Partial discharge level of No. 1 HV motor.

The most notable result is the significant reduction in the partial discharge levels, with decreases exceeding 80%. Under the phase voltage condition (6.35 kV), the partial discharge magnitudes were measured as follows: 9500 pC for motor No. 1, 17,000 pC for motor No. 2, 11,500 pC for motor No. 3, and 17,000 pC for motor No. 4. Based on these measurements, motor No. 1 was classified as being in a satisfactory condition at 6.35 kV, while motors No. 2, No. 3, and No. 4 were categorized as cautionary. These results indicate that localized defects were successfully eliminated and that arc discharge activity was effectively suppressed.

The analysis results are visually presented in Figure 26, clearly illustrating the degree of improvement before and after maintenance work. This allows for a detailed evaluation of the effectiveness of the maintenance in enhancing insulation performance and offers valuable reference data for future maintenance strategy development. The red dashed line in the figure represents the precautionary threshold (10,000 pC), above which the partial discharge level requires attention.

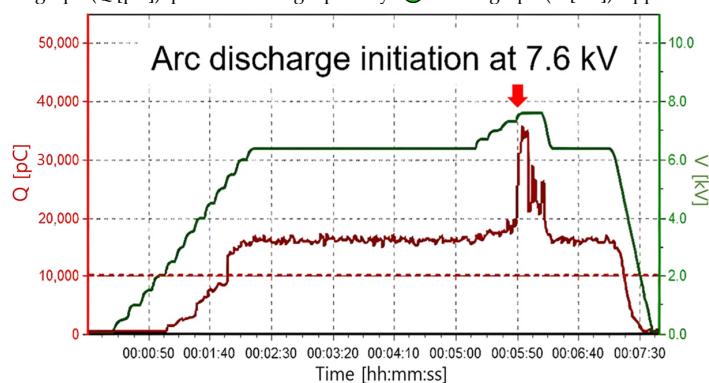
**Figure 27.** Partial discharge level of No. 2 HV motor.

Meanwhile, during the gradual increase in voltage to measure 1.25 times the phase voltage, a sharp rise in the partial discharge magnitude was observed at 7.6 kV. This suggests that the arc discharge pathways remaining at the winding terminal were not completely eliminated, indicating the need for additional precise inspections and supplementary maintenance work.

These measurement results are visually presented in Figure 27, providing a clear illustration of the potential issues that remain even after the maintenance work and highlighting areas for further improvement.

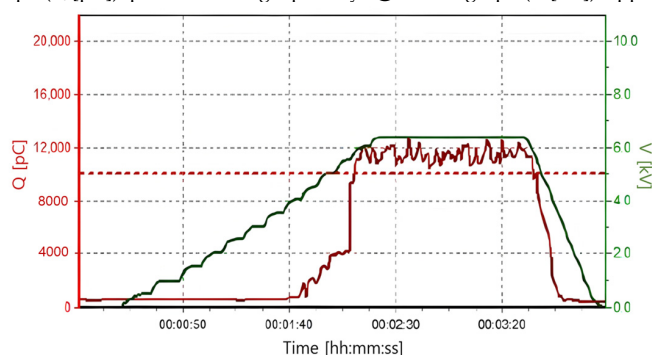
**Figure 28.** Partial discharge level of No. 3 HV motor.

The analysis results are presented in Figure 28, providing a clear illustration of the changes before and after the maintenance work. This highlights the improvement achieved and emphasizes the areas that require additional attention.
