# Study on the Root Causes and Prevention of Coating Cracks in the Cargo Hold of a Product Carrier

**Citation:** Yi, M.-S.; Seo, K.-C.; Park, J.-S. Study on the Root Causes and Prevention of Coating Cracks in the Cargo Hold of a Product Carrier. *Metals* **2022**, *12*, 1688. <https://doi.org/10.3390/met12101688>

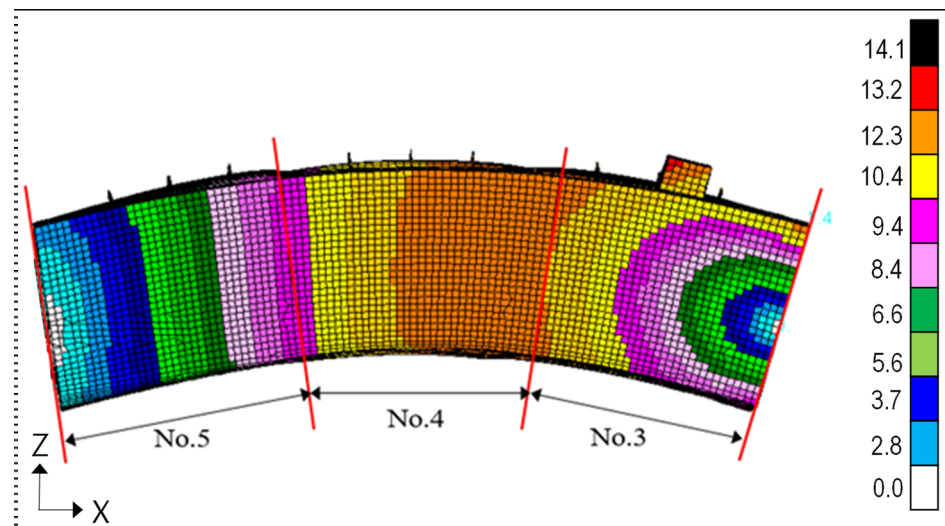
Figure 10 shows the global deformed shape of the middle cargo model under hogging conditions. The load and boundary conditions are well-described under the pure bending behavior in the FE model.

**Figure 10.** Deformed shape and displacement of three cargo hold models under hogging conditions (unit: mm).
