# Contact Fatigue Failure Analysis of Helical Gears with Non-Entire Tooth Meshing Tests

Received: 20 June 2018; Accepted: 24 August 2018; Published: 4 September 2018

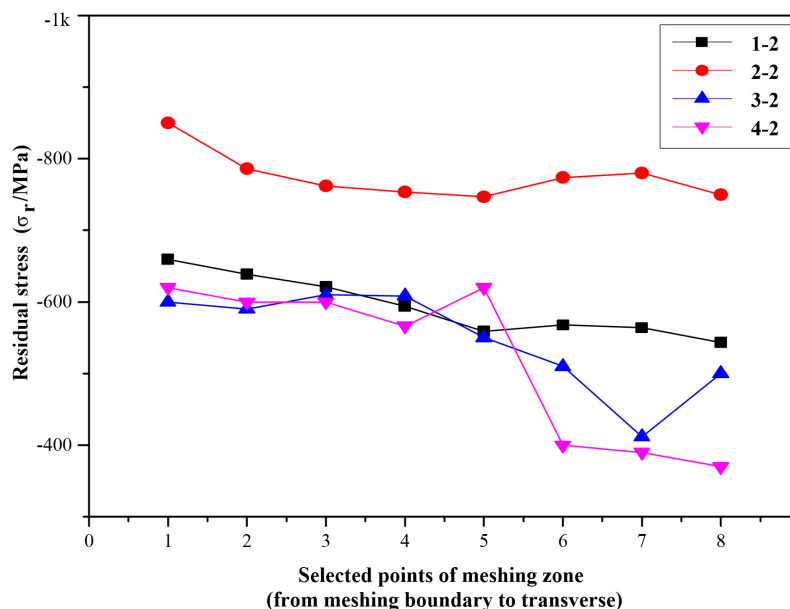
Figure 14. Variation in compressive residual stress along gear pitch circle H5.

For the pitch circle H5 of gear 1-2, residual stress varied between  $-640$  and  $-540$  MPa. This indicated that although carburization enabled the tooth flank to obtain better contact strength, the tooth flank still had a large residual compressive stress value because there was no grinding process after carburization. For  $1.0 \times 10^6$  cycles, the residual stresses in pitch circle H5 of gear 2-2 were higher than those of gear 1-2 but the two distributions showed the same trend. The residual compressive stress value gradually decreased along the direction from the meshing boundary to the transverse profile. Because the contact stress value of the pitch circle near the transverse was large, the smaller residual compressive stress could avoid contact fatigue failure in the early period of cyclic loading. For  $3.3 \times 10^6$  cycles, diffuse pitting occurred near the pitch circle H5 of gear 3-2 (Figure 10b), thus relaxing the residual compressive stress that dropped between  $-610$  and  $-490$  MPa. For  $5.0 \times 10^6$  cycles, a spalling near the 4-2 gear transverse was observed (Figure 12b), covering about half the pitch circle in the meshing zone. Reduction in the contact area caused residual stress to increase significantly. It appears that residual compressive stress accumulated as loading cycles progressed below the design life. Residual stress relaxed as soon as micro-cracks and pitting occurred and developed in the flank and near-flank regions. Beyond fatigue life, the pitch circle near the transverse deformed plastically. Severe tooth flank spalling yielded higher residual compressive stress in the pitch circle of the tooth flank.

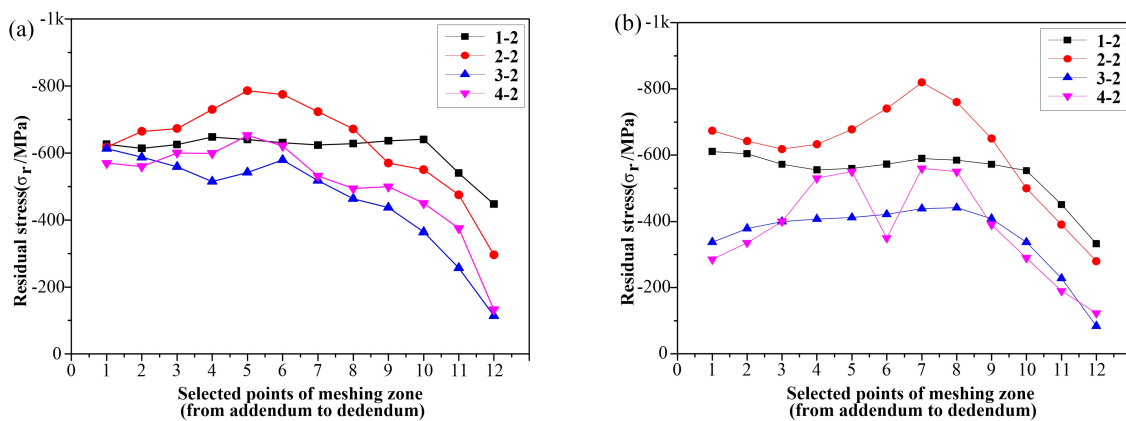
**Figure 15.** Residual stress distributions curve in the direction from the addendum to dedendum: (a) line V2, and (b) line V7: control points are at the intersections between lines H1–H12 and V2, V7. For example, point 3 in (a) is point (V2, H3) in the tooth flank.

The residual compressive stress of line V2 showed a convex distribution with higher values in the central part (Figure 15a). The residual compressive stress value at points 4–6 near the pitch circle was the highest, and it gradually decreased to the lowest at points 11–12 near the dedendum. Similar distributions were obtained for line V7 (Figure 15b). Comparing Figure 15b with Figure 15a, the maximum residual compressive stress transferred to points 6–8, the lower side of the pitch circle. This indicated that the meshing line experienced the maximum contact stress, which led to the most obvious accumulative cycle of the residual compressive stress.
