Use of TLS (LiDAR) for Building Diagnostics with the Example of a Historic Building in Karlino

Abstract: This article presents the use of TLS (LiDAR) measurement for the evaluation of the technical conditions of a historic building. A FARO M70 laser scanner was used in the study. The measurements was taken as an RCP point cloud. The measurement allowed to partially determine the cause of the building damage. The performed measurement allows to propose a precise solution that could be pre-fabricated. The study shows the usefulness of TLS in building diagnostics. Improper measurement could lead to a wrong solution and a certain degree of uncertainty.

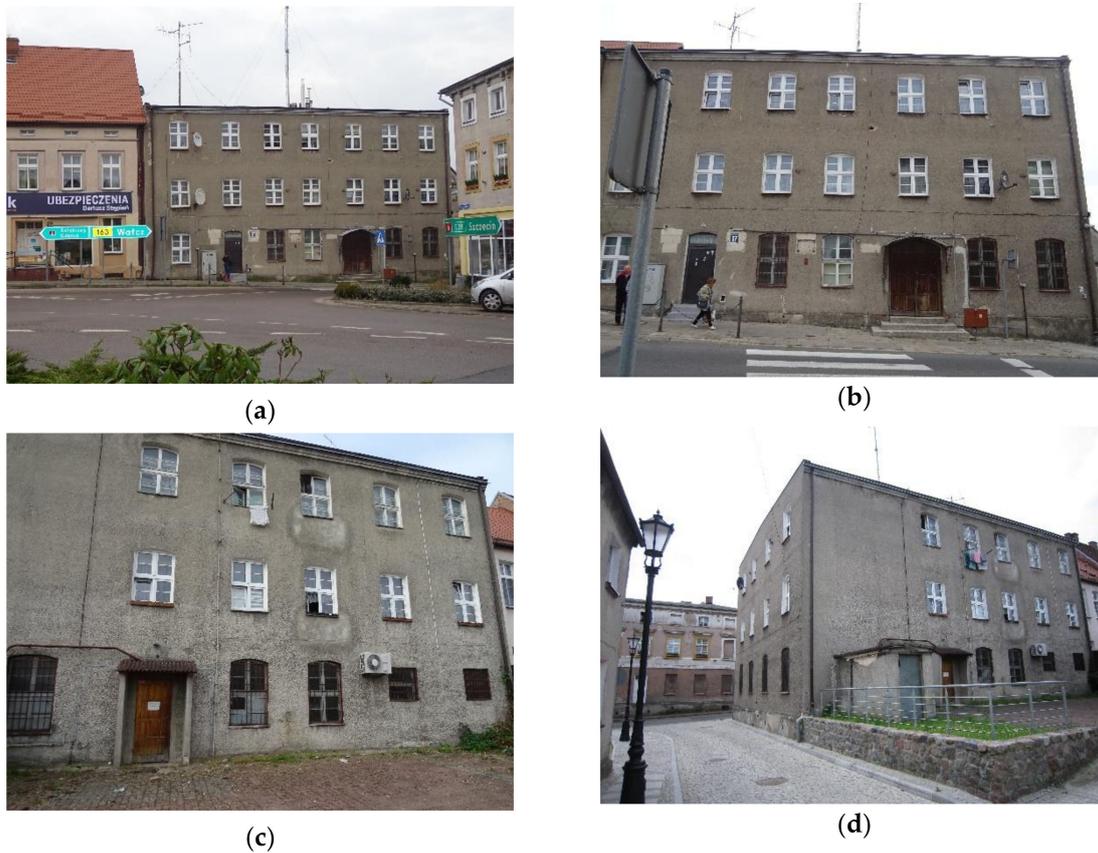
The object of research was a building with a simple cubical shape, with three storeys and a partial basement (Figure 1). The second and third storeys are occupied by residential dwellings. The ground floor is currently not in use; previously, it was used as a public utility, e.g., a police station. The owner of the building (Karlino Commune) plans to rebuild the ground floor and adapt it as a kindergarten.

Figure 1. View of the building: (a) front; (b) front; (c) back; (d) side.

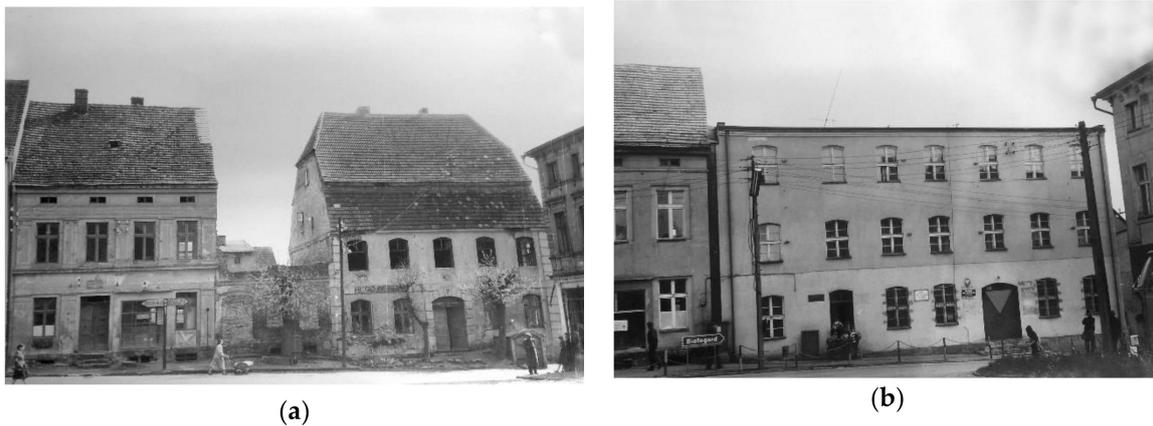
The studied building has been rebuilt several times. The history of the building dates back to the beginning of the 19th century. Only the cellars and foundations have survived to this day. The current area of the building was originally occupied by two tenement houses. Figure 2a shows the condition of the buildings from the period after World War II, with its original division of the space. Figure 2b shows the reconstructed design, which has been preserved to this day. The reconstruction of the building was carried out on the old foundations of both houses. Both foundations of the previously existing tenement houses were on two different levels. The accepted solution was wrong. The difference in the foundation levels in both parts of the building can cause uneven settlement. A better solution would be a complete demolition, including foundation and a whole-scale reconstruction. Alternatively, one could consider improving the foundation of a smaller tenement house (connecting building).

The initial inspection of the building showed only a single vertical crack on the facade (Figure 3). The cause of the crack was, at that time, unknown. Further investigation of the archival photographs (Figure 2) allowed to determine the reasons. The crack was located at the point where the two original tenement houses were connected. The crack in the building was visible from both the courtyard and the front elevation. It can be assumed that the building spontaneously split itself at the location of foundations difference. Apart from the crack, no other significant signs of structural damages were visible on the outside. The structure of the building was not designed to withstand such dilatation.

Figure 2. Archival photos: (a) before the reconstruction; (b) after the reconstruction.

Incorrectly made connection of building walls (vertical cracks visible from the outside) should be repaired by rebuilding the walls and adding reinforcement $\phi 8$ BSt500S L = 2 m in every second joint. The dimensions of bars should be determined with regard to existing wall fragment.

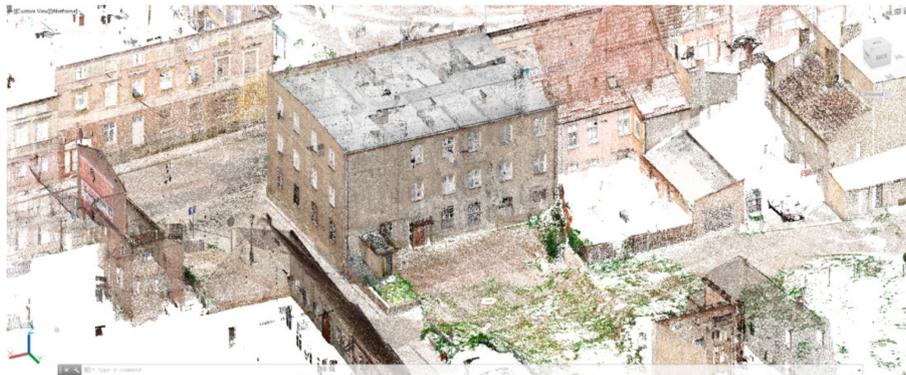
The measurements were made for the whole external body of the building and the geometry of the internal floors with basements (Figures 8 and 9). As a result of the measurements, complete three-dimensional geometrical data of the object were obtained, which allowed to carry out a detailed analysis of its technical condition. External measurements were made in the full-colour spectrum while interior was scanned in monochrome. Colour measurement requires additional measurement with photographs in order to superimpose colour textures on the resulting point clouds, which extends the measurement process.

Figure 8. Outside view of the building made using TLS in Autocad 2015—axonometry.

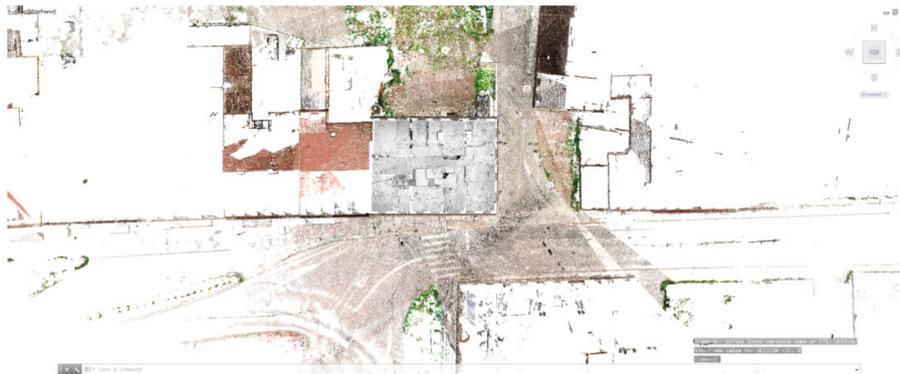
Figure 9. Outside view of the building made using TLS in Autocad 2015—aerial view.
