# Assessment and Rehabilitation of Culturally Protected Prince Rudolf Infantry Barracks in Zagreb after Major Earthquake

This paper presents the procedure of a detailed inspection of a building under cultural heritage protection. The case study building was damaged in the earthquake and needs to be renovated according to new laws in Croatia to ensure the safe and functional future use of the building.

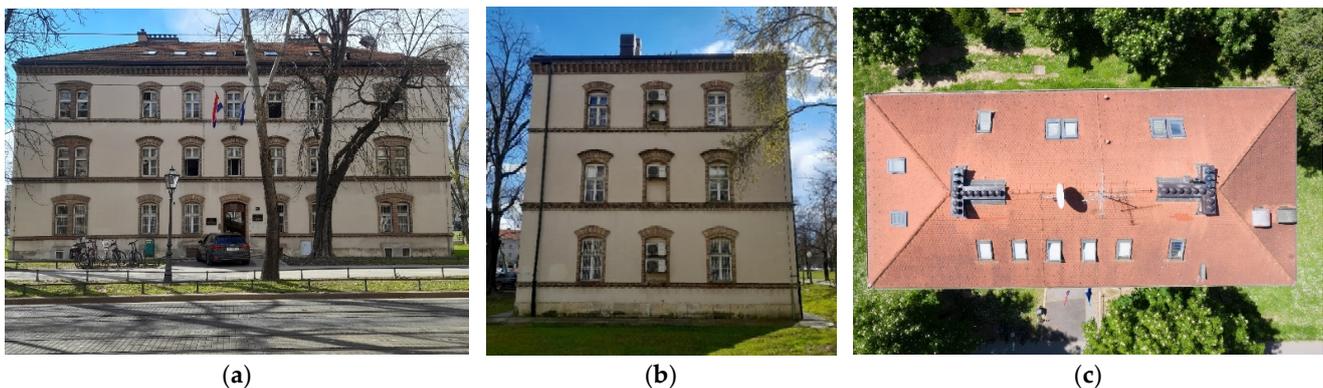
**Figure 5.** (a) View of the east façade; (b) View of the north façade; (c) View of the roof (photo credit: Mislav Stepinac).

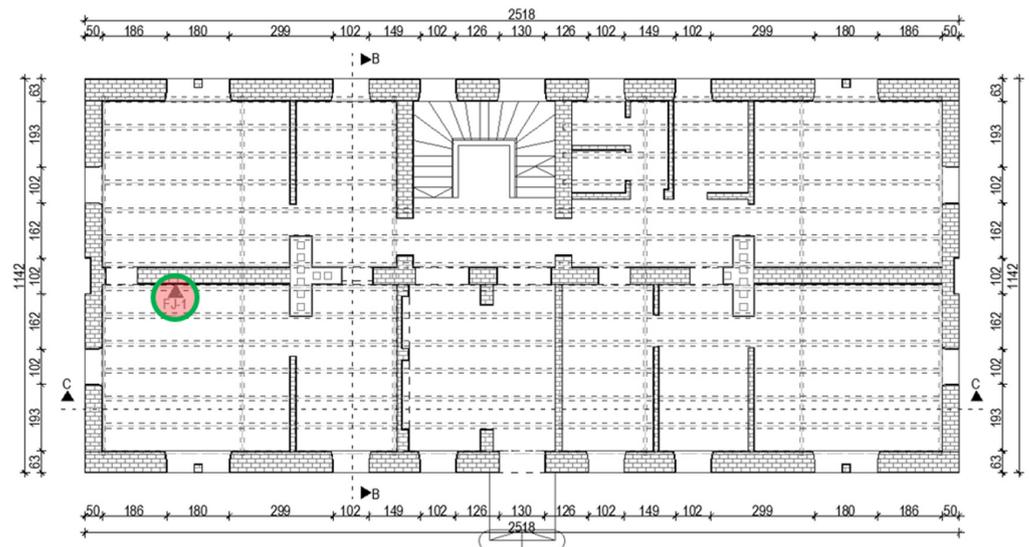
The flat-jack method determined the vertical stress, the modulus of elasticity and the masonry's shear strength. The test was conducted on the ground and first floors on the same wall (Figure 9).

**Figure 9.** Ground floor plan with a marked test site.

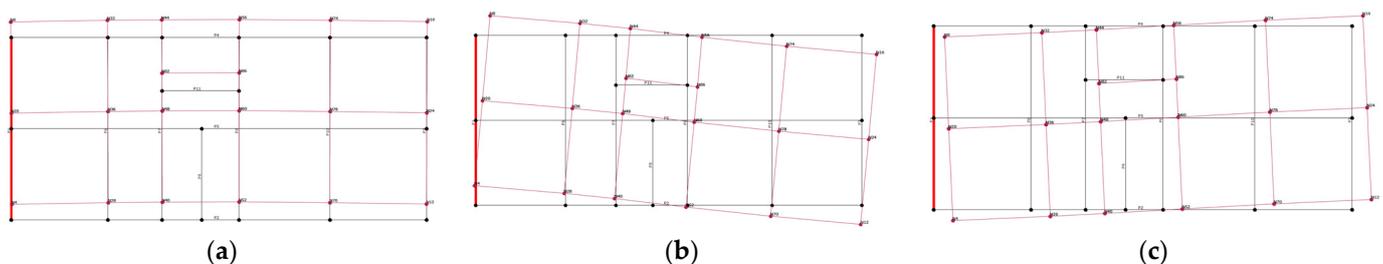
The 3Muri software has a module for conducting modal analysis. This module offers the calculation of all possible mode shapes. In this paper, 10 mode shapes are considered, and 3 are shown in Figure 14 and in Table 4. The first and third modes are predominantly translational, while in the second mode, slight torsion occurs.

Figure 14. (a) First mode; (b) second mode; (c) third mode.

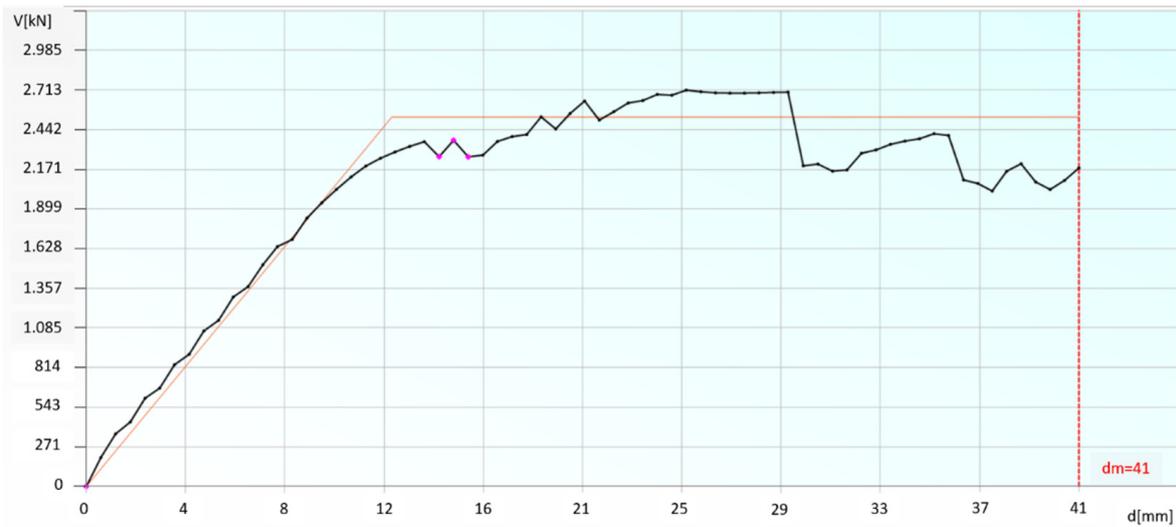
**Figure 16.** Capacity curve (black) and its bilinear idealization (orange) for  $x$ -direction.

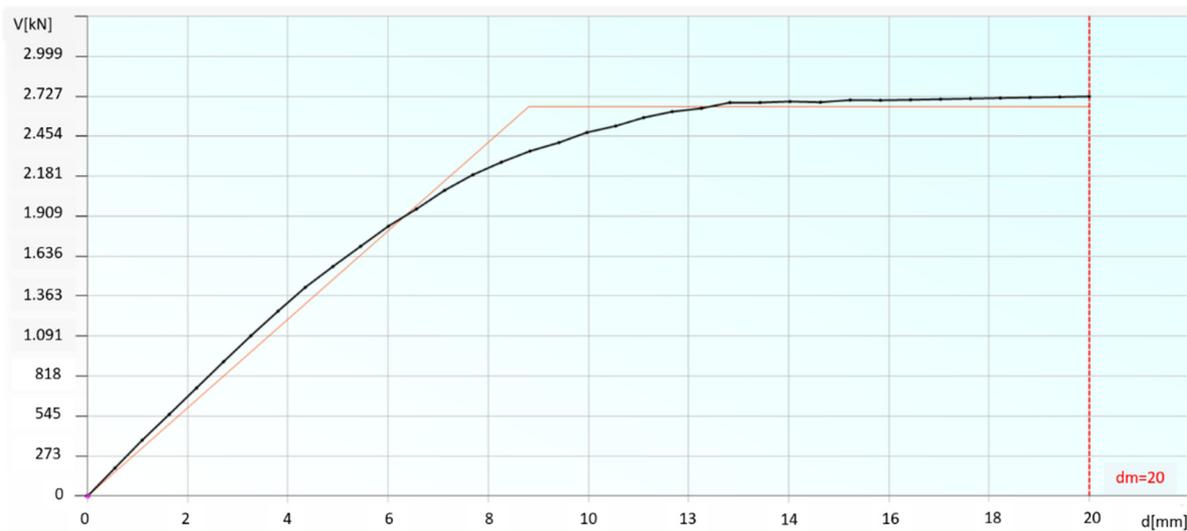
**Figure 17.** Capacity curve (black) and its bilinear idealization (orange) for  $y$ -direction.
