# Post-Earthquake Assessment and Strengthening of a Cultural-Heritage Residential Masonry Building after the 2020 Zagreb Earthquake

**Citation:** Ademović, N.; Toholj, M.; Radonić, D.; Casarin, F.; Komesar, S.; Ugarković, K. Post-Earthquake Assessment and Strengthening of a Cultural-Heritage Residential Masonry Building after the 2020 Zagreb Earthquake. *Buildings* **2022**, *12*, 2024. <https://doi.org/10.3390/buildings12112024>

### 3. Case Study-Building in the Street Ribnjak

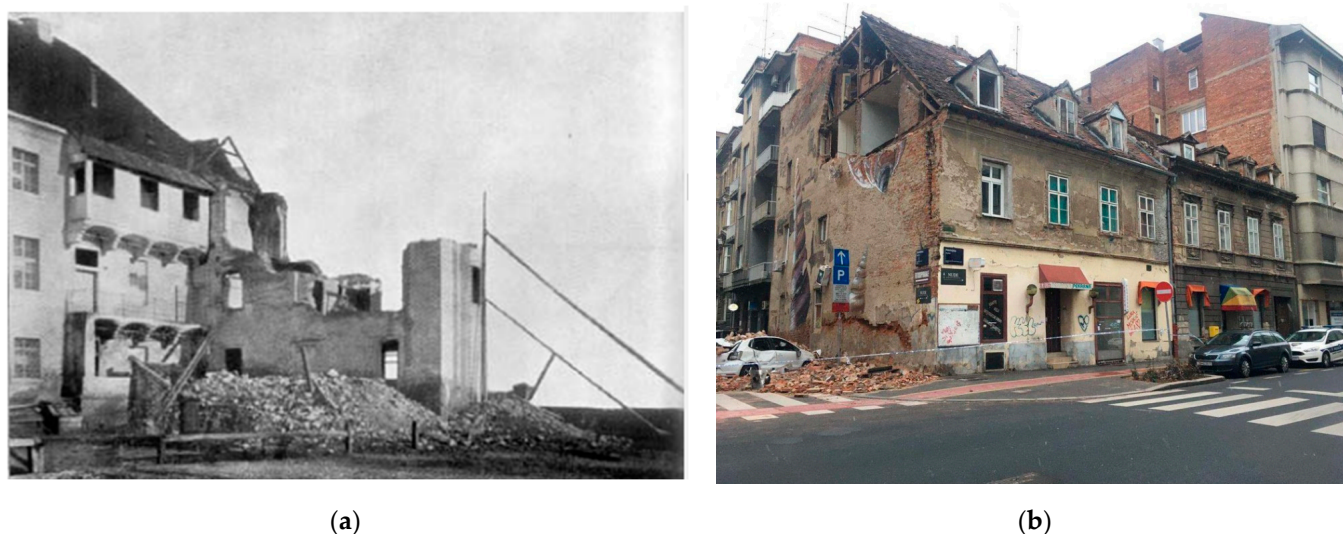
estimated magnitude ( $M_L = 6.3$ ) [3], according to macroseismic observations, which had caused tremendous damage. In the building's assessment report, it was stated that 1758 residential buildings were damaged and out of that 27.6% were heavily damaged (Figure 1a). Numerous buildings of various usage (residential buildings, public buildings, medical facilities, historical monuments, etc.) were damaged by the 2020 Zagreb earthquake, having different levels of damage from minor damage to severe damage, and even partial collapse of buildings (Figure 1b). The most affected area was in the vicinity of the epicenter, the Lower Town of the city of Zagreb, constituted of cultural heritage buildings. Additionally, buildings constructed in the late 19th and 20th centuries, mainly unreinforced masonry structures were damaged to a great extent. It is estimated that up to 25,000 buildings were affected by this earthquake. Luckily, not many human fatalities were registered (one human life was lost) and this can be connected to the COVID-19 restrictions at that time.

**Figure 1.** Building devastation after: (a) 1880 Zagreb earthquake [4] Reproduced with permission from Zagreb City Museum, 2022.; (b) 2020 Zagreb earthquake (author's figures).

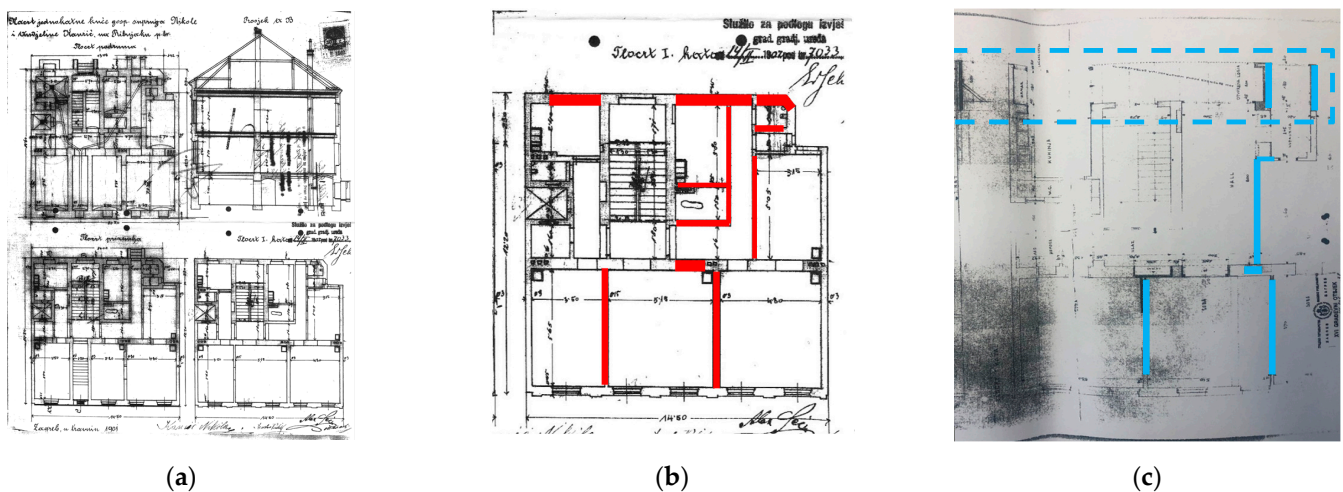
First of all, it was necessary to obtain the archive drawings from the State Archives in Zagreb (Figure 4a–c). As can be seen from the drawings, the design was created in 1901. Since its construction, the building has undergone several reconstructions and upgrades. The first one was conducted in 1937 when several walls were demolished and a new lodge in the courtyard was constructed (Figure 4b,c). Demolition of the façade load-bearing walls looking at the courtyard additionally decreased the loadbearing capacity of the structure in the X direction. To make a wider open space, the construction of the new walls did not follow the position of the existing walls on the ground floor causing the change in load transfer. The reconstruction of the apartments was not synchronized causing a change in the global behavior of the structure. In 1998, several reconstructions were conducted on the first floor, while in 2015, in the apartments, several steel girders have been constructed. The demolition of the longitudinal walls, as will be proved later on by the calculations, caused a lot of difficulties in the reconstruction process. A new lodge was constructed (see Figures 4c and 5b) founded on new steel columns. The constructed lodge is not adequately connected to the existing structure, the steel columns do not have adequate foundations, and this additionally modified the behavior of the structure.

**Figure 4.** Investigated buildings Ribnjak 44: (a) original drawings from the State Archives in Zagreb; (b) reconstruction-demolished walls shown in red color State Archives in Zagreb; (c) construction of new walls and a lodge [32]. Reproduced with permission from State Archives in Zagreb, 2022.

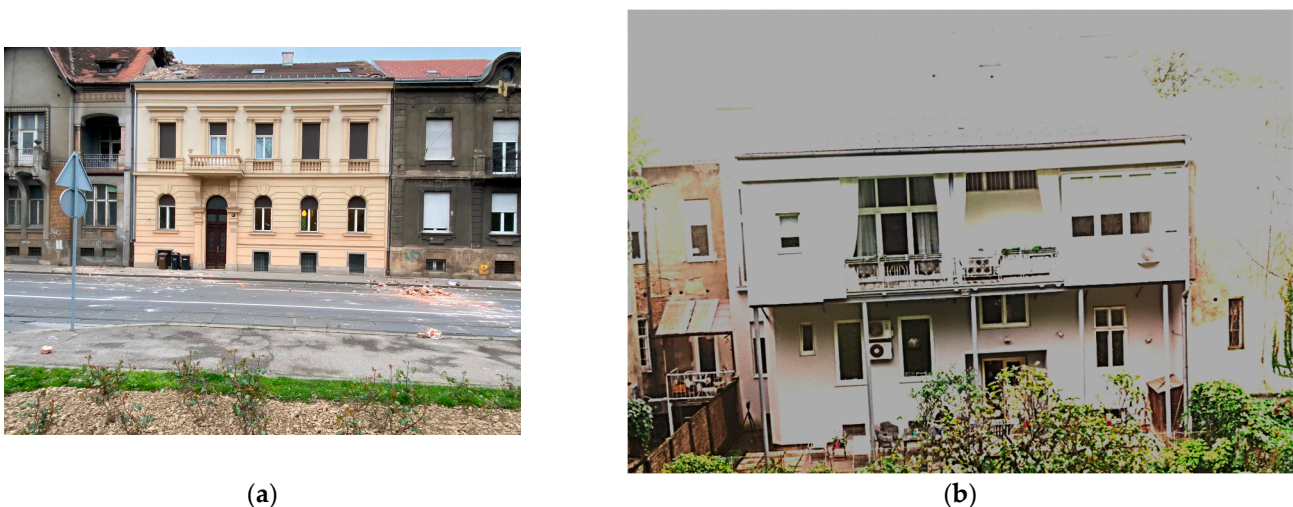
**Figure 5.** Investigated buildings Ribnjak 44: (a) street view (building in the middle); (b) courtyard view [32]. Reproduced with permission from Projekt na kvadrat d.o.o., 2022.

The present state of the unreinforced masonry (URM) buildings is presented in Figure 5a,b. It is a row building (the yellow one) located between two buildings of the same height (on the north and the south side). The building has a regular shape with dimensions  $14.5 \times 17.20$  m in plan, the floor plan of the building is  $217 \text{ m}^2$ , and the gross construction area is equal to  $799.07 \text{ m}^2$ . The structure consists of a basement, two storeys (ground floor and first floor), and an attic.

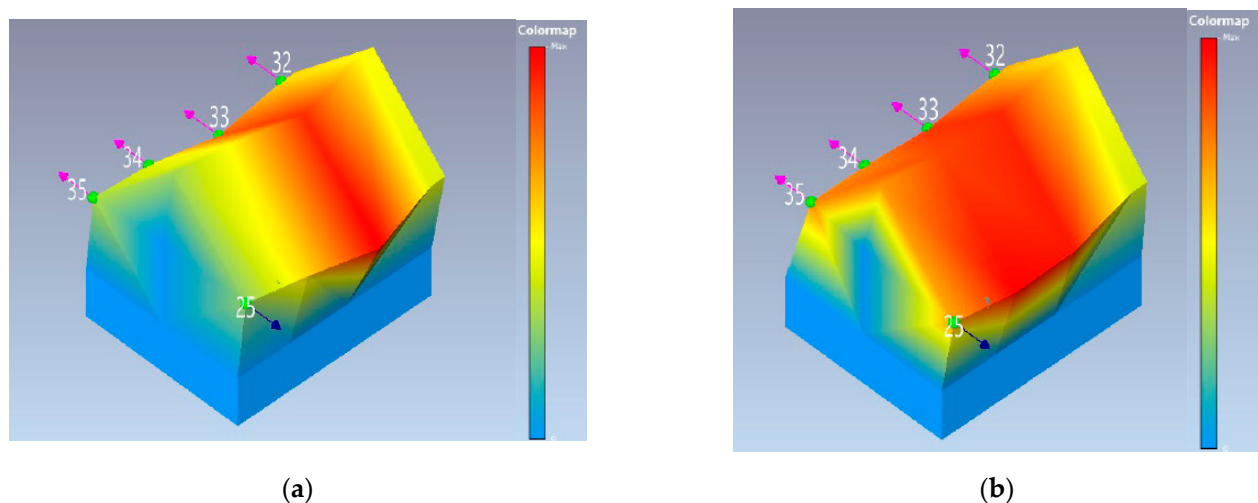
The first two modes were out-of-plane modes, the first one in bending and the second one translational (Figure 10a,b) both in the Y direction.

**Figure 10.** (a) 1st mode; (b) 2nd mode.

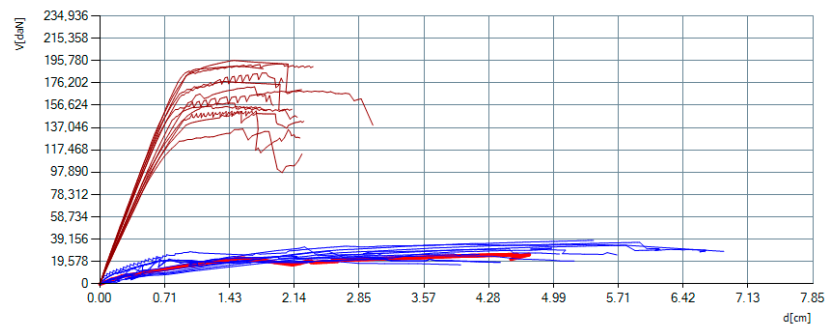
As a result, capacity curves are obtained for all the cases as presented in Figure 13. The structure has rather inferior resistance in the X direction, the appearance of the first crack was observed already at 95.70 kN, while the maximum reached load was 204.17 kN. The structure has rather superior resistance in the Y direction, with the first crack occurring at the force 13.30 times larger, and the maximum load reached was equal to 1468.35 kN, being 7.19 times larger than in the X direction. This can be connected to a large number of openings and a much lower percentage of load-bearing walls in the X direction.

**Figure 13.** Capacity curves in X and Y directions.

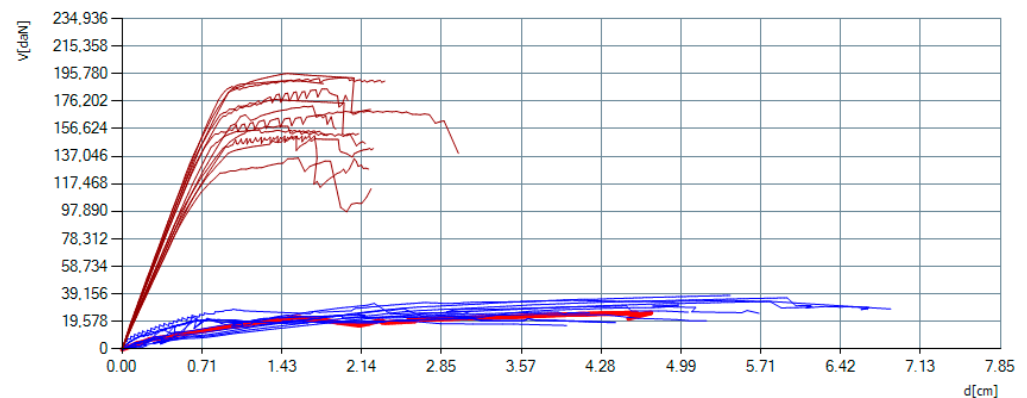
The capacity curves in the X and Y directions of the strengthened existing URM structure are presented in Figure 21. The first crack is noted at the value of 1152 kN in the X direction while the ultimate load reached 1345 kN. In the Y direction, the structure has a much larger capacity, and the occurrence of the first crack is noted at 2423 kN and the ultimate load reached 2549 kN.

Figure 21. Capacity curves in the X and Y directions of the strengthened structure.

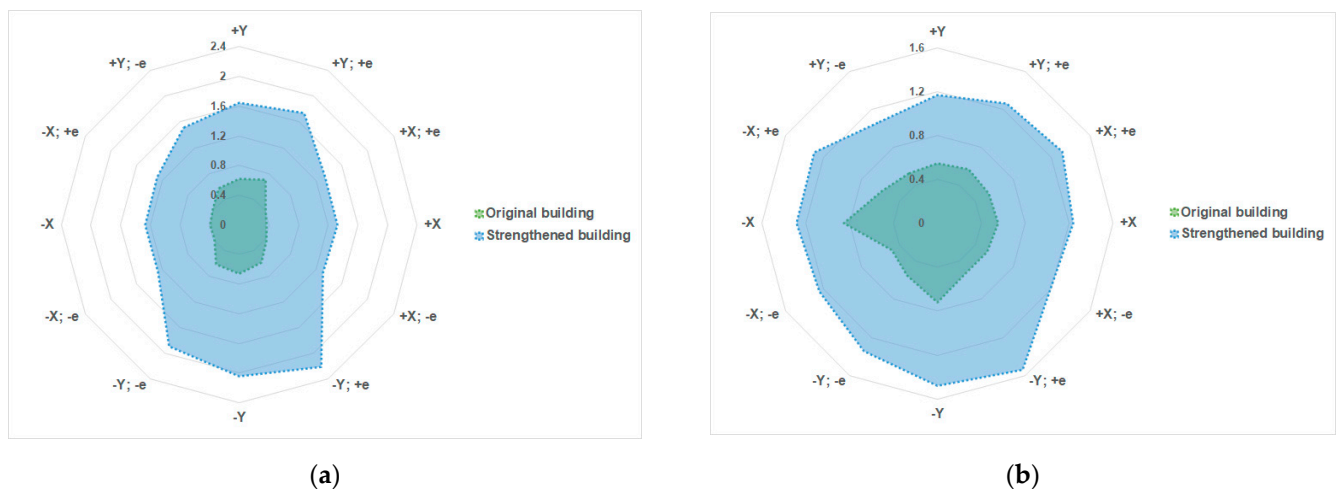
at a load that is 12.04 times larger than for the unstrengthened structure. The increase in initial stiffness in the X direction was 6.4 times, while in the Y direction it was 1.4 times. Additionally, the ultimate reached load in the X direction is more than 6.5 times larger compared to the unstrengthened structure. The ultimate load reached in the Y direction increased by 75% in relation to the unstrengthened structure. It is important to state that the global eigenmodes did not change significantly and this is beneficial, as there should not be a major difference in this aspect. It was observed that now the mode shape in the X direction is translational, while in the unstrengthened structure there were unequal movements of the nodes. In this way, better structural behavior was obtained. The strengthened structure passed all the seismic verification. The value of  $\alpha$  was greater than 1 for all the conducted analyses and limit states. The effect of the strengthening is shown in Figure 22 for the two load distribution patterns.

**Figure 22.** Comparison of  $\alpha$  values for the original building and strengthened building for (a) uniform load distribution; (b) modal load distribution.
