Earth to Earth: Patterns of Environmental Decay Affecting Modern *Pisé* Walls

Dirk H. R. Spennemann

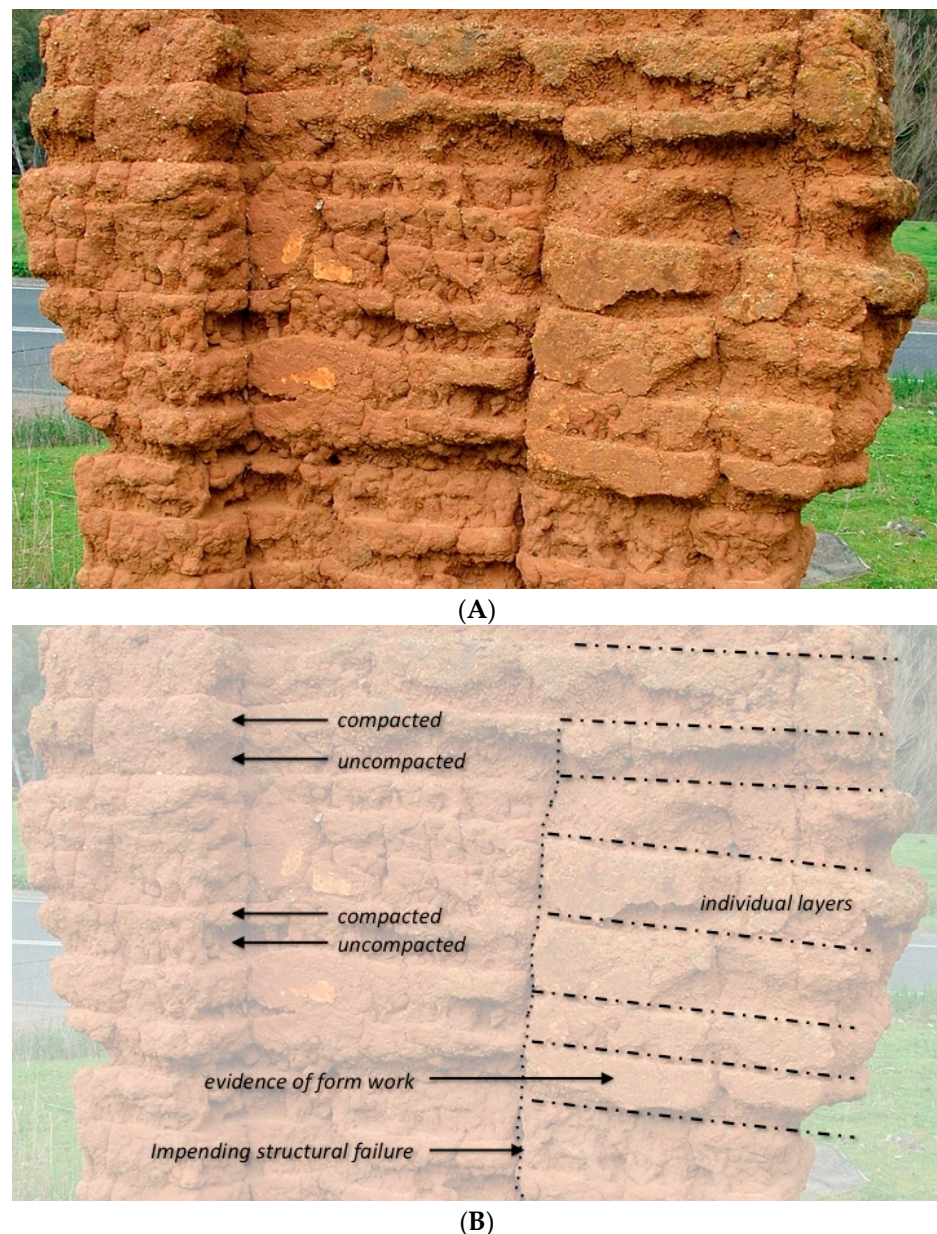
Figure 1. Influences of construction technique and quality of work on the preservation of *pisé* walls of a nineteenth-century ruin at Jugiong (NSW). (A) Photograph of a section of the northern face of the now collapsed southeastern wall block, as seen on 30 September 2005. The layers of fill and compaction are well evident. (B) Annotated interpretation of the image. Reprinted from Ref. [9].

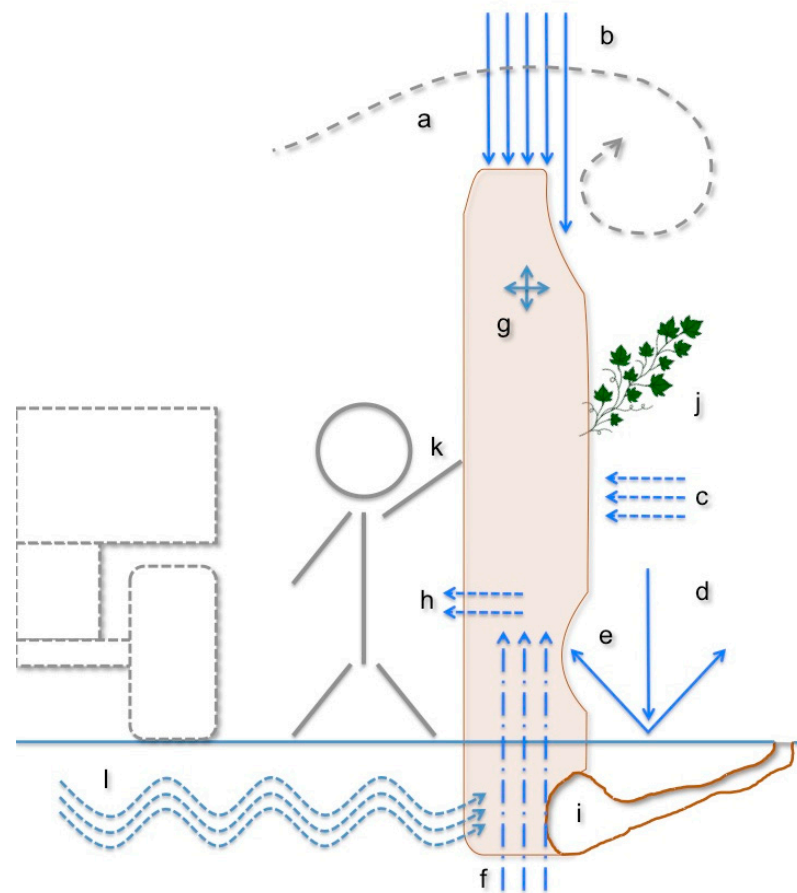
Given the unconsolidated, compressed nature of *pisé* walls, damage to or loss of a roof allows rainfall to enter the unprotected top ends (‘falling damp’, Figure 3b). Prolonged wetness will accelerate the severity of the decay, depending on the intensity of the rainfall, as well as the pre-existing moisture content of the walling at the time of precipitation.

Figure 3. Schematic representation of the decay processes observed in *pisé* buildings after the roof has been removed/collapsed (see text for explanation). Reprinted from Ref. [9].

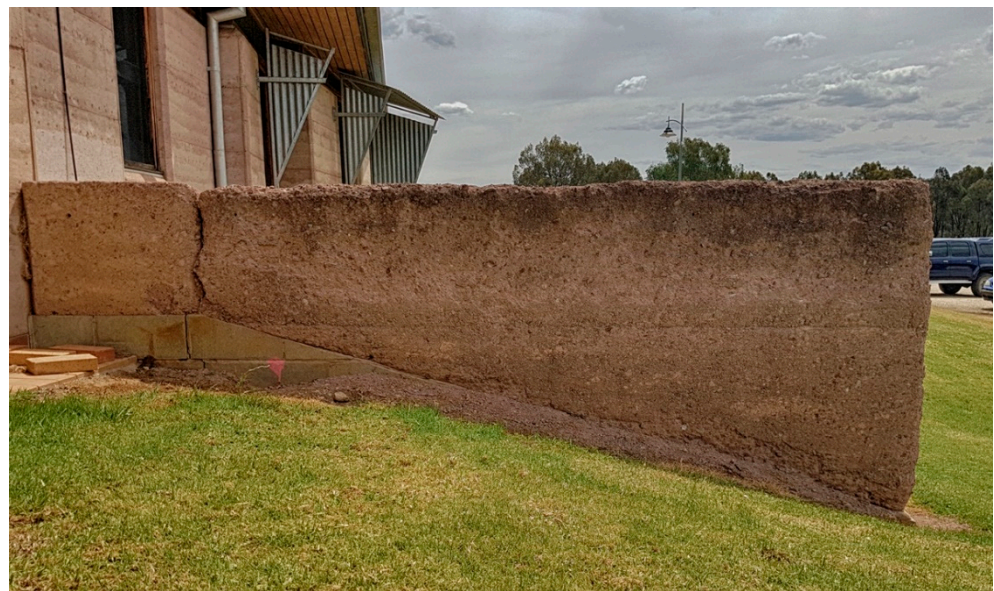
Figure 9. Wall 1 seen from the east.

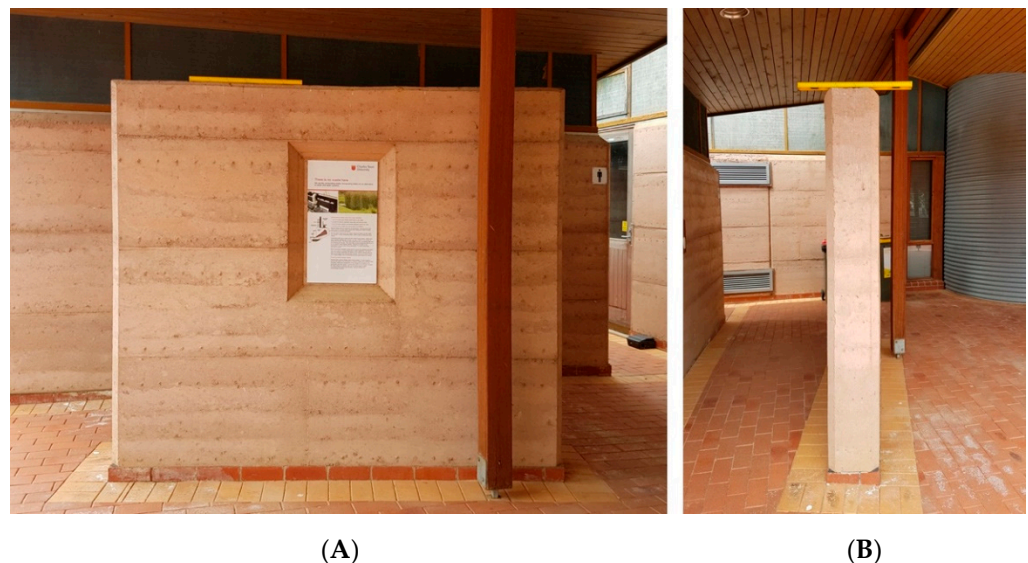
Figure 11. Uncapped, protected wall C1, screening the entrance to the external toilets of building 762: (A) frontal view seen from the south; (B) sideways view seen from the west.

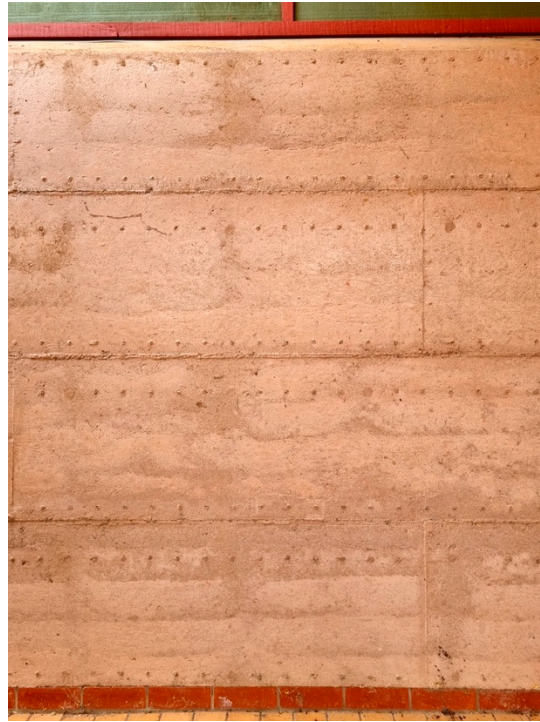
Figure 12. Section of an external wall covered by a large overhanging roof. Note the details of the recessed bolts holding the form boards as well as the sections of form boards (Bldg 762).
