# On-Site Risk Assessment Methodology of Historic Timber Structures: The Case Study of Santa Cruz Church

To carry out this study, we have taken advantage of the course of repair work on the roofs of the Santa Cruz Parish Church in Ecija, a town in Andalusia (Spain) (location (WGS84): 37.543, −5.080).

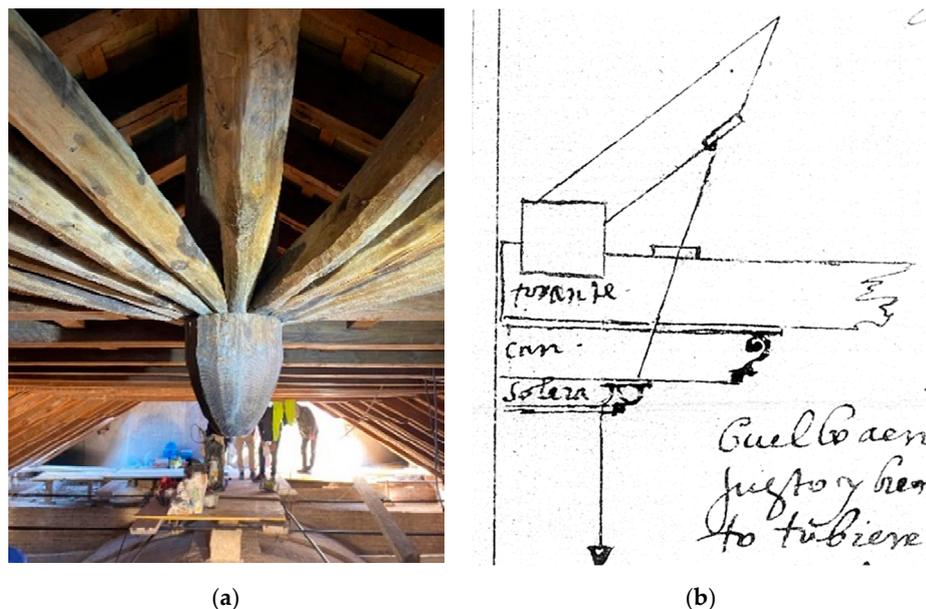
**Figure 1.** (a) Joint of traditional timber frame carpentry, located in the case of study; (b) details of the joint between the rafter, wall plate, tie beam, and the wall, according to the medieval manual. It is designed to avoid contact between the wall and wall plate [7].

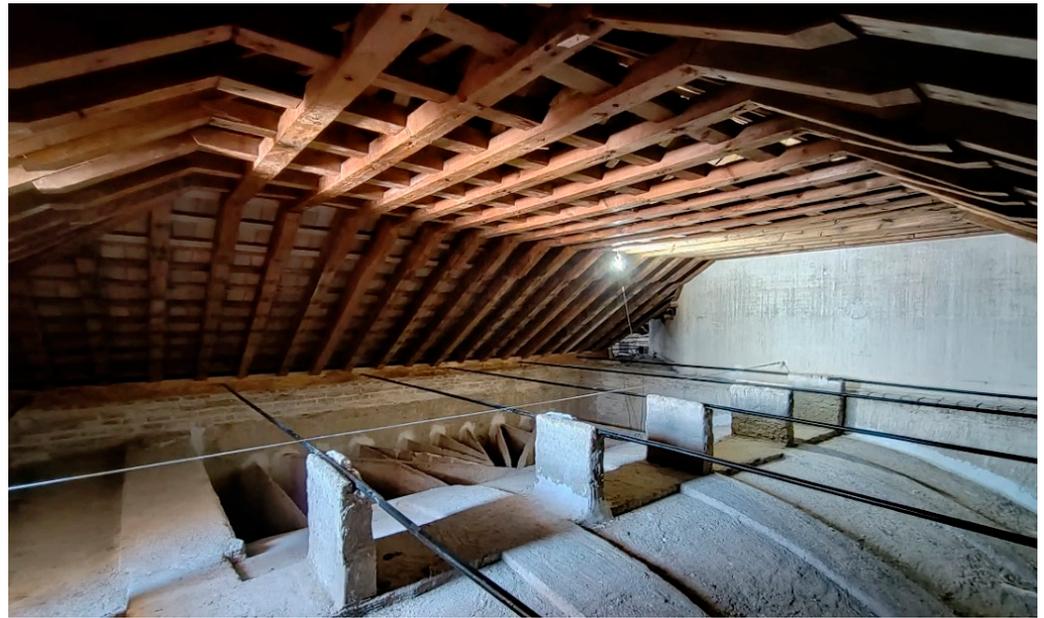
There are different ways to solve the joint between the rafters and the wall plate and the support of these on the wall. The literature [19,62] shows us how medieval builders made details of this joint because it is one of the critical points of these structures. In this, it has been solved with a wall plate that rests directly on a square made on the upper face of the stone wall that discharges the rafters on the wall plates. This constructive solution, although it is very simple to build, entails a problem, which is that the wall plate is set with two hidden faces. These faces are recessed against the wall and are neither visible nor ventilated, which, as seen below, hinders their inspection, maintenance, and also contributes to the appearance of humidity.

**Figure 7.** Timber frame structure under the roof and over the suspended brick vault.

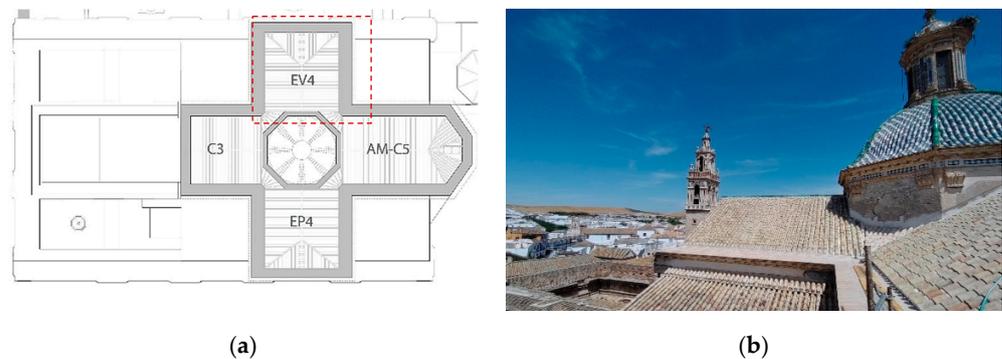
The repair works carried out in the Church of Santa Cruz addressed the intervention in four roof sectors (EV4, C5-AM, EP4, and C3) (see Figure 8a,b). EP4 was the first to be restored because it was severely damaged and at risk of collapse. The other sectors underwent tasks of conservation, repair, and replacement with the intention of avoiding future problems arising from the deterioration of the structural elements.

**Figure 8.** (a) Diagrams of roof sectors: EV4 (in red) is the structure under study; (b) view of the roof sectors; EP4 on the right and C3 in the centre.

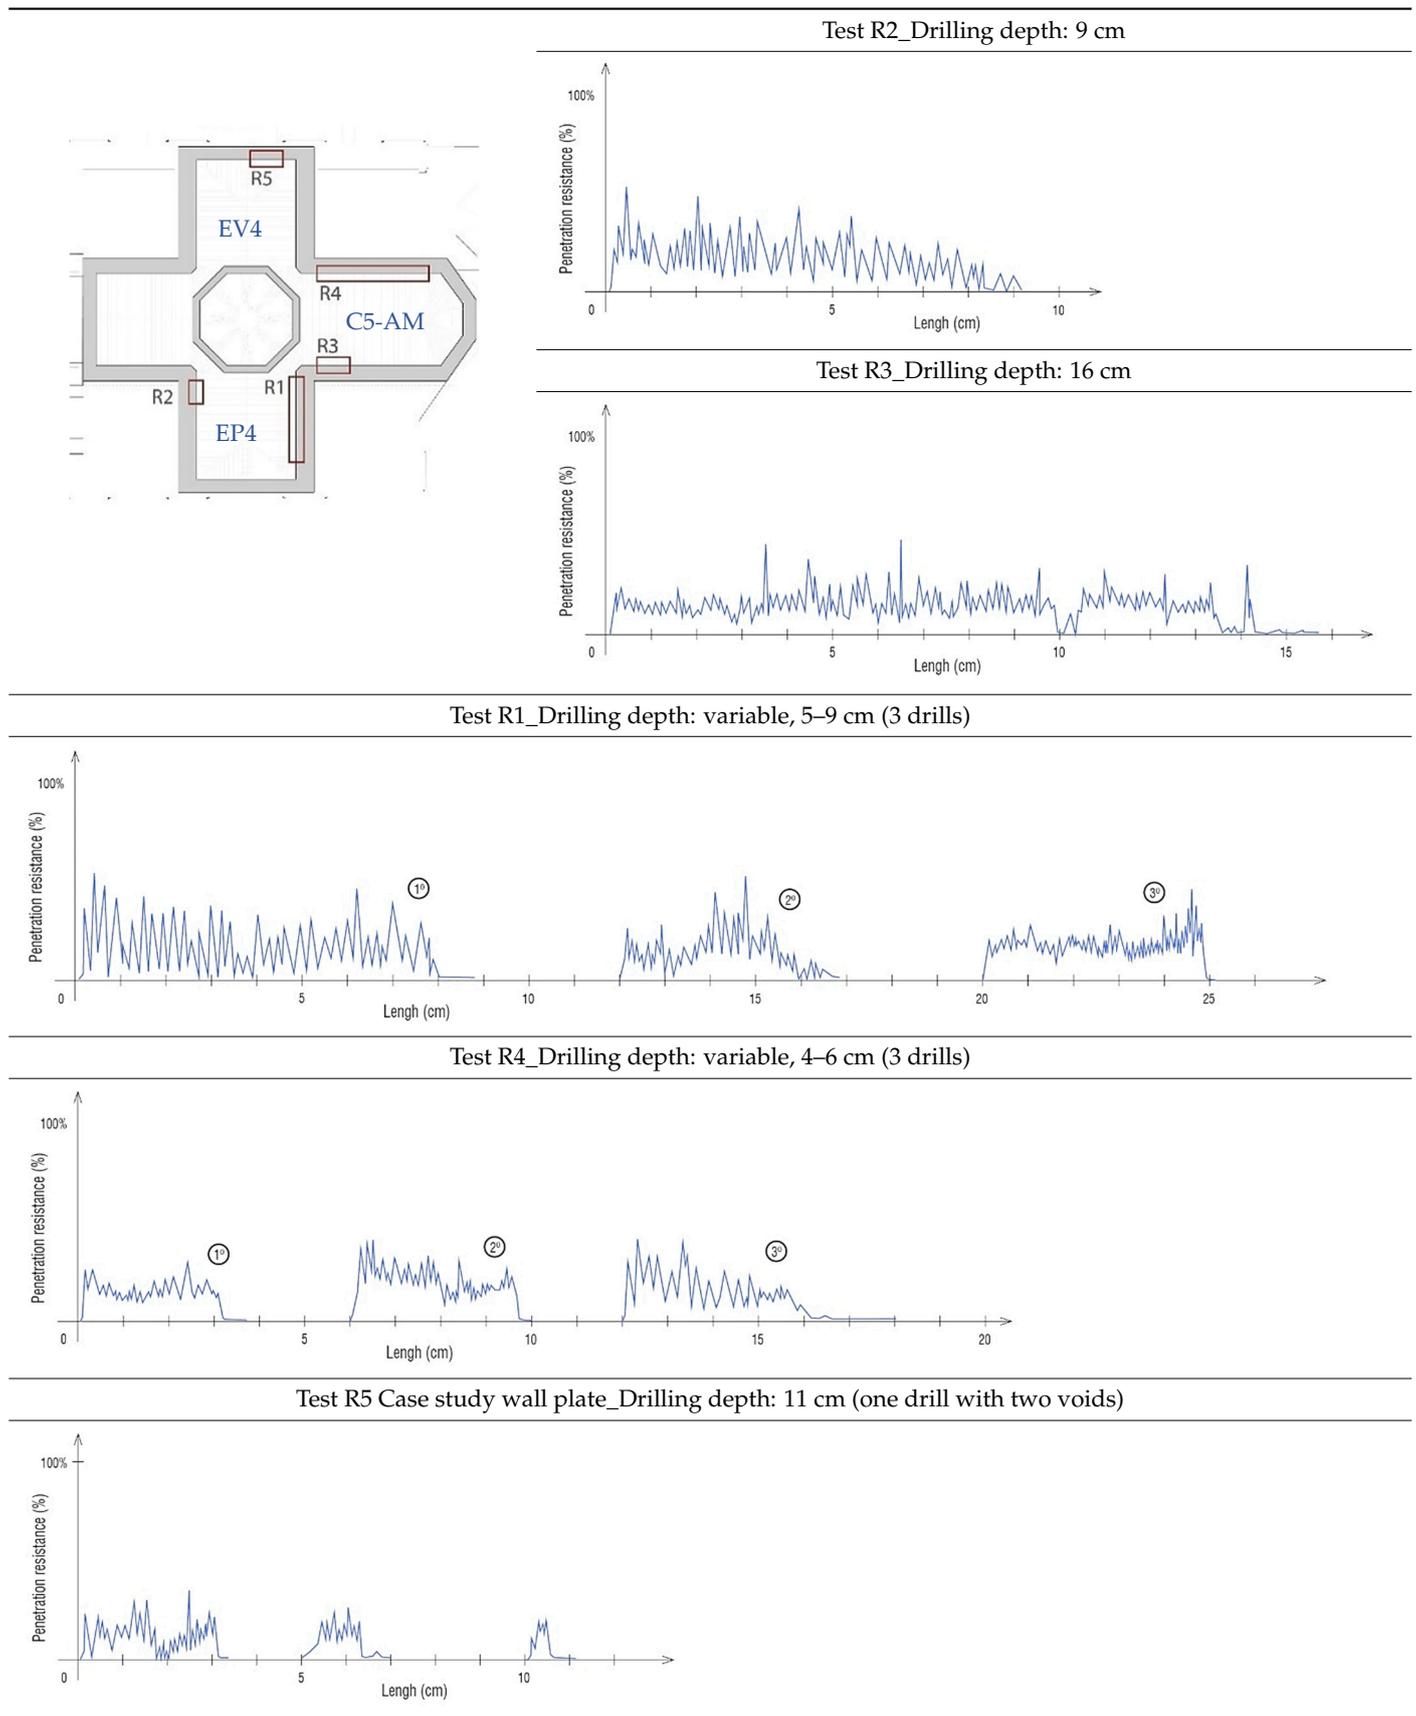
**Table 3.** Location and results of resistography tests.

Resistography perforations were made on some points on the wall plates that can be seen in Table 3. These were selected for presenting visible deformations, humidity, rot, or as potential points of structural stress concentration. Moreover, these pieces had only two visible faces. The results of the tests are in Table 3, and the graph shows the engine consume in percentage and the progression in cm. In all tests carried out, it was found that once the drill was introduced, the timber lost resistance to a depth of between 3 and 14 cm. This evidences the resistant loss of the analysed areas section. Although in most cases they had geometric integrity on the outside, the interior was found with severe alterations (rot or attacks by xylophagous agents attacks).

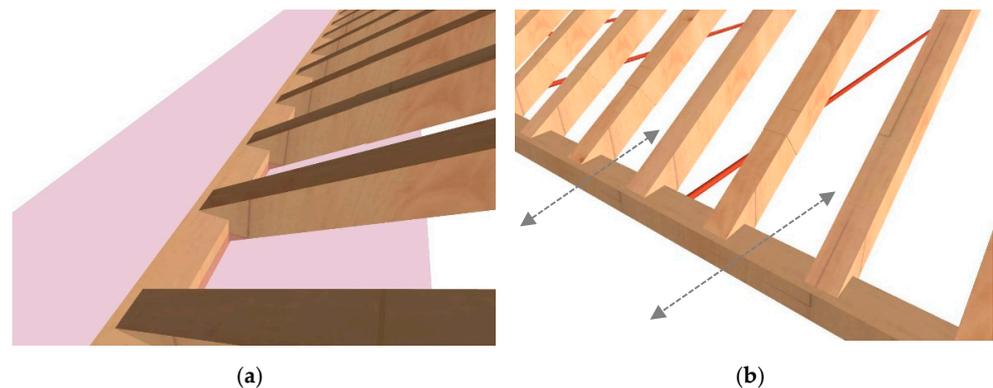
- Hypothesis 2: (Figure 20b) In order to reproduce the structural behaviour, if wall plates sections deformations occur, the structure has been modelled without the external link of the wall. This had previously been already observed in other sectors produced by the rotting of the pieces. Therefore, to this end, the supports of the wall plates have

been configured as supported external links, but with only one degree of freedom of movement in the rafter beam direction. In this manner, if there are resulting efforts from lateral thrust, it implies the wall plate's rigidity and the tie beams coercing the movements. Therefore, the tie beams were responsible for withstand those thrusts, as if there were no walls. This allows the study of wall plates displacement behaviours, a critical piece of this structure, if the internal rot leads to deform it to the point that its inner face moves as if it were not linked to the wall.

**Figure 20.** Different hypotheses modelled: (a) hypothesis 1 with the massive wall link; (b) hypothesis 2, with freedom of movement.
