Mind-Mapping Assessment of Reuse Potential of Glulam: An Experimental Study

Abstract: The goal of this work is to suggest a method for assessing the state of salvaged glued laminated timber and deciding whether it is appropriate for reuse. After conducting a thorough analysis of the wood pathology, a decision tree mind map was created. This was followed by the application of this methodology to evaluate a salvaged glulam frame obtained from a demolition site. To ensure the reliability of this approach, laboratory-based ex situ tests were carried out. A working protocol was established for obtaining a sample of the salvaged timber, and its characteristics were identified by examining the species, density, type of adhesive and its shear resistance, as well as the mechanical properties in the bending of both single and double laminates of timber. The results concluded that the glulam under investigation can be reused. The results revealed that the wood was spruce, with a density of $420 \pm 45 \text{ kg/m}^3$ under dry conditions. The glue used was melamine-urea-formaldehyde with a shear strength of $7.37 \pm 1.79 \text{ MPa}$, which is below the standard threshold. The results of th

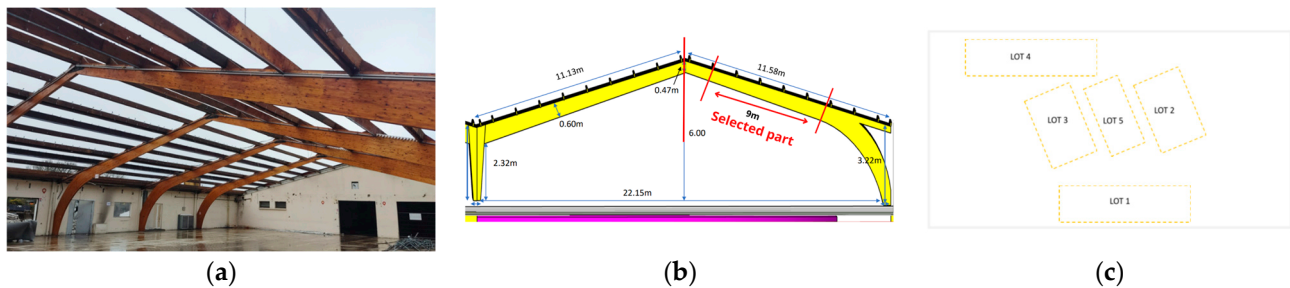
A case study was conducted to apply the developed assessment mind map methodology. To do so, a visit was arranged to an old textile factory (Figure 8a) in Montaigu-Vendée, a western French commune, to assess the condition of its glulam beams. The factory comprises two symmetric frames, with each frame consisting of an outer curved beam and two connected beams on the interior (see Figure 8a,b). The beams had varying cross-sectional profiles, ranging from 34 lamellae in the largest section to 13 lamellae in the smallest (Figure 8a), and the lamellae were 2 cm thick and 10 cm wide. The selected part for testing is shown in Figure 8b. For the record, the construction year was estimated to 1984, according to the supplied archive plans. At the time of the visit, the beams had already been deposited and therefore were numbered according to their arrangement in the yard, as shown in Figure 8c.

Figure 8. (a) Glued laminated timber frame recovered by Articonnex; (b) dimensions and geometry of the structure; (c) lot numbering after removal.

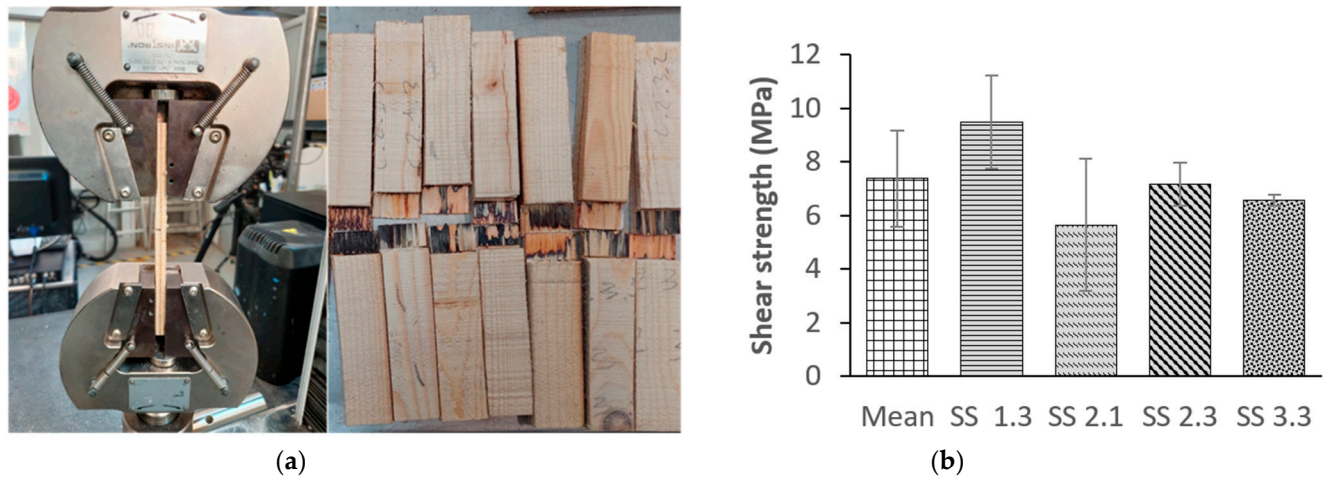
This part was delicate because out of the 32 tested specimens, only 18 produced usable results. This was due to the preparation of the specimens, which had to be cut up to the glue joint with high precision. The tested specimens before and after performing the test are illustrated in Figure 14a, and the testing results are presented in Figure 14b.

Figure 14. (a) Specimens before and after testing; (b) results of the adhesive line shear strength test.

Shear tests were used to obtain the shear mechanical strength of the glue. The mean value of this strength for the entire beam was 7.38 ± 1.79 MPa, with a mean wood failure percentage of 64%. This last value is lower than the values of Wang X.A. and al. [53] for glulam blocks of MUF adhesive with spruce (86.6%), and the value is lower than the specified threshold (>72%) of the NF EN 14,080 standard [44]. It is noteworthy that the weakest results, which can be seen in Figure 15a, were recorded for SS 2.1, with a mean of 5.65 ± 2.45 MPa. More specifically, on the upper side (2.1.1), where the mould was noticeable, the strength was about 4.75 MPa. It is important to note that Figure 15b indicates that the observed variations are not statistically significant. By removing this mouldy SS, the mean value rose to 7.74 ± 0.55 MPa; thus, the deviation was reduced. The value is lower than 10 MPa, which is the threshold strength for new glulam structures given by the standard NF EN 302-1 [40] and in Tran's works [54]. Therefore, it is necessary, a priori, to characterise the GLT.

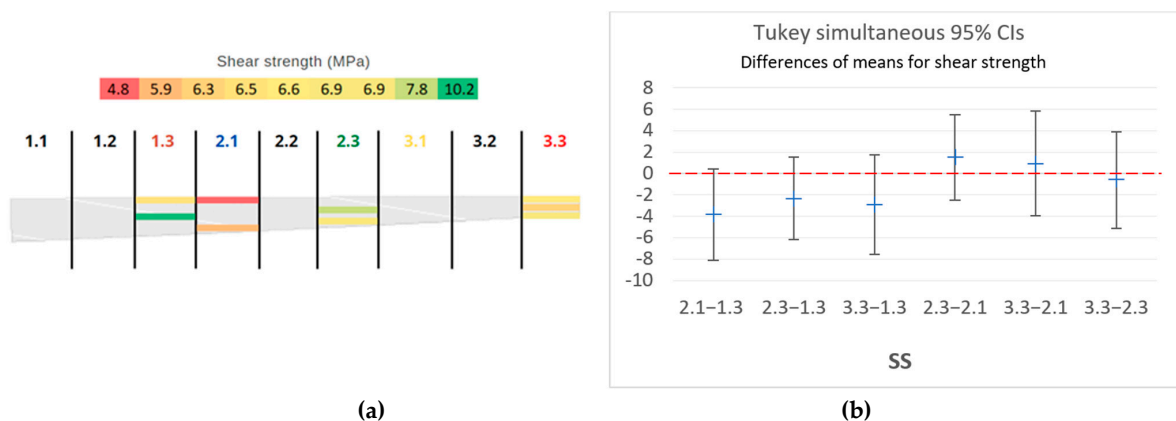
Figure 15. (a) Map summarising the distribution of the shear test results found (in MPa) along the beam. (b) Graphical display of pair-wise comparisons of SSs from Tukey's HSD for the shear strength data.

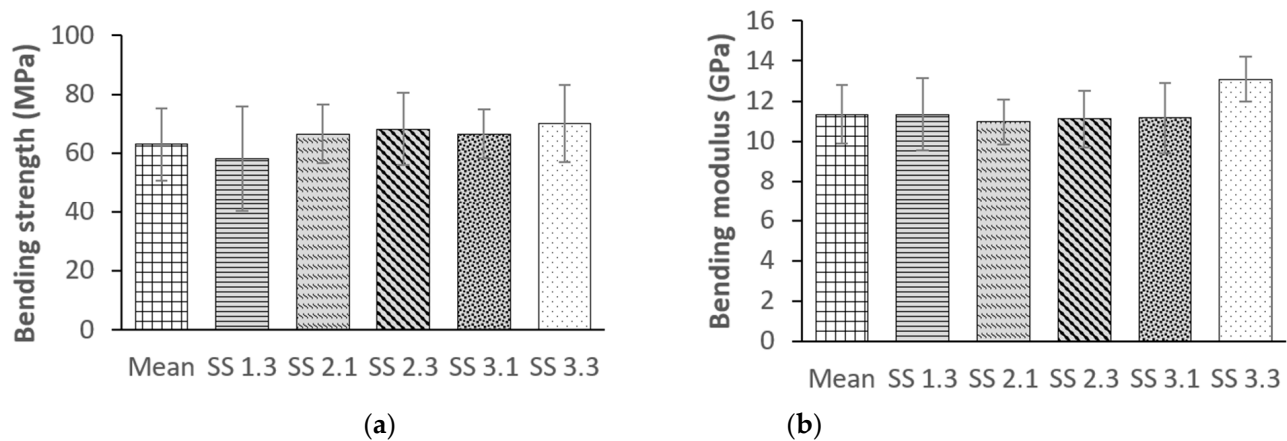
Figure 16 shows the bending strengths and bending moduli of the single laminates. In general, there are several types of wood failure, which include simple tension, transverse tension, splintering tension, strand tension, compression, and horizontal shear, as noted in [55]. The observed mode of breakage in the single laminates was transverse tension.

Figure 16. (a) Bending strengths of single laminates; (b) bending moduli of single laminates.

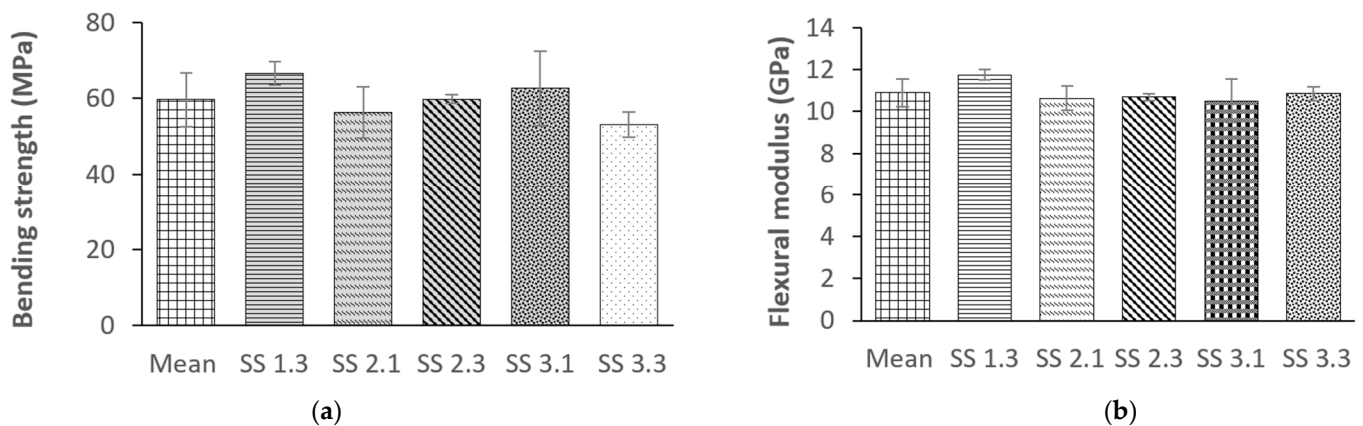
The same procedure was followed for the double laminates. The results are summarised in Figure 20. The resistance was relatively constant throughout the beam, with a mean of 59.79 ± 7.03 MPa. This was also found in the modulus at 10.62 ± 0.66 GPa, on average. The fracture mode observed for the double laminates is, for the lower laminate, the same as that of the single laminates studied earlier, except that, once the glue joint is

reached, the crack spreads very quickly along its axis and the break occurs. Because the crack chooses the least energetic path, this could mean that the glue joint has a weaker resistance than that of the wood. The relatively low values of the shear strength of the glue could also confirm this. Figure 21 shows the variations in the properties along the beam. The low values can be linked to the presence of knots or defects (nail-fixing holes) that triggered the fracture of the double laminate faster. For instance, a knot may have contributed to the fracture of a specimen, as can be seen in Figure 17c. With regard to the mouldy part (SS 2.1), the values seem to be lower than those of the neighbouring sub-section (SS 1.3), which shows the effect caused by the poor adhesive properties. Statistical non-significance is evident in Figure 22a for the bending strength and in Figure 22b for the modulus.

Figure 20. (a) Bending strengths of double laminates; (b) bending moduli of double laminates.
