Article Investigation of Corrosion Effects on Collapse of Truss Structures

Zeynep Fırat Alemdar *^{,†} and Fatih Alemdar [†]

Department of Civil Engineering, Yıldız Technical University, Istanbul 34220, Turkey

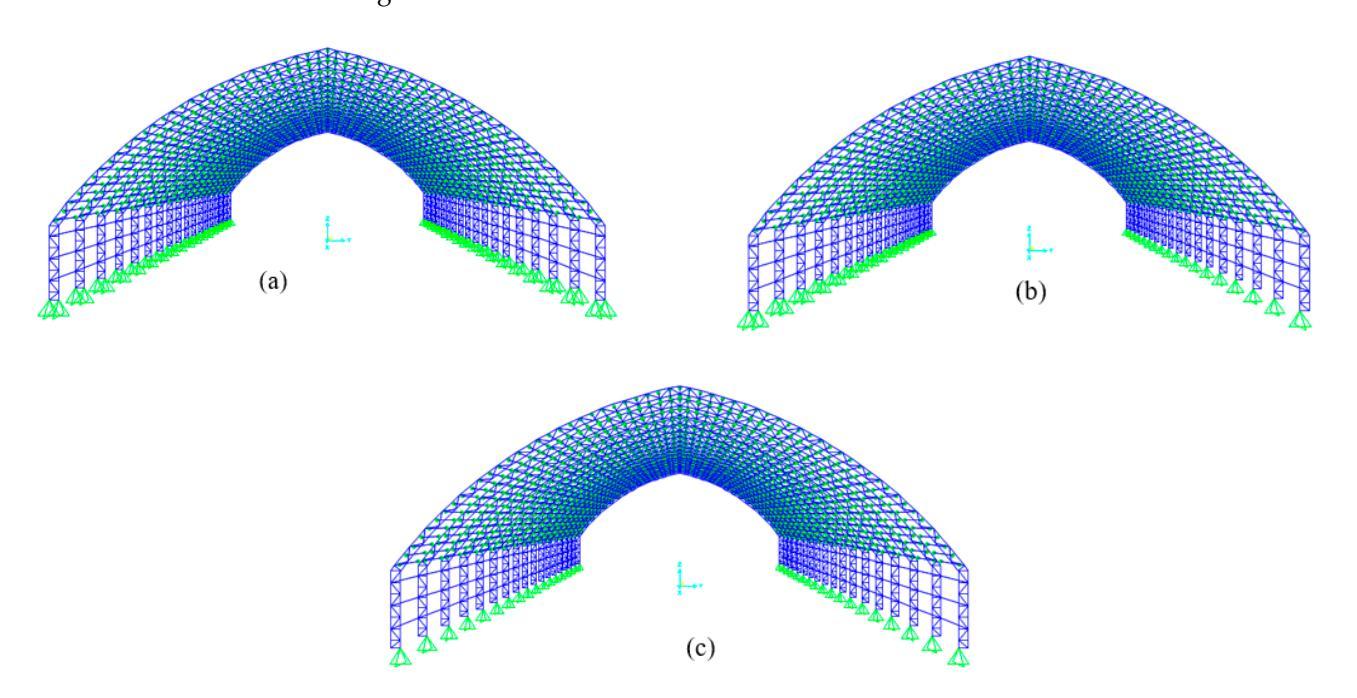
Figure 9. Boundary conditions of Model 1: (a) four supports; (b) three supports; (c) two supports.

First of all, a total of four simple supports were defined for each plane frame system in each of the FE models (Figure 9a). The number of supports was reduced to three and two for each model because the partial or full contact loss between the column members and the support plates occurred due to the corrosion and upward displacements observed during site investigations (Figures 7 and 8). Each FE model was subjected to a full snow load as computed based on the meteorological data, and they were analyzed under three different boundary conditions. The most critical results of the load-carrying capacity ratios were obtained for different support conditions in each model, as given in Table 1. Model 2 had the rafter system configuration in the shop drawing; thus, the maximum capacity ratios on the structural members for Model 2 with different support conditions are shown in Figure 10 as an example. In all FE models, it was determined that the truss column members close to the support regions yielded the maximum capacity ratios for the models with four supports, whereas the rafter system members close to the truss columns got the maximum values for the models with three and two supports, which was similar to the results given in Figure 10. The capacity ratios increased to 1.500 and 1.325 for the models with three and two support conditions, respectively, as it was anticipated. The results were similar between Model 1 and Model 2, as given in Table 1. However, the capacity ratios increased for Model 3 and Model 4 with four simple supports because the moment effect occurred due to the purlins not coinciding with the nodal points of the rafters, as shown in Figure 11. Moreover, the capacity ratios of each model with three supports were higher than those of the models with two supports, as presented in Table 1. This shows that the structural system as well as the load distribution became asymmetric when three supports were defined. In addition, the damage observed in the field on the left and right sides of the rafter system's connections with truss columns in Model 4 are given in Figure 12. The damage modes show consistency with the maximum capacity ratios for Model 4 with three and two supports, as shown in Table 1, exceeding the capacity of the rafter members more than 11 and 9 times, respectively.

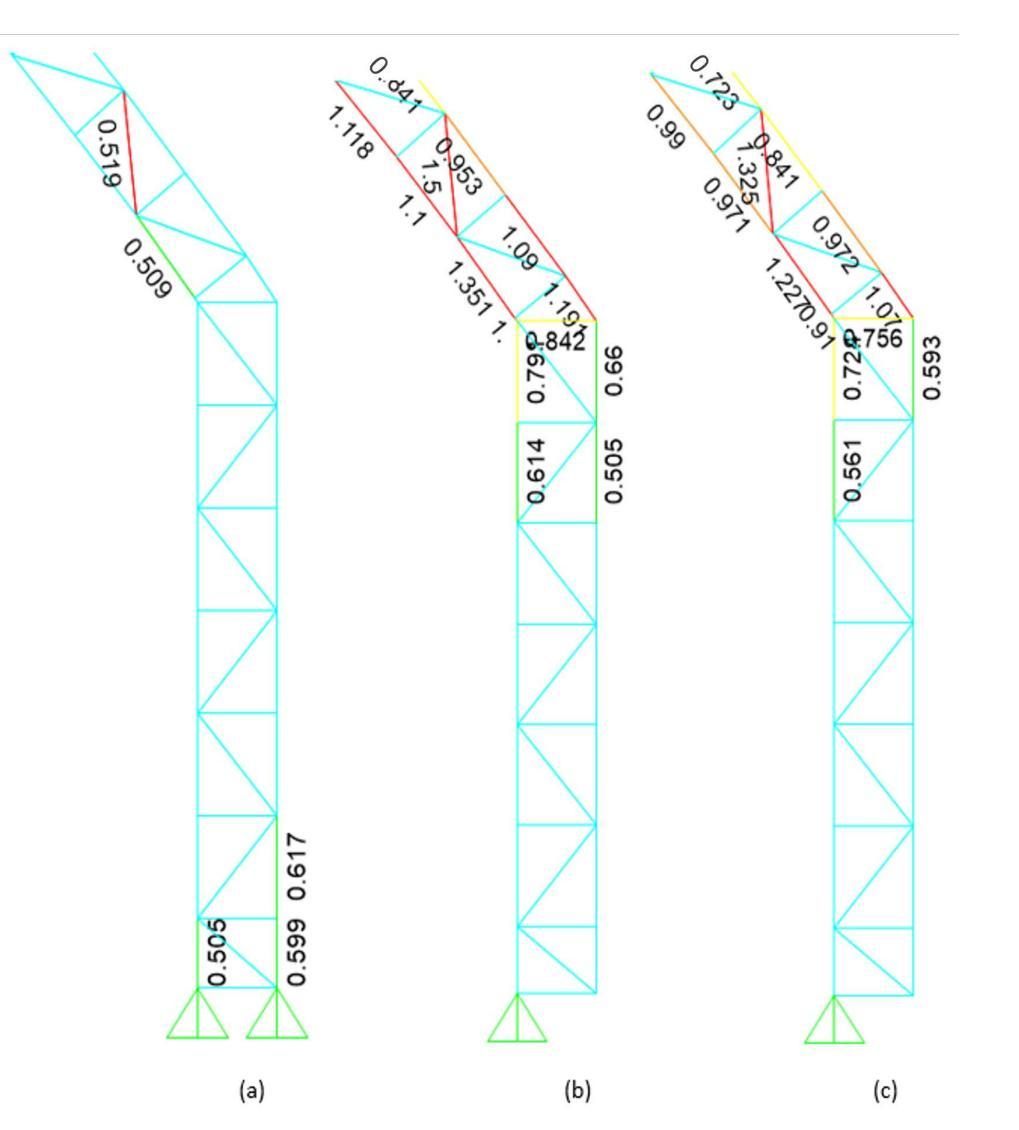
Four Supports	Three Supports	Two Supports
Model 1	0.608	1.345	1.221
Model 2	0.617	1.500	1.325
Model 3	0.997	6.786	5.410
Model 4	0.953	11.755	9.049

Figure 10. The maximum capacity ratios for Model 2 with (**a**) four supports; (**b**) three supports; (**c**) two supports.

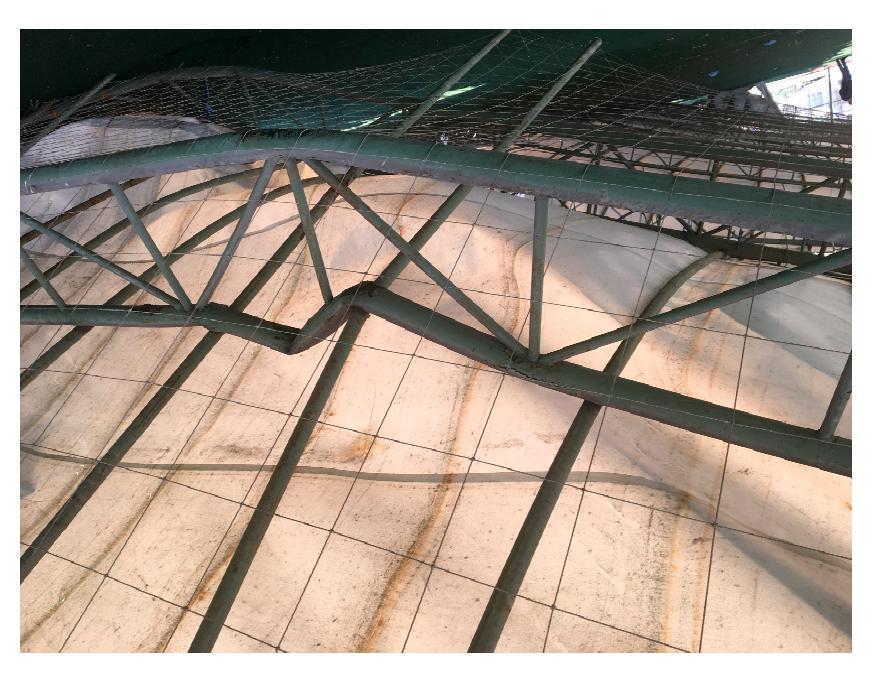
Figure 11. Bending moment effect observed in purlin connections to the rafters.

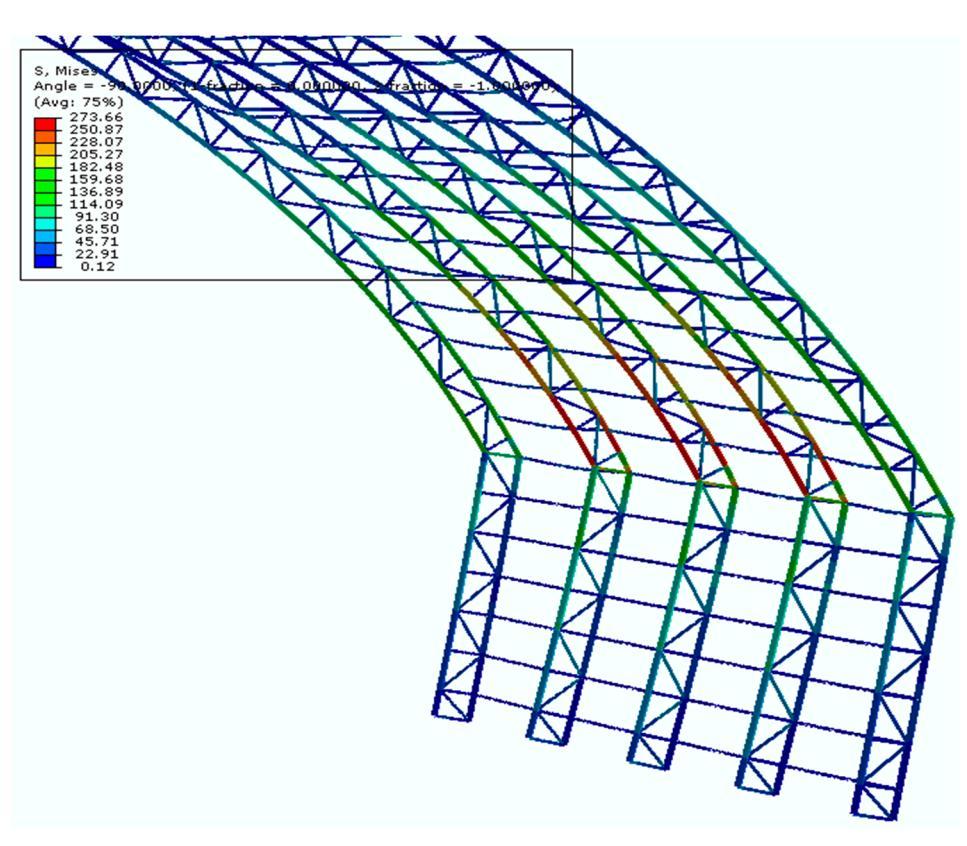
Von–Mises stress distributions were obtained for the different rafter models. The comparisons of the analysis results were made for the rafter system on the second axis because it was subjected to full snow loading. Although the Von–Mises stress values formed in different rafter systems with four simple supports did not reach the yield strength of the steel material, the stresses exceeded the yield capacity in some members of the rafter system in all FE models with three and two supports, as shown in Figure 14. It was observed that the stress values were similar for different rafter systems with the same number of supports (Table 2). High stress concentrations were found along the bottom chord members of the rafter at the connection region to the column profiles (Figure 14). This situation was also observed in the collapsed structures, as shown in Figure 12.

Figure 14. The Von–Mises stress distributions in Model 2 with two supports.
