Architectural Characteristics and Determination Seismic Risk Priorities of Traditional Masonry Structures: A Case Study for Bitlis (Eastern Türkiye)

Citation: Arkan, E.; Işık, E.; Harirchian, E.; Topçubaşı, M.; Avcil, F. Architectural Characteristics and Determination Seismic Risk Priorities of Traditional Masonry Structures: A Case Study for Bitlis (Eastern Türkiye). *Buildings* **2023**, *13*, 1042. <https://doi.org/10.3390/buildings13041042>

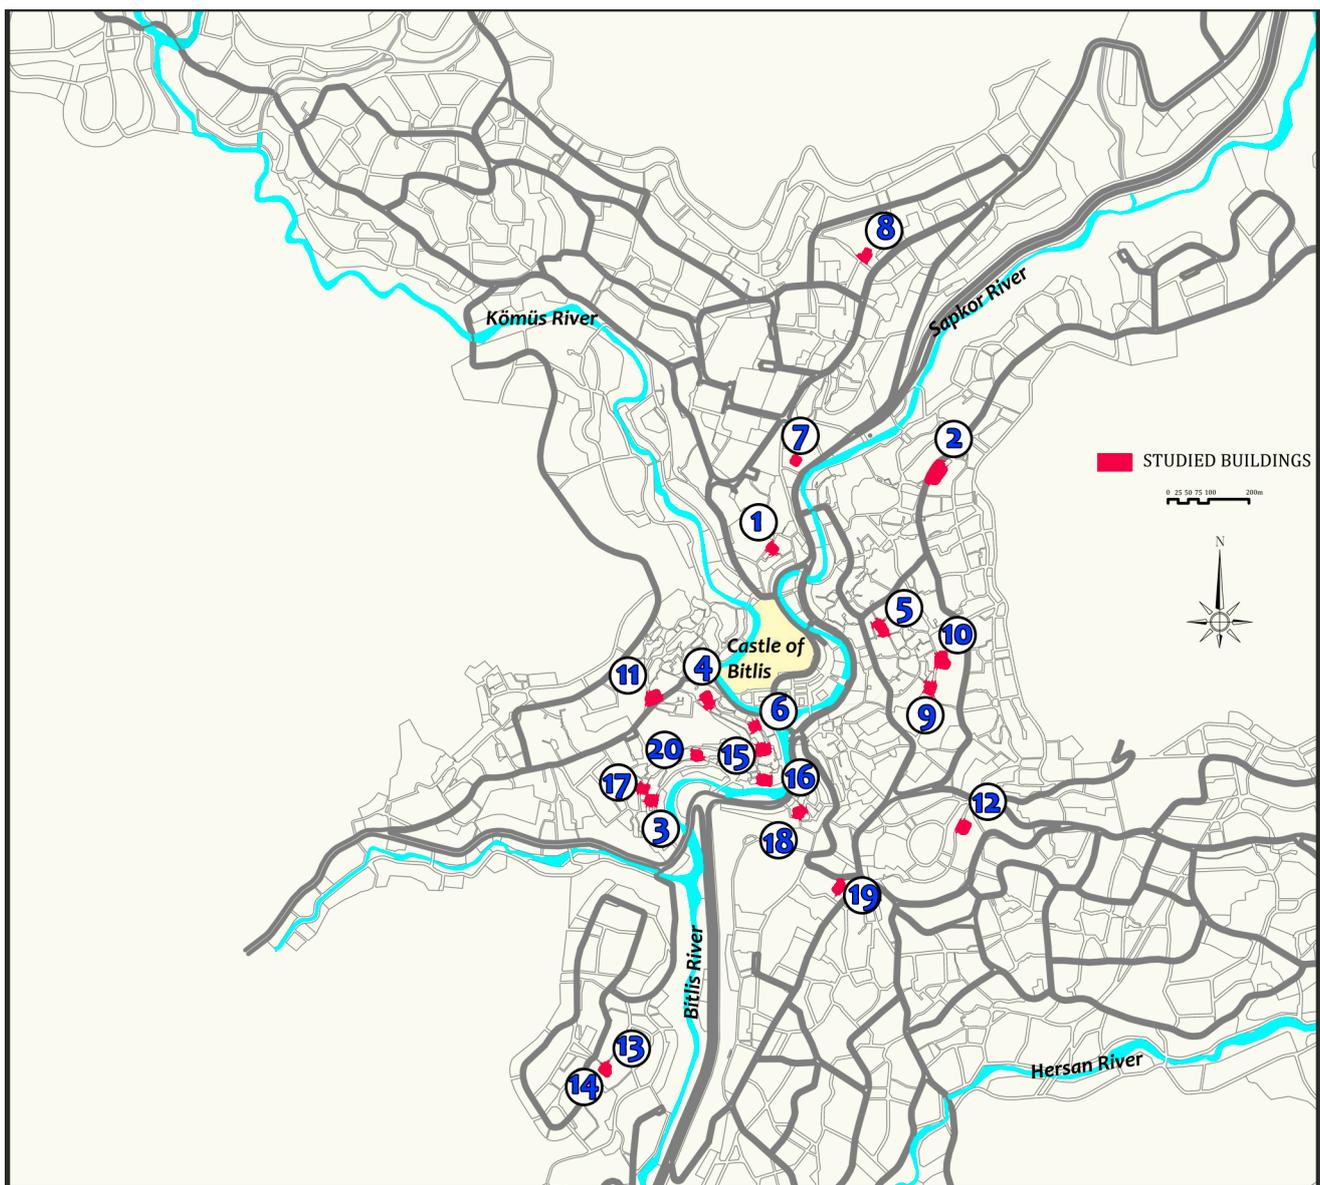
Figure 16. Locations of the twenty investigated structures in the city.

Within the scope of the study, twenty traditional houses built with a masonry system from different districts within Bitlis' city center were examined, as shown in Figure 16. Some examples of masonry structures considered in this context are shown in Figure 17. The ground floor plans of the masonry structures examined are shown in Figure 18.

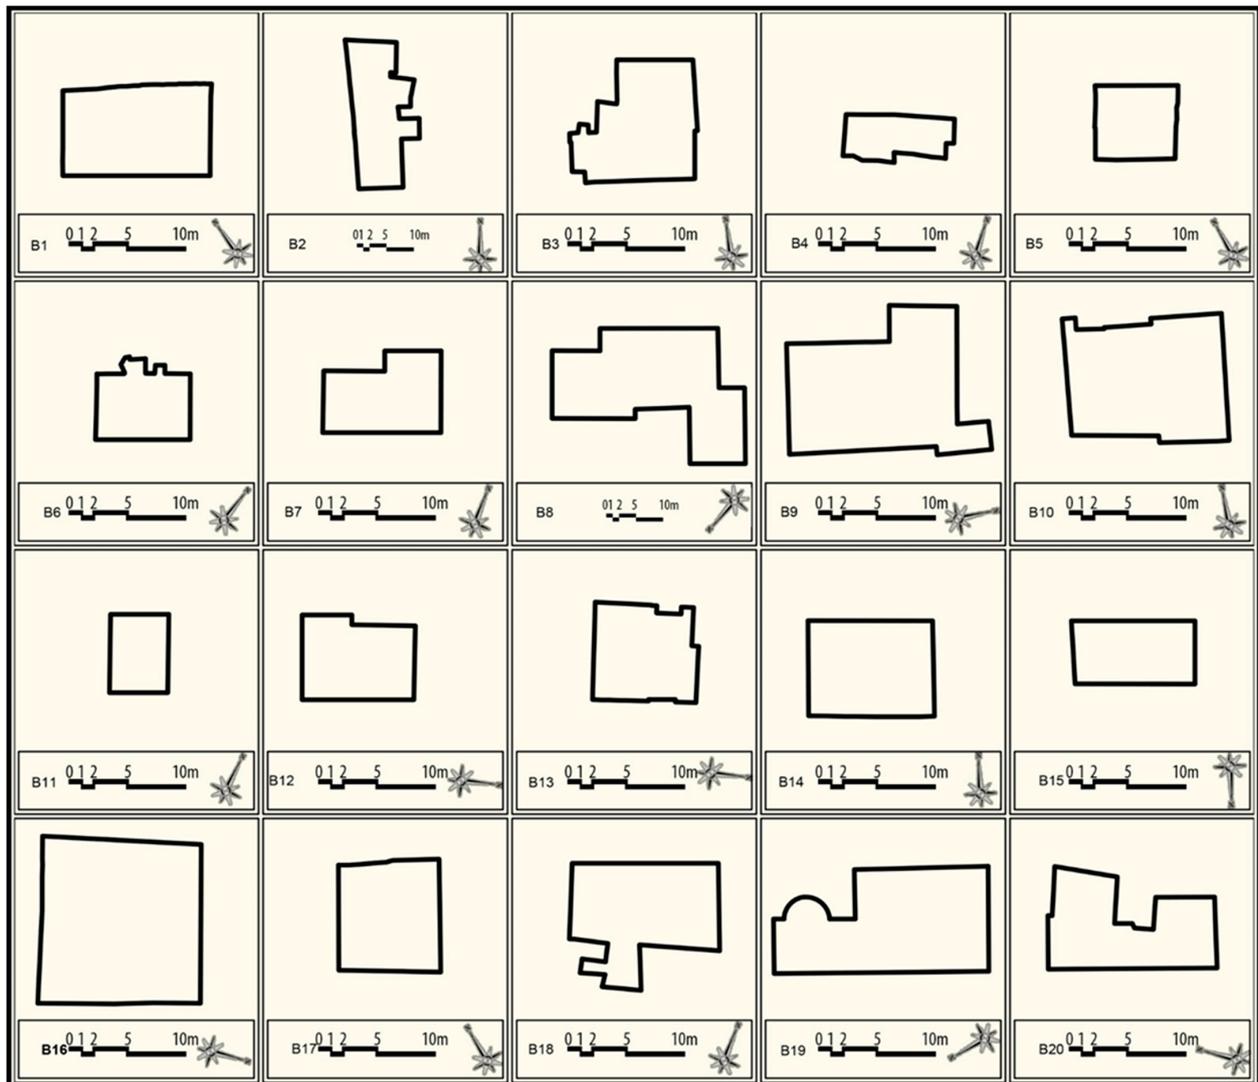
Figure 18. The ground floor plans of the examined masonry structures.

While six of the examined buildings are three-storey, thirteen of them are two-storey, and only one of them is one-storey. In general, traditional Bitlis houses are built as two-storey buildings. With the growth of the nuclear family, storeys were added to the existing structure as much as the masonry construction technique allowed. In houses built in this way, the wall thickness on the lower storey can be two storeys, since it is not suitable for three storeys. Due to the topographical structure of the province of Bitlis and the limited land use, the buildings were built adjacently. A total of 75% of the examined structures were built in adjacent order. These reasons also caused irregularity in the plan of the buildings. Bitlis stone was used in traditional Bitlis houses. These stones, which lost their properties over time, did not encounter any significant problems in terms of material due to the interventions made by the relevant building owners. Since masonry stone workmanship is highly developed in the Bitlis province and there are sufficient personnel in this regard, no significant problems were observed in terms of masonry walls. Mud was used as a joint mortar in all of the buildings. The wall–wall and wall–floor connections are sufficient due to good masonry stone workmanship. Different levels of damage to the masonry structures

have been observed over time due to the heavy and long winter season, the heavy snowfall, and the temperature differences between day and night in Bitlis. In addition, the weak strength properties of the stone used are among the main causes of damage. In many masonry structures, load-bearing walls, windows, and doors are not used symmetrically. Soft story risk was not observed in any examined structures. In general, the purpose of use in the building does not change much. Heavy earthen roofs are used in all masonry structures. Heavy earthen roofs cause additional forces in the structure under the effect of an earthquake and directly affect the level of damage that may occur in the structure. Generally, horizontal/vertical beams were not used in these structures, which were built without any engineering service.
