Article Up-Floating Destruction and Reinforcement Measures of Damaged Basement Based on the Bending Moment and Deformation Analysis

Abstract: Based on the up-floating incident of the basement in a high-rise residential building, the finite element (FE) model of the up-floating destruction region is established to investigate the damage mechanism. The stress states and the deformations of the basement structure are obtained under complex loads including water buoyancy forces, vehicle loads and construction loads. To assess the extent of damage, a novel damage indicator is defined based on two levels: the cracking bending moments and the yield bending moment. The first-level cracking bending moment, second-level cracking bending moment and the yield bending moment can be determined using the section stratification method. By comparing the maximum bending moment of the component with its corresponding cracking moment, one can determine whether the cracks have occurred and assess their severity. Meanwhile, the antifloating failure model is constructed to analyze the mechanism of the up-floating destruction. Finally, a detailed reinforcement treatment plan of 'decompression first and t

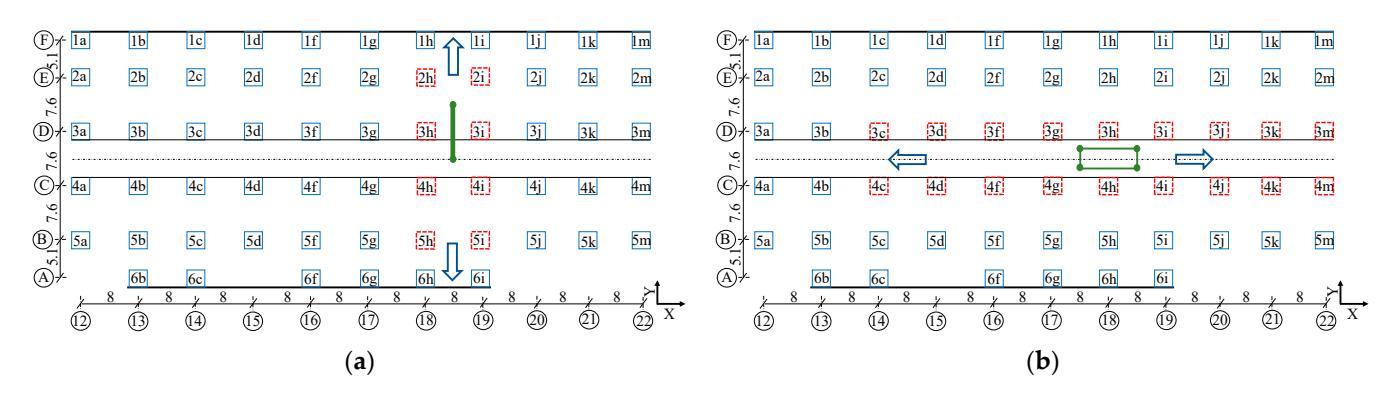
Figure 7. The vehicle loads and the pullout resistance state of the column foundations (Note: Green dots indicate the position of the vehicle loads. Red squares represent the failure of the pullout force of the column foundations. Blue squares denote the existence of the pullout force in the column foundations). (a) The vehicle loads in the Y-direction. (b) The vehicle loads in the X-direction.

In Table 4, it is observed that the maximum bending moments at the top and bottom of the columns are 49.42 kN·m and 33.71 kN·m, respectively, when the vehicle loads act on the travel lane of the roof plate between Axis 18 and Axis 19 in the Y-direction. Neither of these values has yet reached their corresponding Stage 1 cracking moment, indicating no generation of cracks. However, it can be inferred that vehicle loads have a greater impact on the bending moment at the column top than at the column bottom. From Table 5, it can be observed that the bending moment at the top of the 3g column exceeds its Stage 1 cracking moment under the vehicle loads between Axis C and Axis D in the X-direction. The Level B cracks occur at the top of the 3g column, which is referenced as T-2B on 3g column in

Figure 2. Specifically, the bending moment is measured at 59.69 kN·m while the Stage 1 cracking moment is only 57.16 kN·m. Consequently, small cracks may appear at the top of this column but no cracks are visible at its bottom. Similarly, for the 5g column, its bending moment reaches up to 78.93 kN·m which represents approximately 93% of its corresponding Stage 1 cracking moment (84.77 kN·m). The initiation of cracks will occur at the top of the 5g column (T-2D on 5g column). It is evident that all other bending moment values are inferior to their corresponding Stage 1 cracking moments, thus resulting in cracks at these positions along the columns.

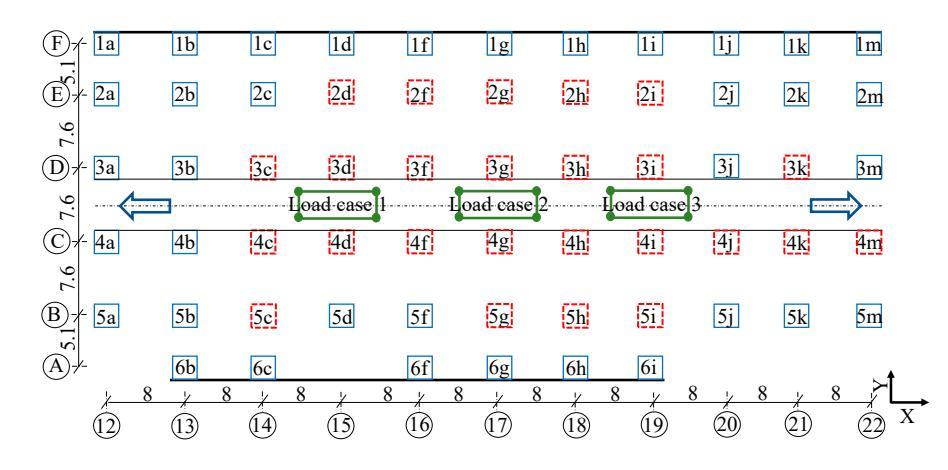
With the advancement of antifloating measures for the damaged columns, an increased occurrence of cracks at both the top and bottom sections have been observed. In this section, a model for antifloating failure is constructed as depicted in Figure 8. The red squares labeled in Figure 8 indicate that the restraints at the bottom of the 3c, 4c, 5c, 2d, 3d, 4d, 2f, 3f, 4f, 2g, 3g, 4g, 5g, 2h, 3h, 4h, 5h, 2i, 3i, 4i, 5i, 4j, 3k, 4k and 4m columns have been released to simulate pullout resistance failures.

Figure 8. The pullout force failure of the columns.

From Table 6, it can be observed that the maximum bending moments of the 2g and 4g columns exceed their corresponding stage 2 cracking moment when the vehicle loads move from left to right on the travel lane of the top slab between Axis C and Axis D. However, these maximum bending moment values do not surpass their corresponding stage 3 bending moments. Even the maximum bending moments of the 2g column in Load case 4 fall within the range between the corresponding stage 2 cracking moment of 53.95 kN·m and yield bending moments of 199.08 kN·m (B-5C, B-3B and T-1B on the 2g column). However, for the 4g column in Load case 4, its maximum bending moments are either close to or less than its corresponding stage 1 cracking moment of 86.25 kN·m (T-2C and B-4C on 4g column). These findings suggest that the columns have experienced severe cracking under vehicle loads and belong to Level C in terms of crack severity. Nevertheless, their mechanical state remains intact within the elastic damage range, which is consistent with on-site observations of column damage.

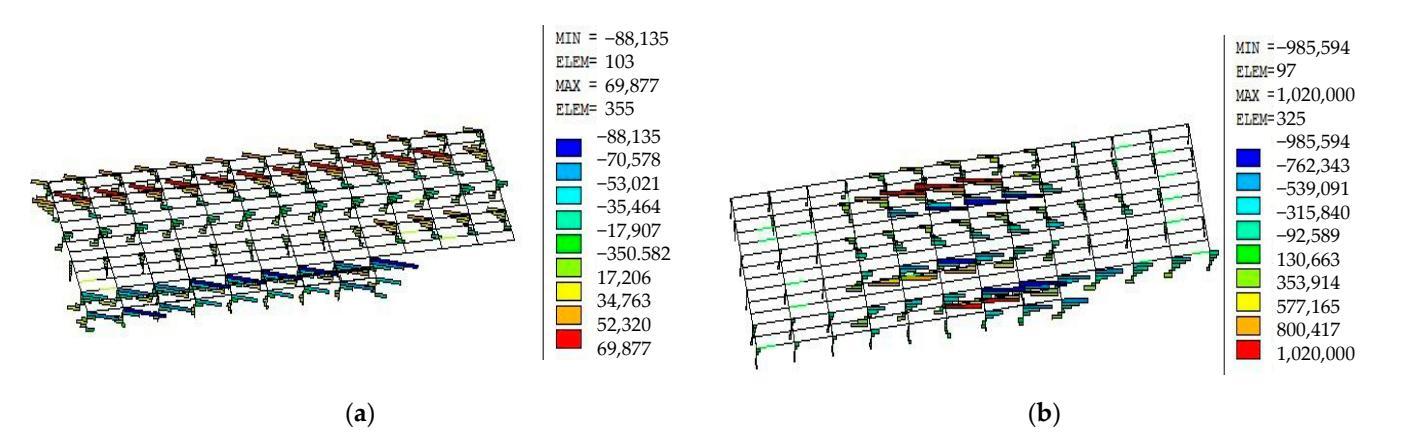
Thus, the loading measures are conducted by laying a 150 mm thick layer of concrete and an 800 mm thick layer of casing soil on top of the basement's top slab. To simulate the reinforcement model, the water buoyancy force is applied to the basement floor, consistent with the conditions in Section 3. Two comparative cases are considered regarding whether or not the foundation of the basement loses pullout resistance. The bending moments and deformations of the basement are illustrated in Figures 11 and 12, respectively. As shown in Figure 11, the maximum moment of columns is 88.135 kN·m when column foundations possess sufficient pullout resistance. However, if there is a failure in pullout resistance, the maximum moment will escalate to 1020 kN·m. In Figure 12, the maximum vertical displacement of the basement is 5.314 mm under pullout resistance, while it increases to 65.931 mm once the partial restraints of column bases are released.

Figure 11. The bending moment of the columns after reinforcement (N·m). (**a**) Pullout resistance stabilization. (**b**) Pullout resistance failure.

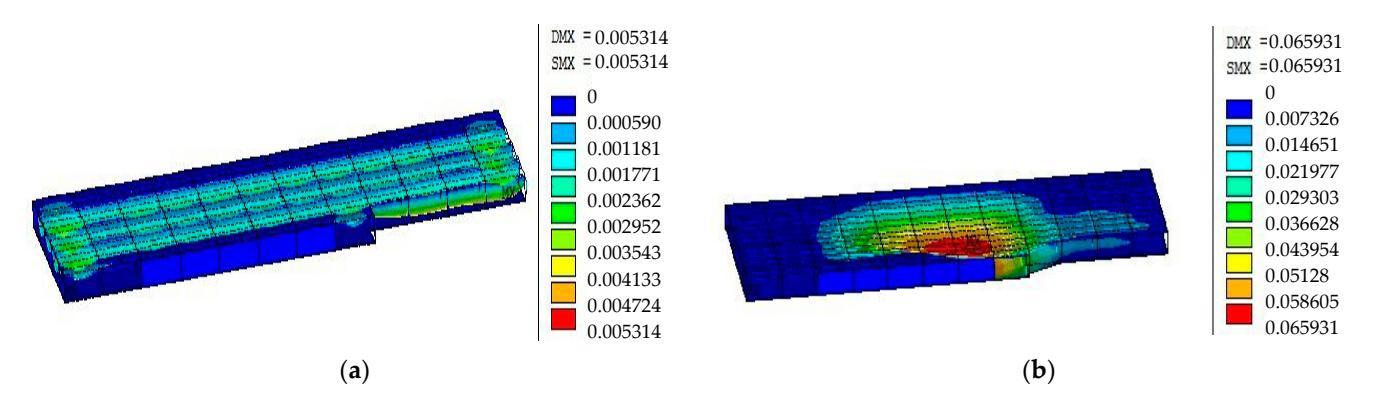
Figure 12. Vertical displacements of the basement structure after reinforcement (m). (**a**) Pullout resistance stabilization. (**b**) Pullout resistance failure.

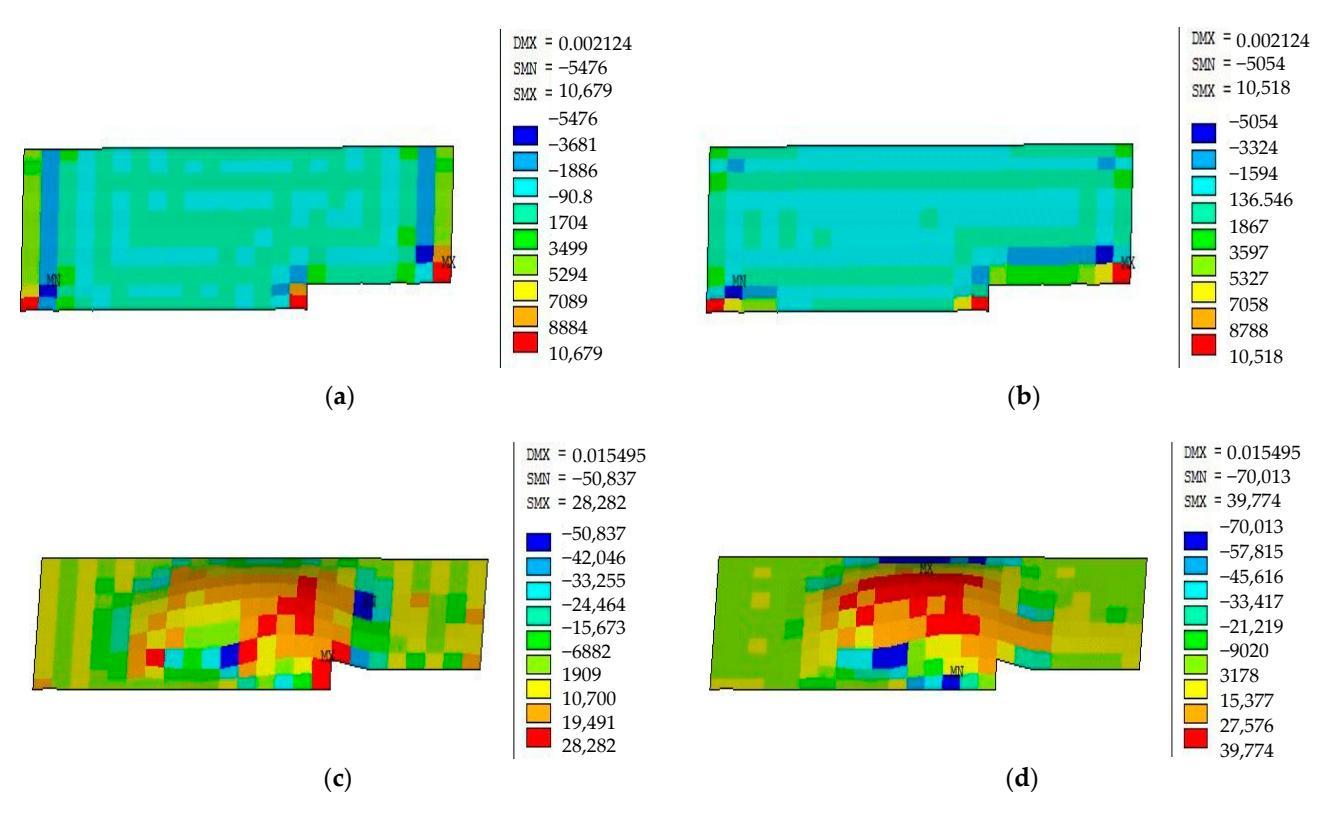
In addition, the 150 mm thick concrete is poured onto the basement floor slab. The pullout resistance stabilization and failure scenarios are simulated to determine the bending moments of the floor slab, as depicted in Figure 13. From Figure 13, the maximum bending moment of the floor slab is 10.679 kN·m when all column bottoms are rigidly constrained. However, with the locally released constraints at the column bottoms, this value increases to 70.013 kN·m.

Figure 13. The bending moment of the floor slab after reinforcement (N·m). (a) M_x in the pullout resistance stabilization. (b) M_y in the pullout resistance stabilization. (c) M_x in the pullout resistance failure. (d) M_y in the pullout resistance failure.

- (4) Thicken both the bottom and top slabs. The basement's bottom slab is filled with 150 mm thick concrete, which is connected to the original concrete using embedded steel bars as shown in Figure 18. After adding the overlay layer, to maintain the original design strength, it is necessary to incorporate a steel mesh into the laminated layer that matches or exceeds the size and spacing of steels in the original surface layer. The top slab is covered with casing soils that are 800 mm thick. According to structural FE calculation in Figures 11–13, these covered loads and the dead loads can meet the requirements of antifloating bearing capacity in the code [37]. Once the cover of the casing soils on the roof plate is fully installed, the spillage holes can be sealed.
