Reflections from the 2019 Durrës Earthquakes: An Earthquake Engineering Evaluation for Masonry Typologies

Abstract: Two earthquakes struck the NW region of Albanian territory on 21 September 2019 ($M_w = 5.6$) and on 26 November 2019 ($M_w = 6.4$). The epicenters of the seismic activity were located offshore NW Durrës, one of Albania's most populated cities, located 30 km from the capital Tirana. Various aftershocks followed subsequently. While there were no reported injuries, a number of buildings sustained significant damage near the epicenter following the initial event. Subsequently, during the second event, there was loss of life and extensive damage to civilian structures, resulting in multiple collapses. This study focuses on the earthquake damages observed in residential and public buildings in the earthquake-affected region. The earthquakes predominantly affected low-rise masonry buildings, while the newly constructed RC structures built according to the latest seismic rules were almost unaffected. The commonly encountered building typologies in the region, together with photos showing the amount of destruction are presented here. As observed by the authors during the rec

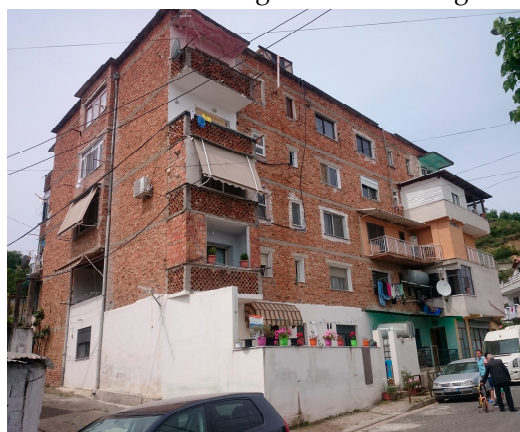
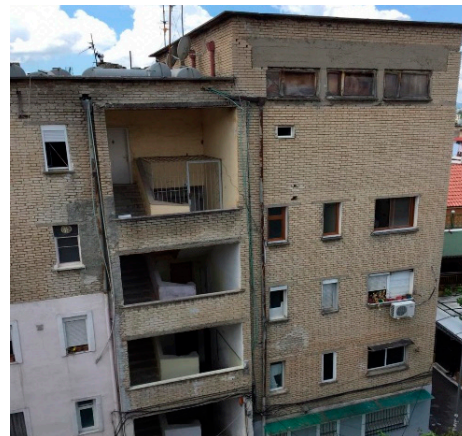
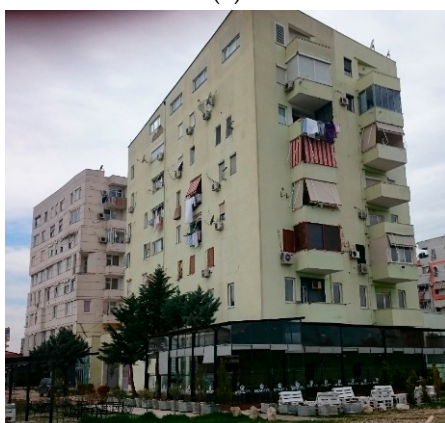
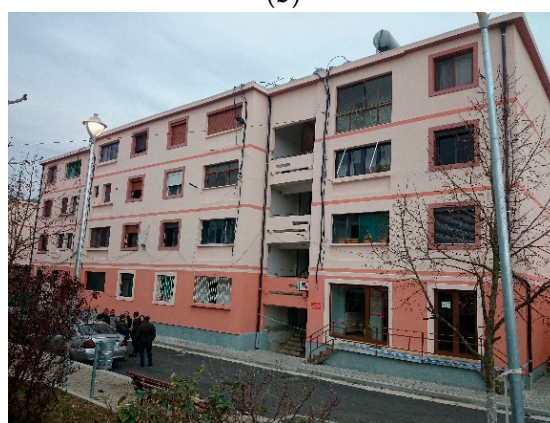
Figure 3. Commonly encountered typologies for multi-story buildings in Albanian building stock: (a) Unreinforced masonry built by clay bricks; (b) Confined masonry made of silicate bricks; (c) newly constructed RC buildings; (d) Large panel Prefabricated buildings.

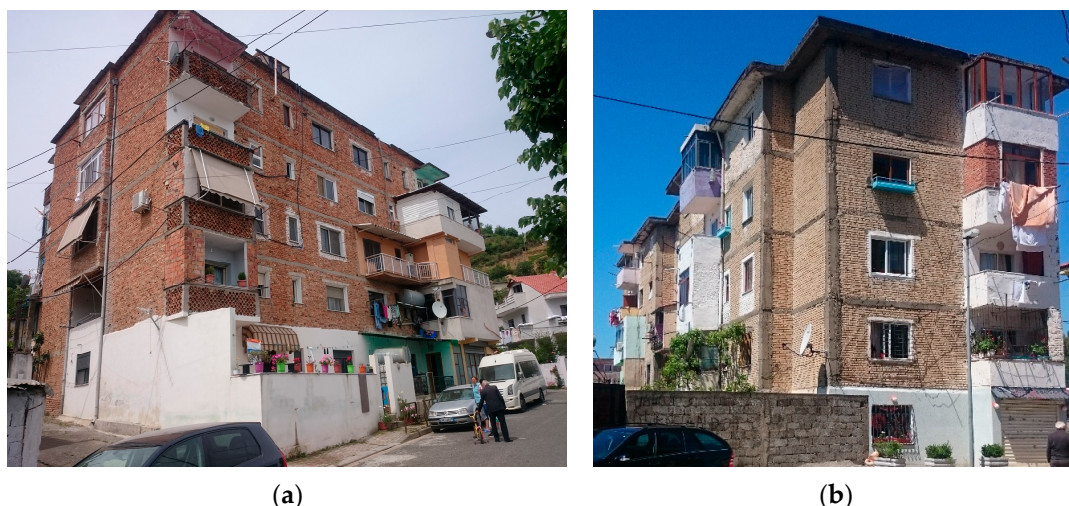
Masonry buildings and RC buildings continue to be in use and represent a significant portion of the dwellings in Albania. These buildings can be categorized into two primary typologies: (1) unreinforced masonry (URM) buildings with load-bearing walls, as illustrated in Figure 8a, and (2) confined masonry (CM) buildings with load-bearing walls reinforced using RC tie-elements, as depicted in Figure 8b.

Figure 8. Typical masonry buildings (a) URM; (b) Confined masonry.

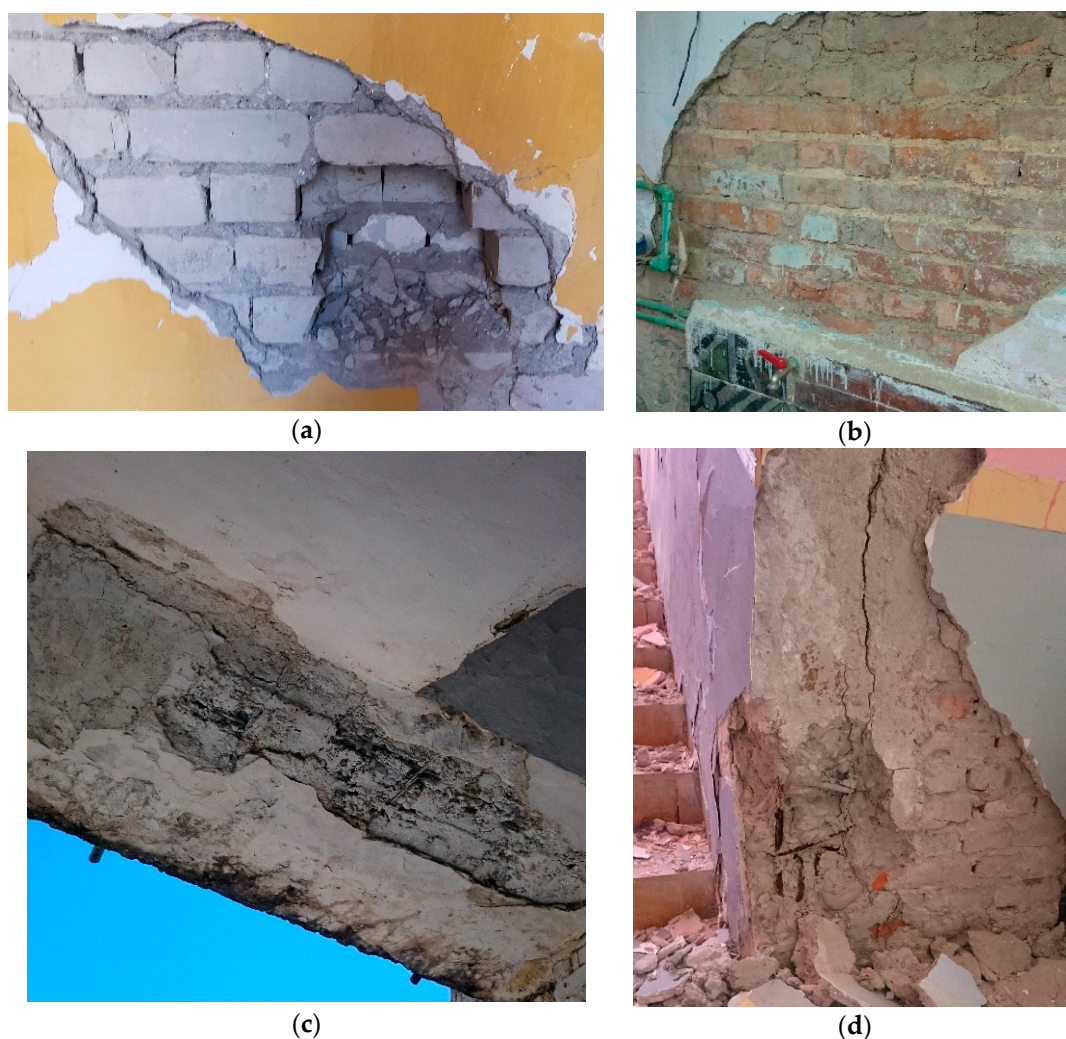
Figure 9. Typical solid bricks and details of the confinement elements used for masonry walls: (a) Silicate bricks; (b) Red clay bricks; (c,d) RC beams and column reinforcements.

In CM buildings (as shown in Figure 9c,d), tie elements are utilized. These tie elements include reinforced concrete (RC) columns with a typical cross-section size of $38 \times 38 \text{ cm}^2$, as well as RC beams with a depth of either 25 cm or 38 cm. The choice of beam depth depends on the thickness of the walls at their respective locations. The concrete used in these tie elements is generally of class C16 or lower. Similarly, the steel grade typically employed in these buildings is S220, as reported [27].
