Preliminary Geospatial and In Situ Reconnaissance of the 8 September 2023 Moroccan Atlas Earthquake Damage

Abstract: This research investigates the post-earthquake performances of structures in four rural villages in the Moroccan Atlas, emphasizing common construction system characteristics and design flaws that render buildings susceptible to seismic events. Village selection was based on a prior multispectral satellite-image study, proving effective for planning high-impact, post-earthquake field campaigns. The significance of this research resides in on-site data collection, facilitating the physical assessment of earthquake-induced damage and identification of inherent vulnerabilities in construction systems. The constructions in the study area exhibited structural design deficiencies, inadequate construction techniques, and urban modifiers, leading to damage extensively documented in the literature, as well as less-documented unique damage. Predominant seismic-design shortcomings in the study area included subpar material quality, insufficient earthquake-resistant design, and unskilled labor. In situ data were complemented by a global geospatial approach using differential sy

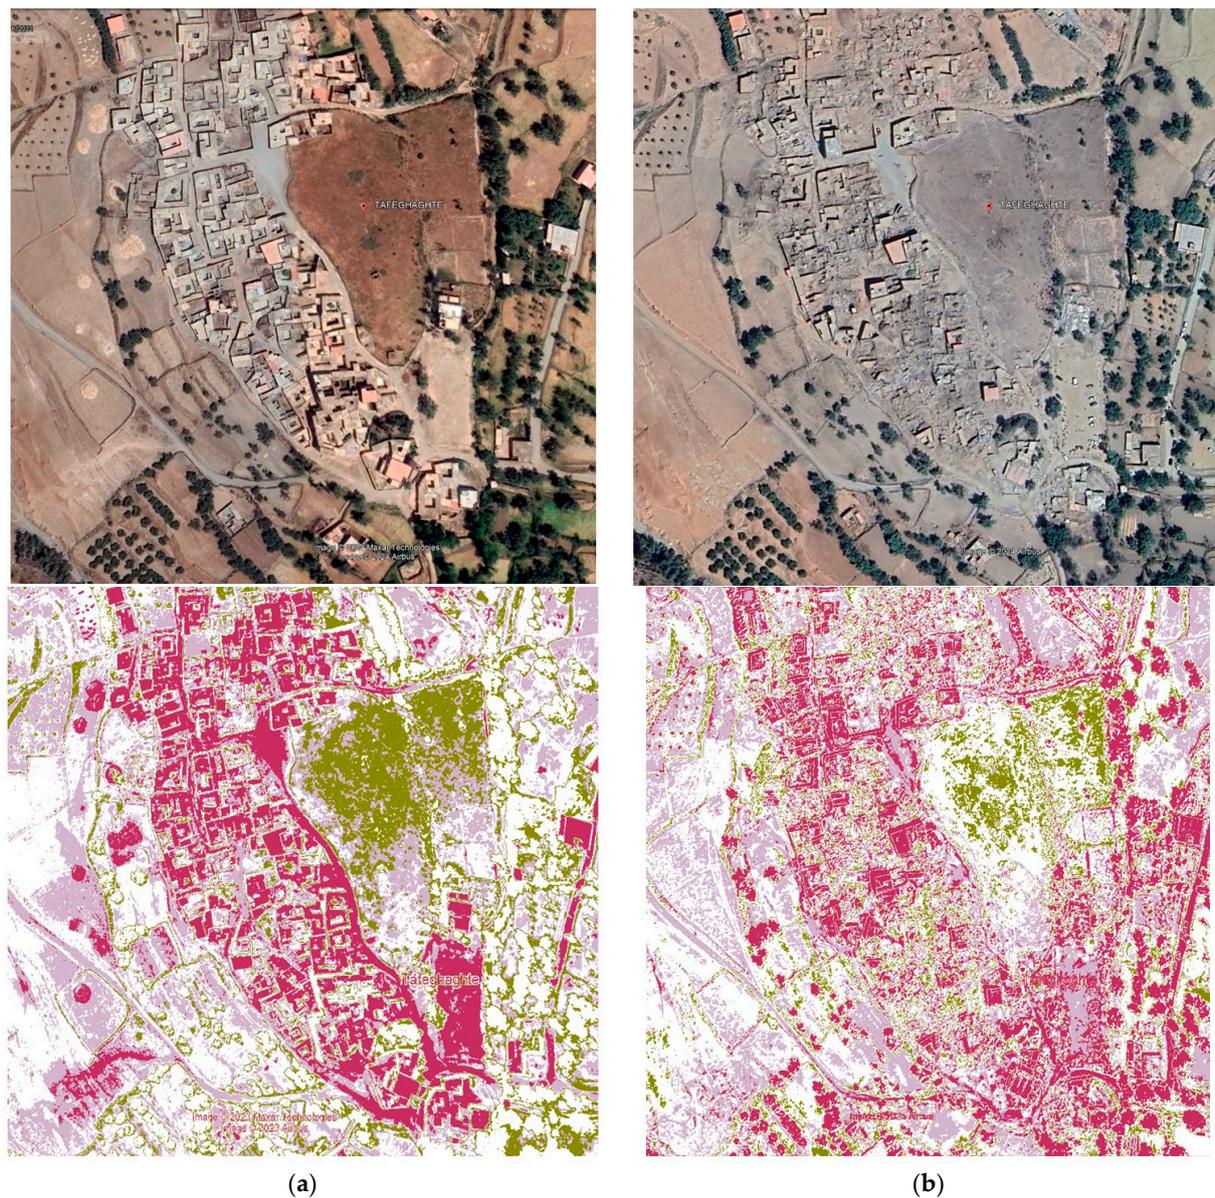
Figure 6. Detail of Tafeghaghte before (06/2022) and after (10/2023) the occurrence of the earthquake of 8 September 2023, (a,b), respectively. Digital classifications of typologies using the k-means algorithm in which two classes of interest (cluster 6 and 7) for research are highlighted, covered by buildings and artificial structures such as roads and streets.

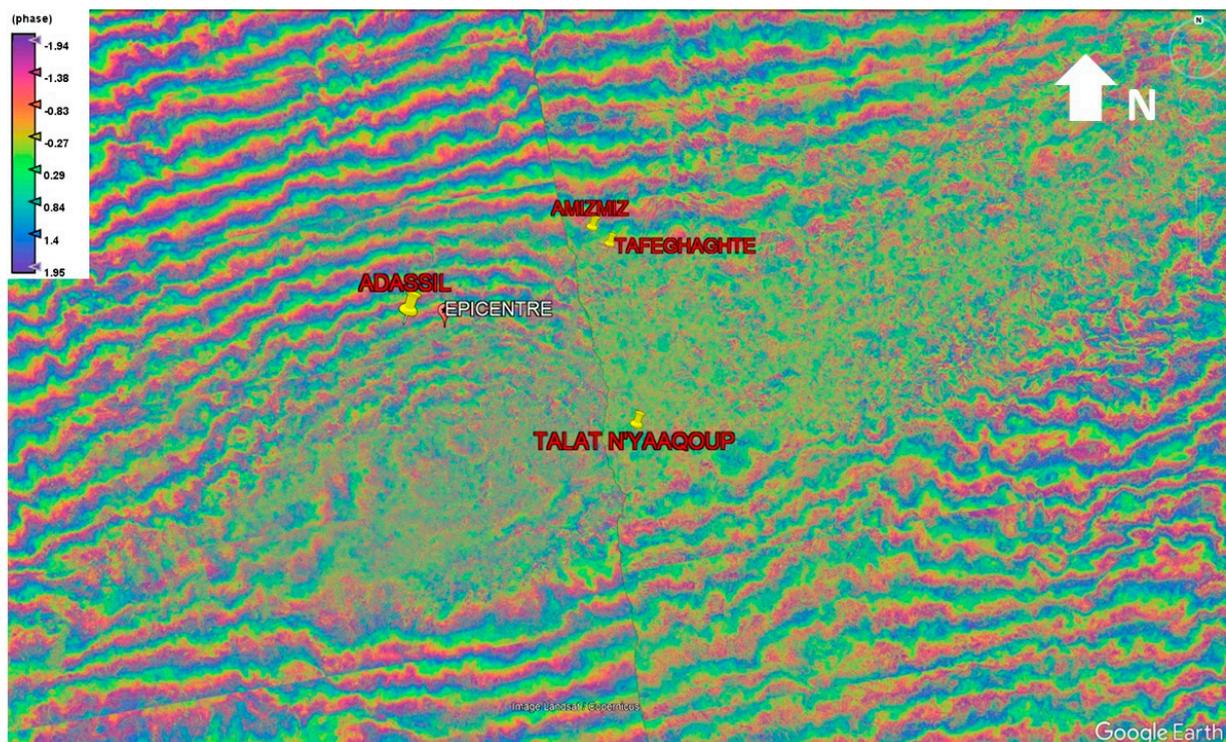
Figure 9. Detail of the differential interferogram DInSAR computed from Sentinel 1 radar images (3–15 September 2023) for Amizmiz, Adassil, Tafeghaghte and Talat N’Yaaqoud. Surface displacements upwards (towards the satellite) or downwards (away from satellite) in the line-of-sight direction of the satellite.

According to the estimations over the computed DInSAR interferogram, in the visited areas the surface moved upwards in Adassil by an amount ranging from 8 to 12 cm, in Tafeghaghte by 19 to 23 cm, in Amizmiz by 19 to 23 cm and in Talat N’Yaaqoud by 23 to 27 cm. Furthermore, an apparent topographic effect, that is, surface uplifts and surface subsidence, was observed in the cases of Tafeghaghte and especially Talat N’Yaaqoud.
