Seismic Damage Characteristics and Mitigation Strategies in Southern Sichuan Basin, China

Zonghang He, Hongmei Guo *, Ying Zhang, Zhen Zhao, Bingxin Shi, Can Zhang and Yuping Yang

Sichuan Earthquake Agency, Chengdu 610041, China; zonghang@scdzj.gov.cn (Z.H.)

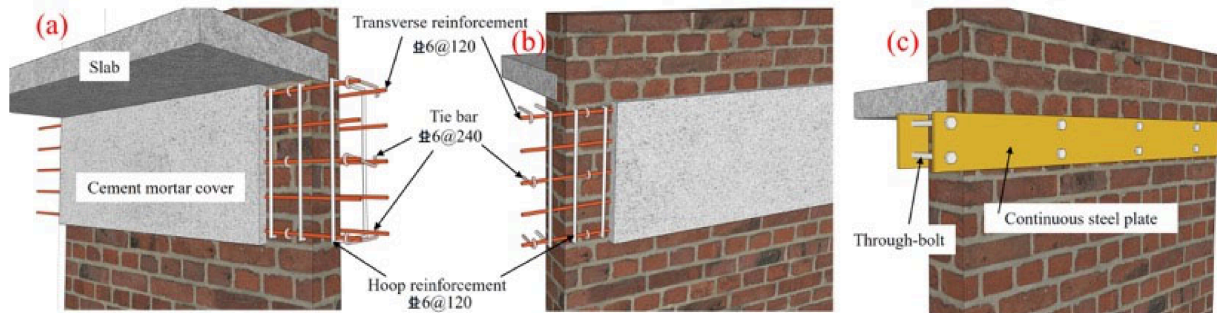
Figure 18. Construction diagram for installing ring beams. (a) Retrofitting with reinforced concrete ring beams on both sides. (b) Retrofitting with reinforced concrete ring beams on one side. (c) Steel plate reinforcement. Note: The brick texture displayed on the walls in all diagrams in Section 7 is solely a visualization effect of the 3D model material, used to differentiate different components, and does not reflect the actual masonry layout or mortar joint structure in the engineering project.

Ring beams and tie columns, while not the primary lateral load-resisting components in masonry structures, serve as essential seismic detailing measures. Their function lies in effectively confining the masonry, enhancing structural integrity, and promoting spatial coordination, thereby playing a significant role in improving the overall seismic performance of buildings. For rural brick-concrete buildings in southern Sichuan, typically two to three stories high and located in regions with seismic fortification intensities of VI–VII, according to the Code for Design of Masonry Structures (GB50003 2011) [35] and the Code for Seismic Strengthening Design of Masonry Structures (GB50702 2011) [36], tie columns should be installed at critical locations, including the four corners of exterior walls, intersections of longitudinal and transverse walls, and corners of stairwells. Closed ring beams are also required at the roof level and at each floor level. Based on the current code framework and prevailing practices in seismic retrofitting, this study summarizes several practical, readily implementable structural reinforcement techniques. For installing additional ring beams, a commonly used method is to place continuous longitudinal reinforcement along one or both sides (typically the exterior side) of the wall at the bottom of the floor slabs. These bars are secured with stirrups and anchoring ties, then covered with an outer layer of cement mortar or fine-aggregate concrete to form a reinforced mortar band. Alternatively, an equivalent ring beam system can be constructed by anchoring steel plate strips on both sides of the wall and connecting them with high-strength through-bolts, thereby forming a confinement mechanism with similar restraining effects. The addition of tie columns fol-

lows a similar design principle. To accommodate on-site construction conditions, steel plate reinforcement components may be employed as substitutes for conventional reinforced concrete columns. The diameters, spacing, and detailed configurations of the reinforcement bars used in the aforementioned techniques are clearly shown in Figures 18 and 19, providing concrete technical references for engineering implementation.

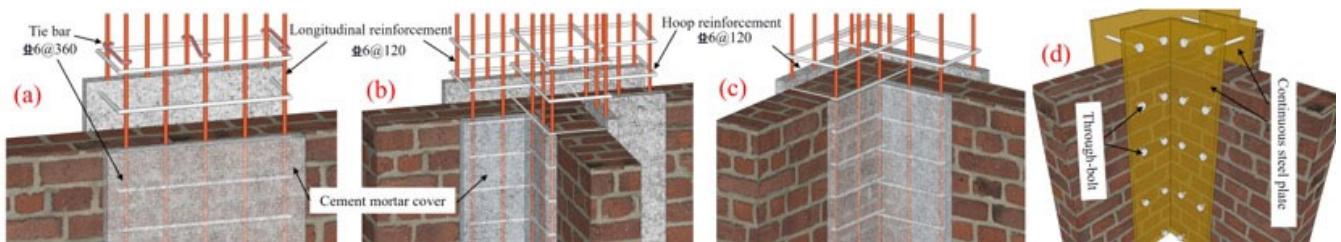
Figure 19. Construction diagram for installing tie columns in various wall configurations. (a) Straight wall. (b) Intersection of longitudinal and transverse walls. (c) Building corner. (d) Steel plate reinforcement at the junction of transverse and longitudinal walls.

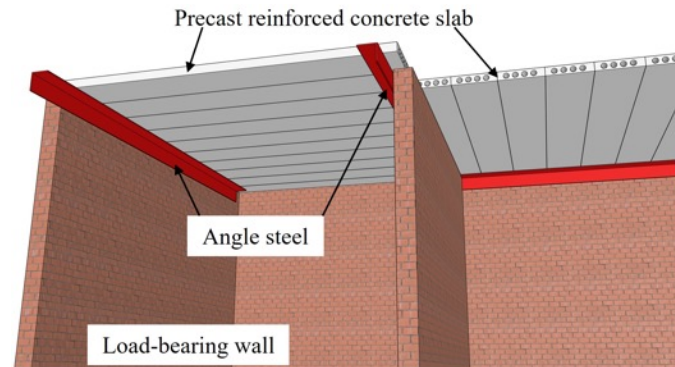
The primary seismic vulnerability in precast slab floor systems lies in the insufficient effective bearing length at the supports and the lack of reliable anchorage between the slabs and the supporting structures. Under seismic loading, such structural deficiencies can easily lead to slab dislodgement or collapse, potentially triggering a progressive failure cascade, including wall instability and subsequent collapse. Therefore, the reinforcement of precast slab floors must address two key aspects: integrating discrete precast units into a unified structural system to improve in-plane stiffness and overall integrity, and strengthening the connection between slab ends and supporting walls to ensure effective load transfer and more uniform internal force distribution, thereby preventing wall damage due to localized stress concentrations. To achieve both effective reinforcement and construction simplicity, the use of angle steel connectors, based on engineering judgment, represents a practical and efficient method. A schematic representation of the slab reinforcement approach is shown in Figure 20. Specifically, angle steel plates are installed at the vertical support interface between the precast slabs and the wall, serving both to extend the bearing length and to ensure structural continuity. During construction, these steel plates must be securely anchored to both the wall and the slab to establish an effective load-transfer path. On the wall side, high-performance structural adhesives or mechanical anchors may be used to secure the steel plate. On the slab side, however, drilling is not recommended due to

Figure 20. Schematic diagram of precast slab floor reinforcement measures.

internal voids in the precast elements. Instead, non-destructive bonding methods, such as structural adhesive, are preferred to ensure safe and reliable connections. It should be noted that this reinforcement measure is specifically intended for slab end supports. Steel connectors are typically unnecessary along the slab sides running parallel to the wall, to avoid imposing redundant constraints and further simplify construction.

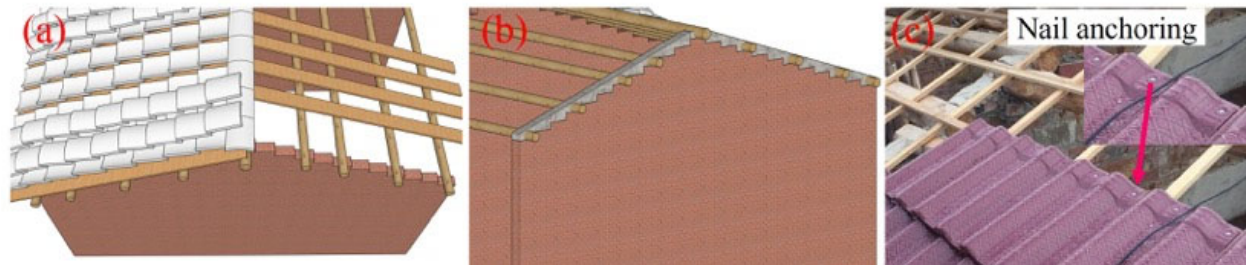
The traditional wooden roof system, characterized by joint connections made through mortise and tenon or simple nails, generally exhibits poor overall integrity. Under seismic forces, components are prone to misalignment, loosening, and even the collapse of the roof trusses. This not only poses a direct safety risk but may also inflict significant damage to the underlying walls. Therefore, the core objective of reinforcing wooden roofs is to strengthen the connections between various roof components and ensure reliable anchoring of the roof structure to the walls. This will transform the roof into a cohesive unit with sufficient rigidity and stability, enabling it to effectively transfer and distribute horizontal forces during an earthquake, thereby preventing localized instability and subsequent progressive failure. Before 2000, the construction method of wooden roofs typically involved placing wooden beams directly on top of the walls, with wooden purlins laid across the beams. Roof tiles were stacked in layers atop the purlins, and stability was mainly maintained through the weight of the tiles and friction between the contact surfaces (Figure 21a). Based on the seismic damage observed in existing wooden roof trusses, the primary modes of failure can be categorized into two types: first, the sliding off of roof tiles; second, the overall detachment of the roof truss from the walls. As these buildings were constructed many years ago, overly complex reinforcement techniques, while effective, present challenges such as high costs and excessive intervention with the original structure. Based on previous applications, at the junction between the wooden beams and the walls, cement mortar or fine aggregate concrete can be poured to form a localized embedded node (Figure 21b). This approach not only enhances the connection performance between the wooden beams and the walls, making it less prone to relative slippage or detachment under horizontal forces, but also, due to the relatively low weight of traditional wooden roof structures, results in smaller inertial forces during an earthquake. The localized strengthening at these junctions significantly enhances the overall resistance to collapse. Upgrading the traditional tile system to a modern glazed tile system is another effective measure to improve roof integrity and prevent tiles from being dislodged during seismic events. Glazed tiles have larger surface areas, providing better friction, and most of them are designed with pre-drilled nail holes or claw teeth on the underside. During construction, the tiles are not simply stacked but fixed directly to the rafters with galvanized copper wire or stainless steel nails, creating a secure bond that makes the tiles an integral part of the roof structure (Figure 21c) rather than merely resting on top. Additionally, the interlocking seams between the tiles are

Figure 21. Reinforcement methods for the wooden roof. (a) Traditional wooden roof with directly laid rafters. (b) Anchorage of wooden frame support ends. (c) Replacement of traditional tiles with fixable new-type tiles.

precisely designed, allowing for better engagement. This method has been widely applied in both new construction and renovation projects, offering both technical feasibility and ease of construction. Of course, the aforementioned reinforcement measures assume that the wooden beams possess sufficient load-bearing capacity. If the wooden beams show significant signs of decay, insect damage, or severe degradation of mechanical properties, they must be replaced or locally reinforced before proceeding with further strengthening; otherwise, the reinforcement will not achieve the desired results.

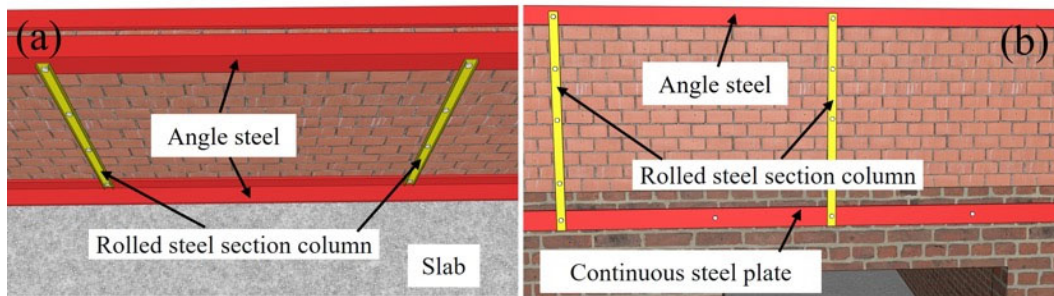
Figure 22. Schematic diagram of parapet reinforcement measures. (a) internal view. (b) external view.

The parapet wall, serving as a low boundary on the roof perimeter of a building, has a relatively high center of gravity and is weakly connected to the underlying structural elements. Under seismic forces, it is highly susceptible to cracking, tilting, or even complete collapse. This not only poses an immediate risk of falling debris causing secondary injuries, but may also compromise the structural integrity of the lower walls or the roof edge due to the impacts of the parapet wall's collapse. Therefore, the primary objective of reinforcing the parapet wall is to enhance its stability and ensure a reliable anchorage with the underlying roof structure or main walls, thereby resisting overturning and sliding during seismic events. According to applicable building codes, parapet walls should incorporate tie columns to improve seismic performance; however, many rural residences in southern Sichuan lack these essential components. As a practical solution informed by an engineering practice perspective, a reinforcement method employing a composite structure of steel plates is proposed to simulate the function of structural columns (Figure 22). The specific procedure is as follows: continuous angle steel should be installed at both ends of the parapet wall and at the junction with the roof. Additionally, continuous steel plates should be arranged along the external face of the load-bearing walls below the parapet wall and anchored to the wall with bolts. Vertical steel columns should connect the continuous sections, with these columns further anchored within the wall using through-bolts. This system not only achieves structural integrity for the parapet wall itself, but also establishes a reliable connection with the roof and wall through the steel connection system. Consequently, this effectively prevents independent tilting or large-scale collapse of the parapet wall during seismic events, significantly enhancing its seismic safety performance.

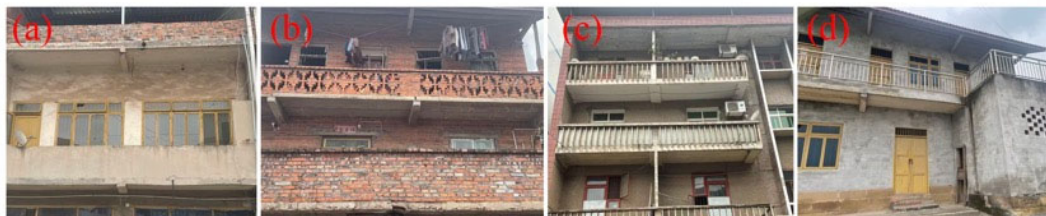
Figure 23. Different types of railing protective structures. (a) Solid brick masonry. (b) Hollow brick masonry. (c) Hollow precast concrete component. (d) Metal railing.

Railings that exhibit the same failure mechanisms as parapet walls pose significant challenges to overall reinforcement due to their diverse styles, some of which feature openwork designs (Figure 23b,c). These characteristics render them particularly susceptible to overturning, fracturing, and falling during seismic events, which can result in personal injury. Therefore, priority should be given to renovation or replacement strategies. The specific approach involves removing the existing heavy masonry or concrete railings and replacing them with lighter, more ductile stainless steel or lightweight steel railings (Figure 23d). New railing posts should be securely anchored to the underlying walkway

beams or walls at both ends and at midpoints, using embedded steel plates or chemical anchor bolts. This modification not only significantly reduces the vertical load imposed by the railings, but also fundamentally eliminates the risk of collapse associated with the original railings.

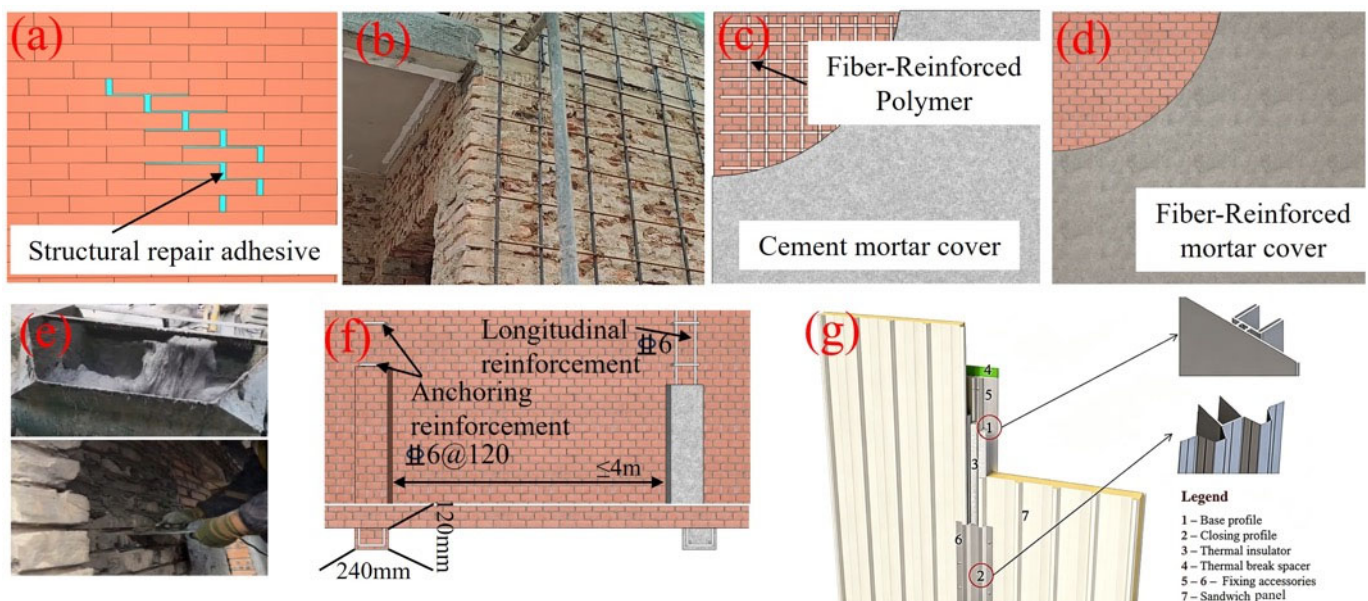
Figure 24. Wall load-bearing capacity enhancement measures. (a) Wall crack repair; (b) externally bonded steel mesh reinforcement; (c) externally bonded fiber-reinforced polymer reinforcement; (d) enhanced mortar rendering; (e) addition of buttresses; (f) addition of buttresses; (g) MIL 15.s Eco-Seismic Insulation System [39].

The walls, as the only structural components in masonry structures that bear both vertical loads and lateral seismic forces, play a crucial role in determining the building's overall safety and durability. However, some existing walls suffer from reduced shear strength, inadequate integrity, and crack propagation due to factors such as degraded mortar bonding, material aging, structural defects, or long-term environmental exposure. These issues severely impair the structure's seismic performance and safety reserves. A more critical concern is that the thickness of existing walls in many buildings is generally quite thin, with most walls being 180 mm thick and some even as thin as 120 mm, which is significantly below the current minimum thickness requirement of 240 mm specified in the building codes. Therefore, conducting systematic inspections and effectively reinforcing the walls have become key measures to enhance the building's seismic capacity and ensure its safety. Given that numerous codes and studies have systematically addressed wall reinforcement techniques, several simple, fast, and cost-effective methods are summarized below. Wall crack repair is a technique that involves pressure grouting or stitching existing cracks to restore the continuity and overall load-bearing capacity of the wall (Figure 24a). Bidirectional reinforced mortar surface treatment is a method in which a steel mesh is applied to the wall surface, followed by spraying high-performance mortar to create a composite load-bearing surface. This approach significantly enhances the wall's shear and bending capacity and has already been implemented in the region (Figure 24b). It is worth noting that traditional reinforced mesh mortar coatings, which require a relatively thick layer to adequately protect the reinforcement, are gradually being replaced by lighter, thinner, high-performance reinforcement methods. With advances in materials technology, the application of carbon fiber-reinforced polymer sheets has become increasingly widespread [37,38]. This method involves adhering carbon fiber fabric or plates to the wall surface (Figure 24c), leveraging their high strength, lightweight, and

corrosion-resistant properties to effectively constrain wall deformation, improve shear strength, and significantly enhance the wall's energy dissipation and ductility under cyclic loads. This technique is easy to apply, has minimal impact on the original structure, and is particularly suited for spaces with limited access or for rapid construction. If the wall's quality is not severely compromised, it is also possible to spray fiber-reinforced mortar directly onto the surface without the need for fiber materials (Figure 24d). This low-cost and easy-to-construct method is also very popular in the local area (Figure 24e). Another traditional and effective reinforcement method involves adding buttresses to the external wall (Figure 24f). By placing buttresses at weakened sections or corners and securely anchoring them to the original wall with anchor bars, this method can significantly improve the wall's lateral stiffness and stability, effectively preventing out-of-plane instability and enhancing overall seismic resistance. In addition to traditional brick buttresses, reinforced concrete buttresses can also be used. Vertical reinforcement bars are placed at the anchor bars, and concrete is poured to form an integral system. This not only significantly increases the wall's load-bearing capacity, but also allows the vertical reinforcement bars to contribute to shear resistance, providing a constraining and strengthening effect similar to that of structural columns. The above methods can be reasonably selected and combined based on the current state of the structure, seismic demands, and construction conditions to ensure that the reinforcement measures work synergistically with the existing structure, ultimately achieving a systematic improvement in structural safety and seismic performance. In addition to the aforementioned methods, some research teams abroad have also achieved notable results. For example, Formisano and Longobardi [39] developed an innovative solution that combines metal exoskeletons with insulation panels to enhance seismic resistance while reducing thermal dispersion. This method has been widely adopted in Europe.

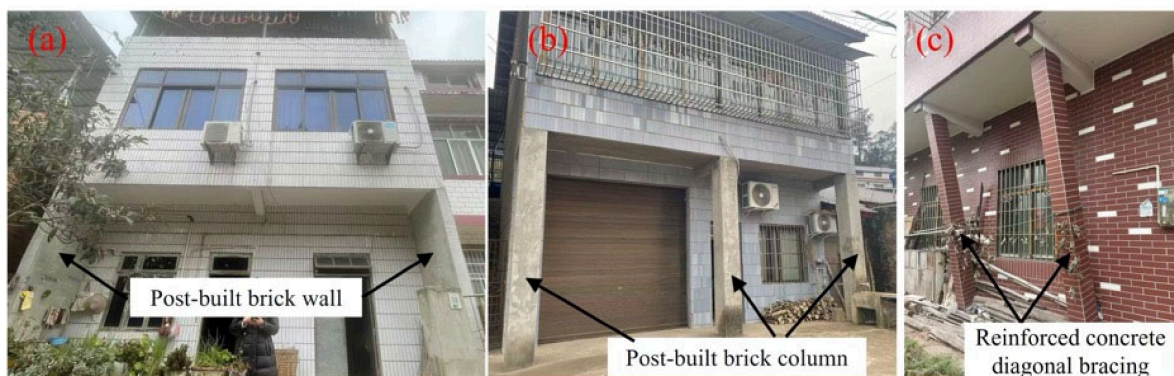
When buildings exhibit irregular geometric shapes or an uneven distribution of stiffness and mass centers, significant eccentric torsional effects can occur under seismic actions. This exacerbates localized stress concentrations within walls, potentially leading to severe

structural damage. Such issues are particularly prevalent in brick-concrete structures in southern Sichuan, where cantilevered structures are commonly found on the second floor and above. This design introduces abrupt changes in vertical stiffness and discontinuities in the center of mass, resulting in the connections between the first and second-floor walls becoming weak points in terms of seismic resistance. These areas are prone to cracking or even localized collapse during an earthquake. To address these safety concerns, some residents have implemented various rudimentary reinforcement measures. These measures primarily include constructing additional brick walls on both sides of the cantilevered sections to enhance lateral support or installing brick columns at the junctions of cantilever beams to provide localized support (Figure 25a,b). However, only a small number of buildings incorporate diagonal bracing under each cantilever beam at the time of construction, with the opposite ends anchored to the foundation (Figure 25c). This configuration enables a more direct transfer of vertical loads to the foundation, effectively alleviating the forces and eccentricity associated with the cantilevered sections. Nevertheless, these diagonal braces hinder movement in certain areas, often relegating lower spaces to storage.

Figure 25. Current self-designed reinforcement measures by residents. (a) Later-added brick wall. (b) Later-added brick column. (c) Additional reinforced concrete diagonal bracing.

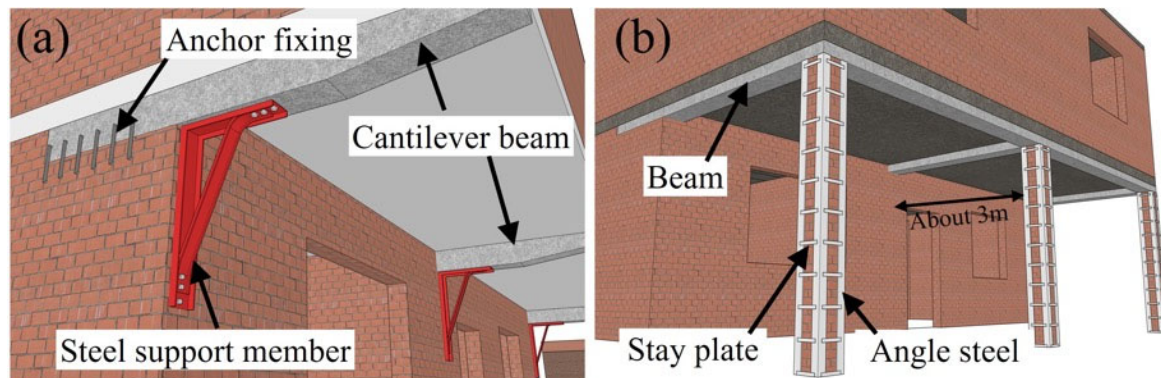
Figure 26. Reinforcement of vertically irregular masonry structures. (a) Enhancing the support capacity of cantilever structures using triangular steel braces. (b) Enhancing the load-bearing capacity of brick columns using encased steel sections.

Based on engineering experience, this paper proposes a composite reinforcement strategy that combines active load reduction with anchorage enhancement (Figure 26a). First, diagonal steel braces are installed beneath the cantilevered section. This configuration not only significantly shortens the effective span of the cantilever beam, but more importantly, diverts a portion of the cantilever load directly to the underlying main structure. Second, high-strength anchorages are installed at the fixed end of the cantilever beam to provide a rigid connection to the rear wall, thereby resisting the uplift force induced by the cantilever moment and ensuring joint integrity. This method effectively suppresses excessive deflection and warping of the cantilever beam under vertical loads and seismic excitation, thereby enhancing its load-bearing capacity, stiffness, and overall seismic performance. In addition to vertical irregularities caused by cantilevered components, another common form of structural irregularity is observed when the ground floor of a building is recessed by approximately one bay in depth. In such configurations, the beam ends of the recessed walls are supported by brick columns that lack internal reinforcement (Figure 26b). This structure differs from the condition illustrated in Figure 25b in that the brick columns here serve as non-structural supplementary members. Even in the absence of these columns, the structure remains stable under gravity loads. However, in the latter case, where the cantilever span extends approximately three meters, the brick columns are essential for carrying the primary vertical loads. Under normal service conditions, these brick columns are subjected mainly to axial compression and generally maintain structural safety. Nevertheless, during seismic events, significant differential shear deformation may

occur between the walls and the brick columns, potentially leading to brittle failure due to the inadequate shear capacity of the unreinforced masonry. To mitigate this risk, it is recommended that steel angle bars be installed at the four corners of each brick column and connected into an integrated system with batten plates. This combined wrapping reinforcement method can effectively improve the stiffness, ductility, and deformation compatibility of the columns, thereby enhancing their seismic performance.
