# What Changed in Post-Earthquake Reinforced Concrete Damage in Türkiye? A Comparative Study from 1992 (Erzincan) to 2023 (Malatya)

This study presents a damage-based comparative assessment of reinforced concrete buildings affected by the 1992 Erzincan earthquake (Mw 6.8) and the 2023 Kahramanmaraş earthquake sequence (Pazarcık, Mw 7.7; Elbistan, Mw 7.6), two destructive earthquake events in Türkiye separated by nearly three decades. A distinctive contribution of the study is the presentation of original color photographs from the 1992 Erzincan earthquake, systematically documented and comparatively evaluated for the first time and directly compared with post-earthquake field observations from Malatya following the 2023 earthquake sequence. To complement the field-based evidence, representative strong ground motion records from both earthquake events were processed and compared using standard seismic intensity and spectral response parameters. The spectral evaluation indicates that the 1992 Erzincan ground motion and the 2023 Elbistan-related motion recorded in Malatya imposed comparable seismic demands relevant to typical reinforced concrete buildings, thereby providing a rationa

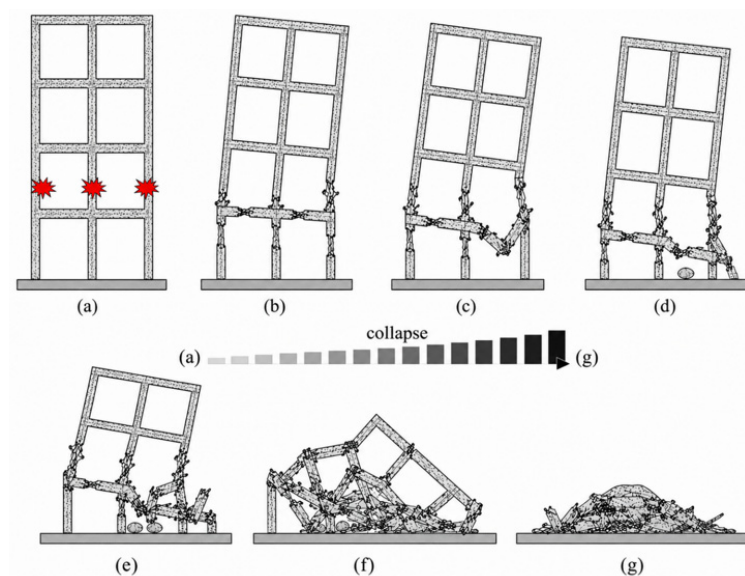
**Figure 23.** Observed sequence of progressive collapse in frame buildings following the Erzincan (1992) and Malatya (2023) earthquakes: (a) initial failure of lower-story columns, (b) propagation of collapse to adjacent floors, (c) impact between beams and columns, (d) element deformation under seismic loads, (e) element separation, (f) progressive collapse of upper stories and (g) accumulated debris (adopted from [79,80]).

Established codes such as Eurocode 2 [81] and ASCE/SEI 7-16 [82] do not recommend anything regarding the progressive collapse mechanism in the design of reinforced concrete frame structures. However, the US General Services Administration (GSA-2016) [83] and the US Department of Defense (UFC 4-023-03) [84] offer some recommendations for simulating the progressive collapse mechanism to maintain the current serviceability of structures in special situations such as explosions. Progressive collapses induced by earthquakes pose serious threats to life safety and property, resulting in substantial social and economic consequences [85]. Figure 24 shows examples of progressive collapse damage observed in the provinces of Erzincan and Malatya. The photograph shows a four-story building in Erzincan, where the collapse propagated along a horizontal plane. Observations indicate that the primary deficiency leading to progressive collapse was the presence of weak-story conditions. The absence of shear walls and inadequate interstory drift capacity further exacerbated structural vulnerability, leading to sequential failure and partial or total collapse of affected buildings. In the eight-story building located in Malatya, five stories completely collapsed, resulting in a pile of debris. It is believed that the ground floor served commercial purposes, which caused a stiffness irregularity. In addition, the condition of the upper stories indicates that the failure of this structure occurred suddenly and sequentially.
