# The Partial Collapse of the South Road Axis Viaduct in Brasilia—A Forensic Investigation

## Abstract

The partial collapse of the South Road Axis Viaduct in 2018 generated widespread concern about the safety of similar critical bridges and viaducts built during the same historical period in Brasilia. Since many of these structures were designed with analogous structural systems, a thorough post-incident investigation was conducted to understand the failure mechanisms involved. The viaduct collapse remains insufficiently examined in the available technical literature. The present work offers a detailed forensic investigation of the partial collapse of the asset, clarifying the key structural elements and governing mechanics that triggered the sudden failure. This study combined the collection of historical documentation, in situ debris investigation, geometrical and mechanical characterization, manual and numerical calculations, and the determination of structural performance. The results revealed that the viaduct had hidden vulnerabilities (such as a lack of structural redundancy and insufficient reinforcing steel) and significant material degradation and that it was operating u

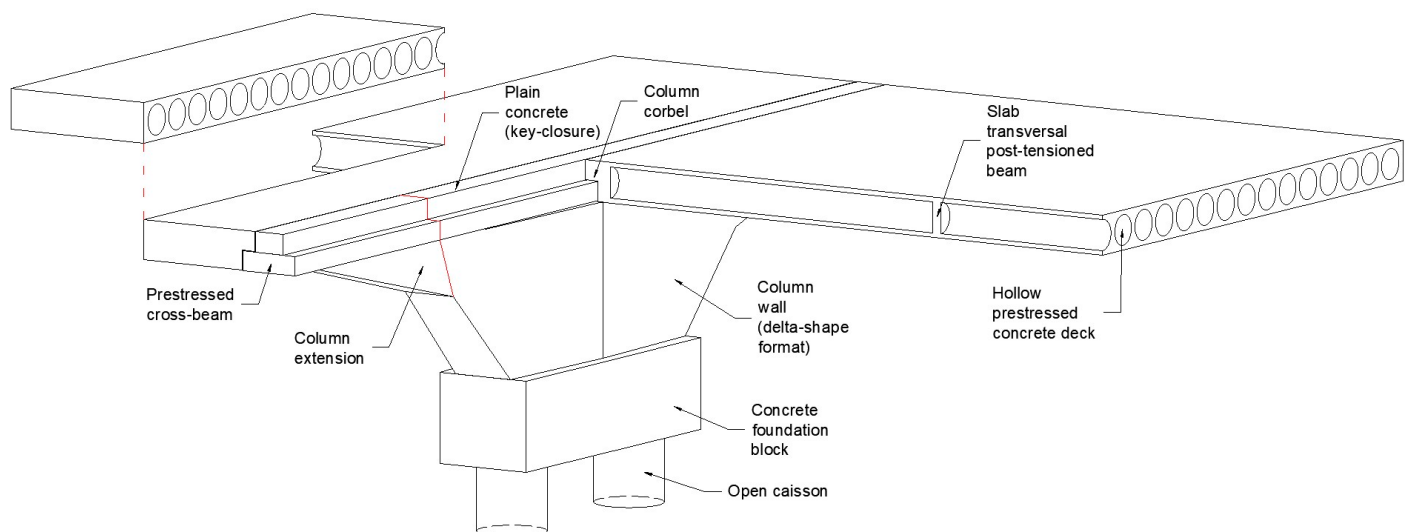
**Figure 2.** Three-dimensional view of the viaduct's structural components, with indication of failure plane and slab projection.

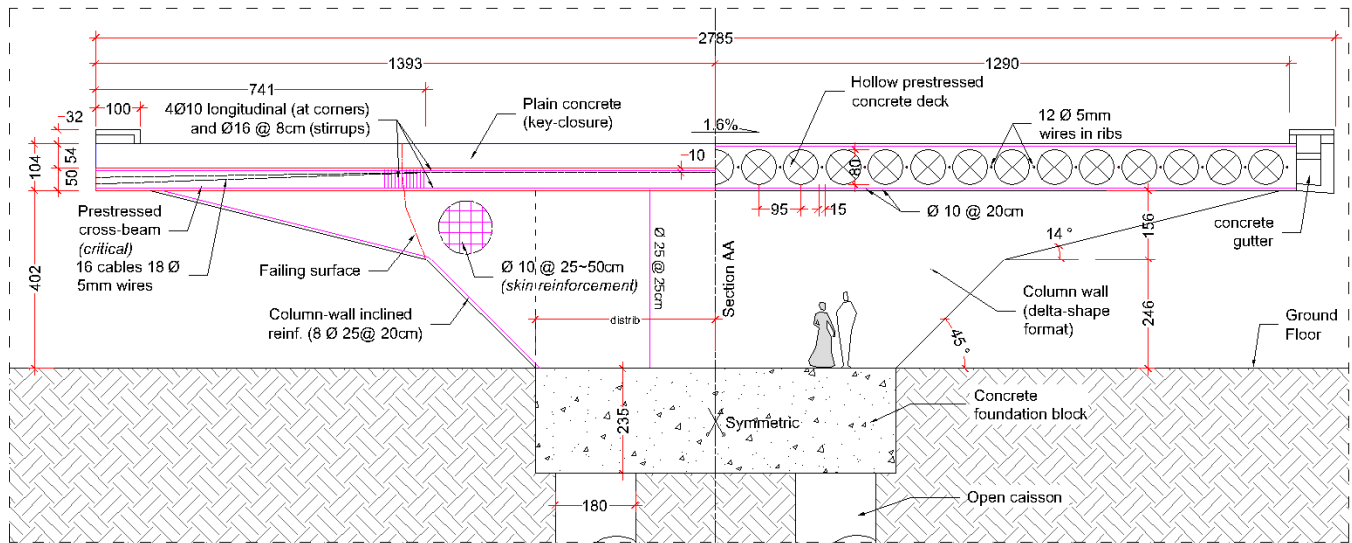
Plan View - Column-wall

**Figure 3.** Plan view of the column wall in cm. Left: details retrieved through site investigations (indicating reinforcing steel in magenta and plain concrete in blue). Right: hollow prestressed concrete deck; units are in cm (with dimension lines in red).  $\varnothing$  = diameter of rebars; @ = spacing of centers.

Post-failure forensic investigation enabled consistent mapping of the rupture plane and detailed characterization of the steel configuration within the column-wall cross-beam extension, as depicted in Figure 3. In summary, the viaduct failure was probably the mechanical realization of long-term systematic vulnerabilities, which can be synthesized into a combination of six core problems:

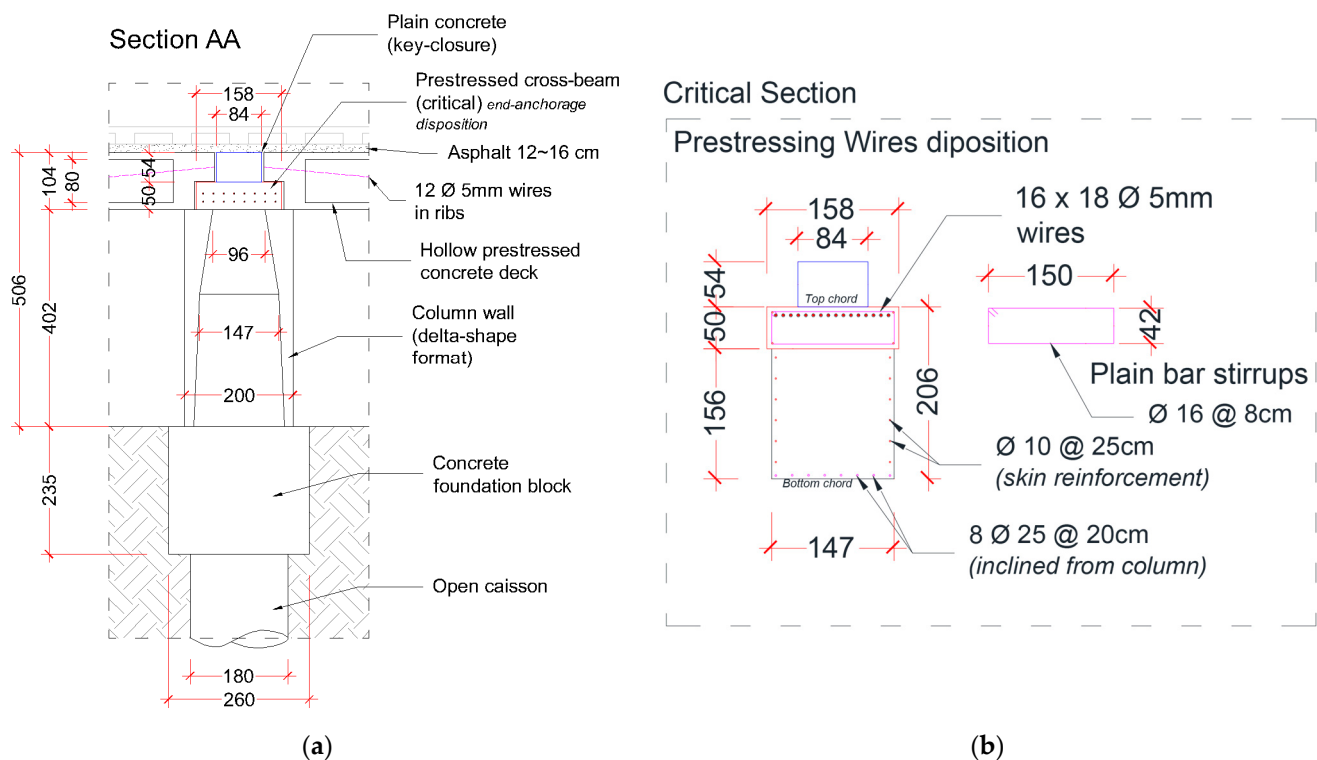
**Figure 4.** Detailing retrieved from site investigations: (a) Section AA of the column wall, which supports the hollow deck; (b) critical section for computing the capacity of the element. Units in cm, rebars are in magenta, plain concrete is in blue, dimension lines in red,  $\varnothing$  = diameter of rebars; @ = spacing of centers.

Another important detail of the assembly is the inverted T-beam extension of the column wall. It is, in fact, composed of two rectangular elements attached to one another where the failure occurred (see Figure 4a). The lower section (red rectangle  $158 \times 50 \text{ cm}^2$ ) is a prestressed concrete cross-beam comprising 16 strands (18 wires, 5 mm diameter each), while the upper section (blue rectangle  $84 \times 54 \text{ cm}^2$ ) is a key-closure plain concrete encasement. This key insertion of plain concrete was poured after the placement of the concrete slabs to seal off the prestressing cables from moisture, which was intended to isolate and protect the anchorage systems of these members. Therefore, this unreinforced element was not fully attached to the main cross-beam, nor could it attain flexural or shear resistance due to the lack of reinforcing steel. Thus, this element should be ignored in design calculations.

As shown in Table 1, the total bending moment demand over the critical section is 10,366.5 kNm, while the total shear demand is around 2888 kN. For the critical section shown in Figure 4b, the resisting bending moment (considering section equilibrium) is about 11,980.4 kNm, corresponding to a capacity demand of 86.5%. The flexural strength of the section was determined using nominal strengths (no reduction factors applied to the material strengths) for a total of 16 cables.

In terms of shear strength, the determination of the section shear capacity can be complicated since stirrups did not extend through the whole critical section depth, considering the generalized truss theory. As indicated in Figure 4b, transverse reinforcement is present only in the prestressing cross-beam, which has an effective depth of 37 cm. If the entire cross-section is considered, the effective depth is 193 cm, which is much larger than the former. This, however, should be carefully considered since the lack of transverse reinforcement could violate the hypothesis of the generalized truss model or jeopardize the strut anchorage and tie action within the section. Perhaps a more sophisticated method of calculation could be employed, such as the strut-and-tie method (STM), to assess the strength. Either way, the authors determined the shear strength for both effective depths using

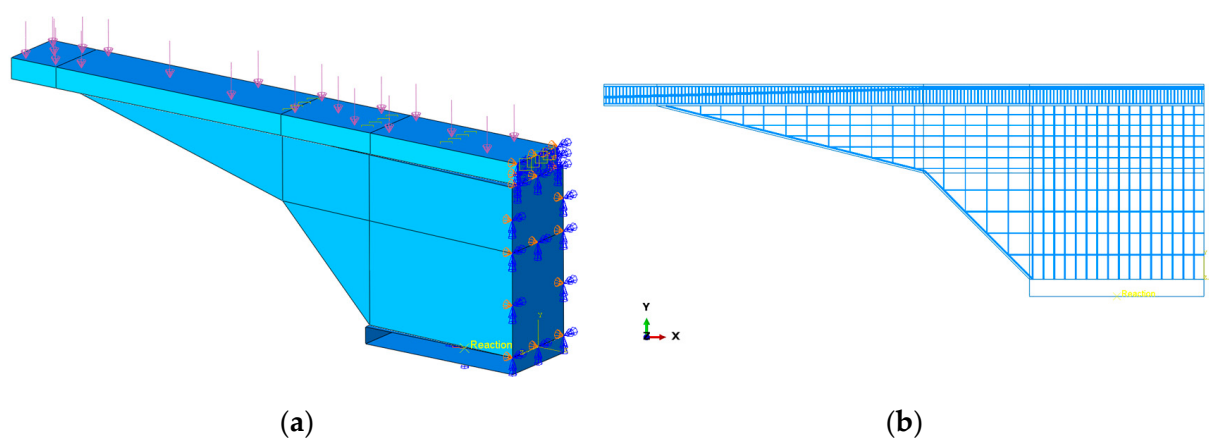
**Figure 12.** ABAQUS model of half of a column wall: (a) geometry and boundary conditions; (b) steel cage arrangement.

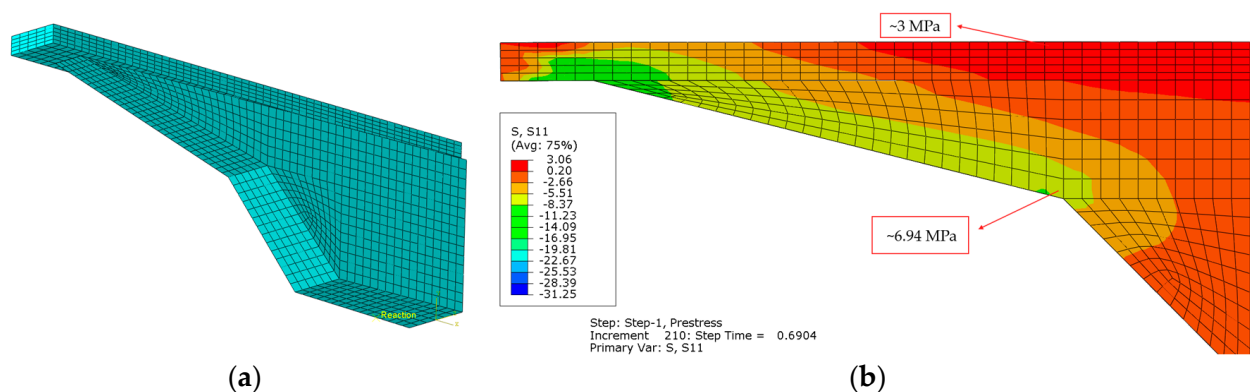
**Figure 13.** (a) Finite-element mesh arrangement; (b) level of stress for estimated service demands, showing that the top chord was operating under tension.

Self-weight loads were automatically calculated by the software based on section geometries and material densities. At the same time, prestressing forces were induced by predefined fields, and service loads were imposed as surface pressures over the cross-beam. Figure 13b shows the level of stress in the critical section under operational loads, which is fairly similar to that manually calculated and displayed in Table 4 for Crare.

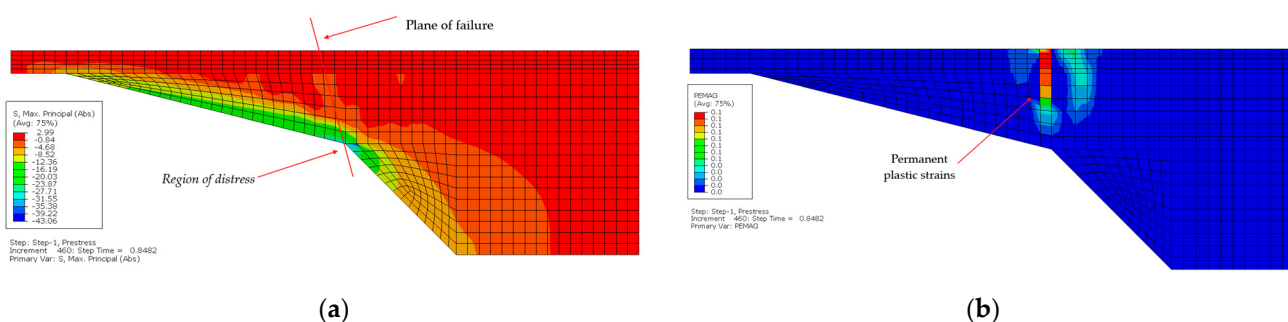
The first observation made when assessing the stress gradient across the column-wall element is that the stress path was transmitted through a tied-arch mechanism rather than a beam effect, as shown in Figure 15a. In this situation, strain distributions might be highly nonlinear, and the section may not remain plane, meaning that classical linear elastic bending theory could be invalid. In the same figure, it can be seen that the stresses at the top chord of the cross-beam exceeded the lower-bound tensile strength of the concrete. Another observation was the development of permanent plastic strain within the critical section (starting at the top cross-beam chord and propagating toward the bottom chord, where there is a geometric shift) once the tensile strength thresholds were exceeded (Figure 15b).

**Figure 15.** Model without prestressing forces in post-processing (undeformed shape): (a) stress distribution across column-wall depth; (b) permanent plastic strain distribution in critical section.

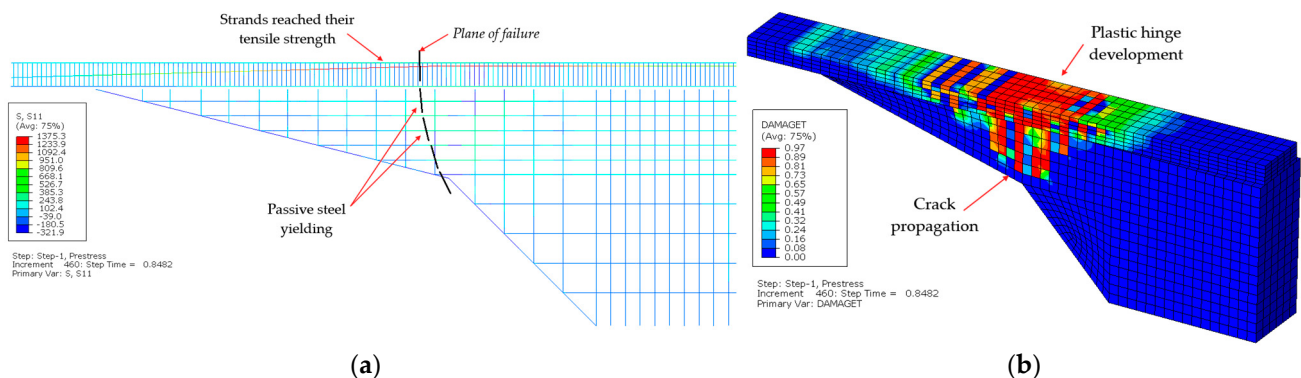
**Figure 16.** Model without prestressing forces in post-processing (undeformed shape): (a) stresses in reinforcing steel; (b) concrete damage plasticity (CDP) model with crack propagation.

The preceding figures suggest that the modeling technique employed could effectively capture the failure mode observed, summarized as follows: the failure initiated during bending, with crack propagation throughout the entire depth of the column-wall extension. This was followed by the yielding of the flexural reinforcement and the formation of a plastic hinge in the cross-beam. Once this mechanism developed, extensive cracking and deformation would have been expected, and without proper reinforcement detailing, the section would shear off.

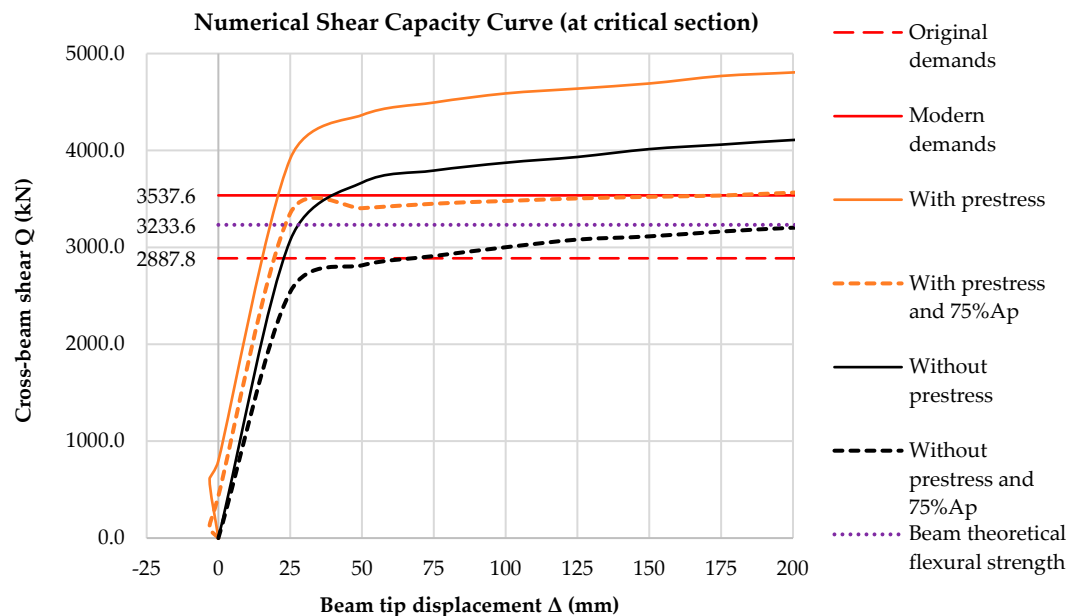
Figure 17 suggests that the numerical model was able to withstand the prescribed load demand recommended by the former Brazilian standard for both models with and without prestressing. In both cases, yielding was initiated after the beam-end deflection exceeded 25 mm (0.3% drift), with the model without prestressing exhibiting lower strength during the post-elastic regime. In addition, prestressing forces induced an upward beam deflection (negative, since the positive reference is downward), which was eventually counteracted by the increasing surface pressure over the cross-beam. The prestressing model showed higher capacity and similar ductility, as both strengths increased due to the steel strain-hardening property. This assessment indicates that the structural design might have been adequate for the load demand during the construction period and even for modern demands. However, since the viaduct collapsed suddenly (brittle failure), the structure may have lost part of

its ductility capacity over time, as evidenced by the observations in Section 3.2. When the dashed lines meet the solid capacity curve lines, failure could have occurred at a small deformation demand (under 25 mm), indicating little available ductility. This suggests that material degradation coupled with a loss of ductility (due to a reduction in steel areas and stress corrosion) might have triggered the collapse mechanism rather than excess load or poor engineering judgment.

**Figure 17.** Capacity curves of numerical models with and without prestressing forces.
